Section B

SURFACE AND POINT SOURCE EROSION (ROADS/SKID TRAILS)

Willow Creek / Freezeout Creek Watershed Analysis Unit

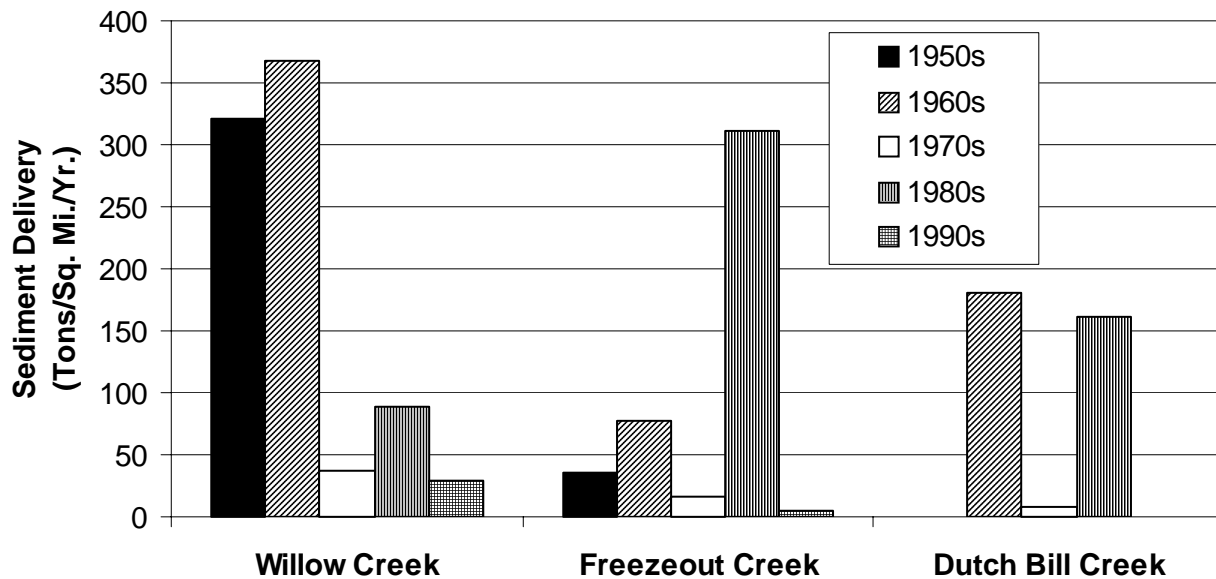
Figure B-1. Estimated Skid Trail Sediment Delivery Rate by Watershed and Decade for the Willow/Freezeout Creek WAU.

In Willow Creek the entire forested portion of what is now the MRC ownership was harvested using tractor based yarding during the 1950s and 1960s. This high level of skid trail construction and use is estimated to contribute a high level of sediment delivery. The sediment delivery estimated from skid trails in Willow Creek is by far the highest in the 1950s and 1960s (Figure B-1). Freezeout Creek was almost completely harvested using tractor based yarding during the 1980s and thus the highest sediment delivery for that watershed occurred during that decade. Dutch Bill Creek lands had high skid trail use and sediment delivery in both the 1960s and the 1980s.

Skid trail sediment delivery diminishes in the 1990s in all watersheds. This is produced from a combination of less harvest activity and stricter regulations on tractor based yarding use. Future skid trail sediment delivery rates will be lower than past rates because California Forest Practice Rules and MRC policy mandate better managed tractor yarding activities. Better erosion control measures are used on skid trails such as increased water bar spacing and a practice by MRC of packing the trails with logging debris (slash), when available, after operations to prevent surface erosion. Furthermore, skid trail operation is limited next to watercourses and prohibited directly in watercourses.

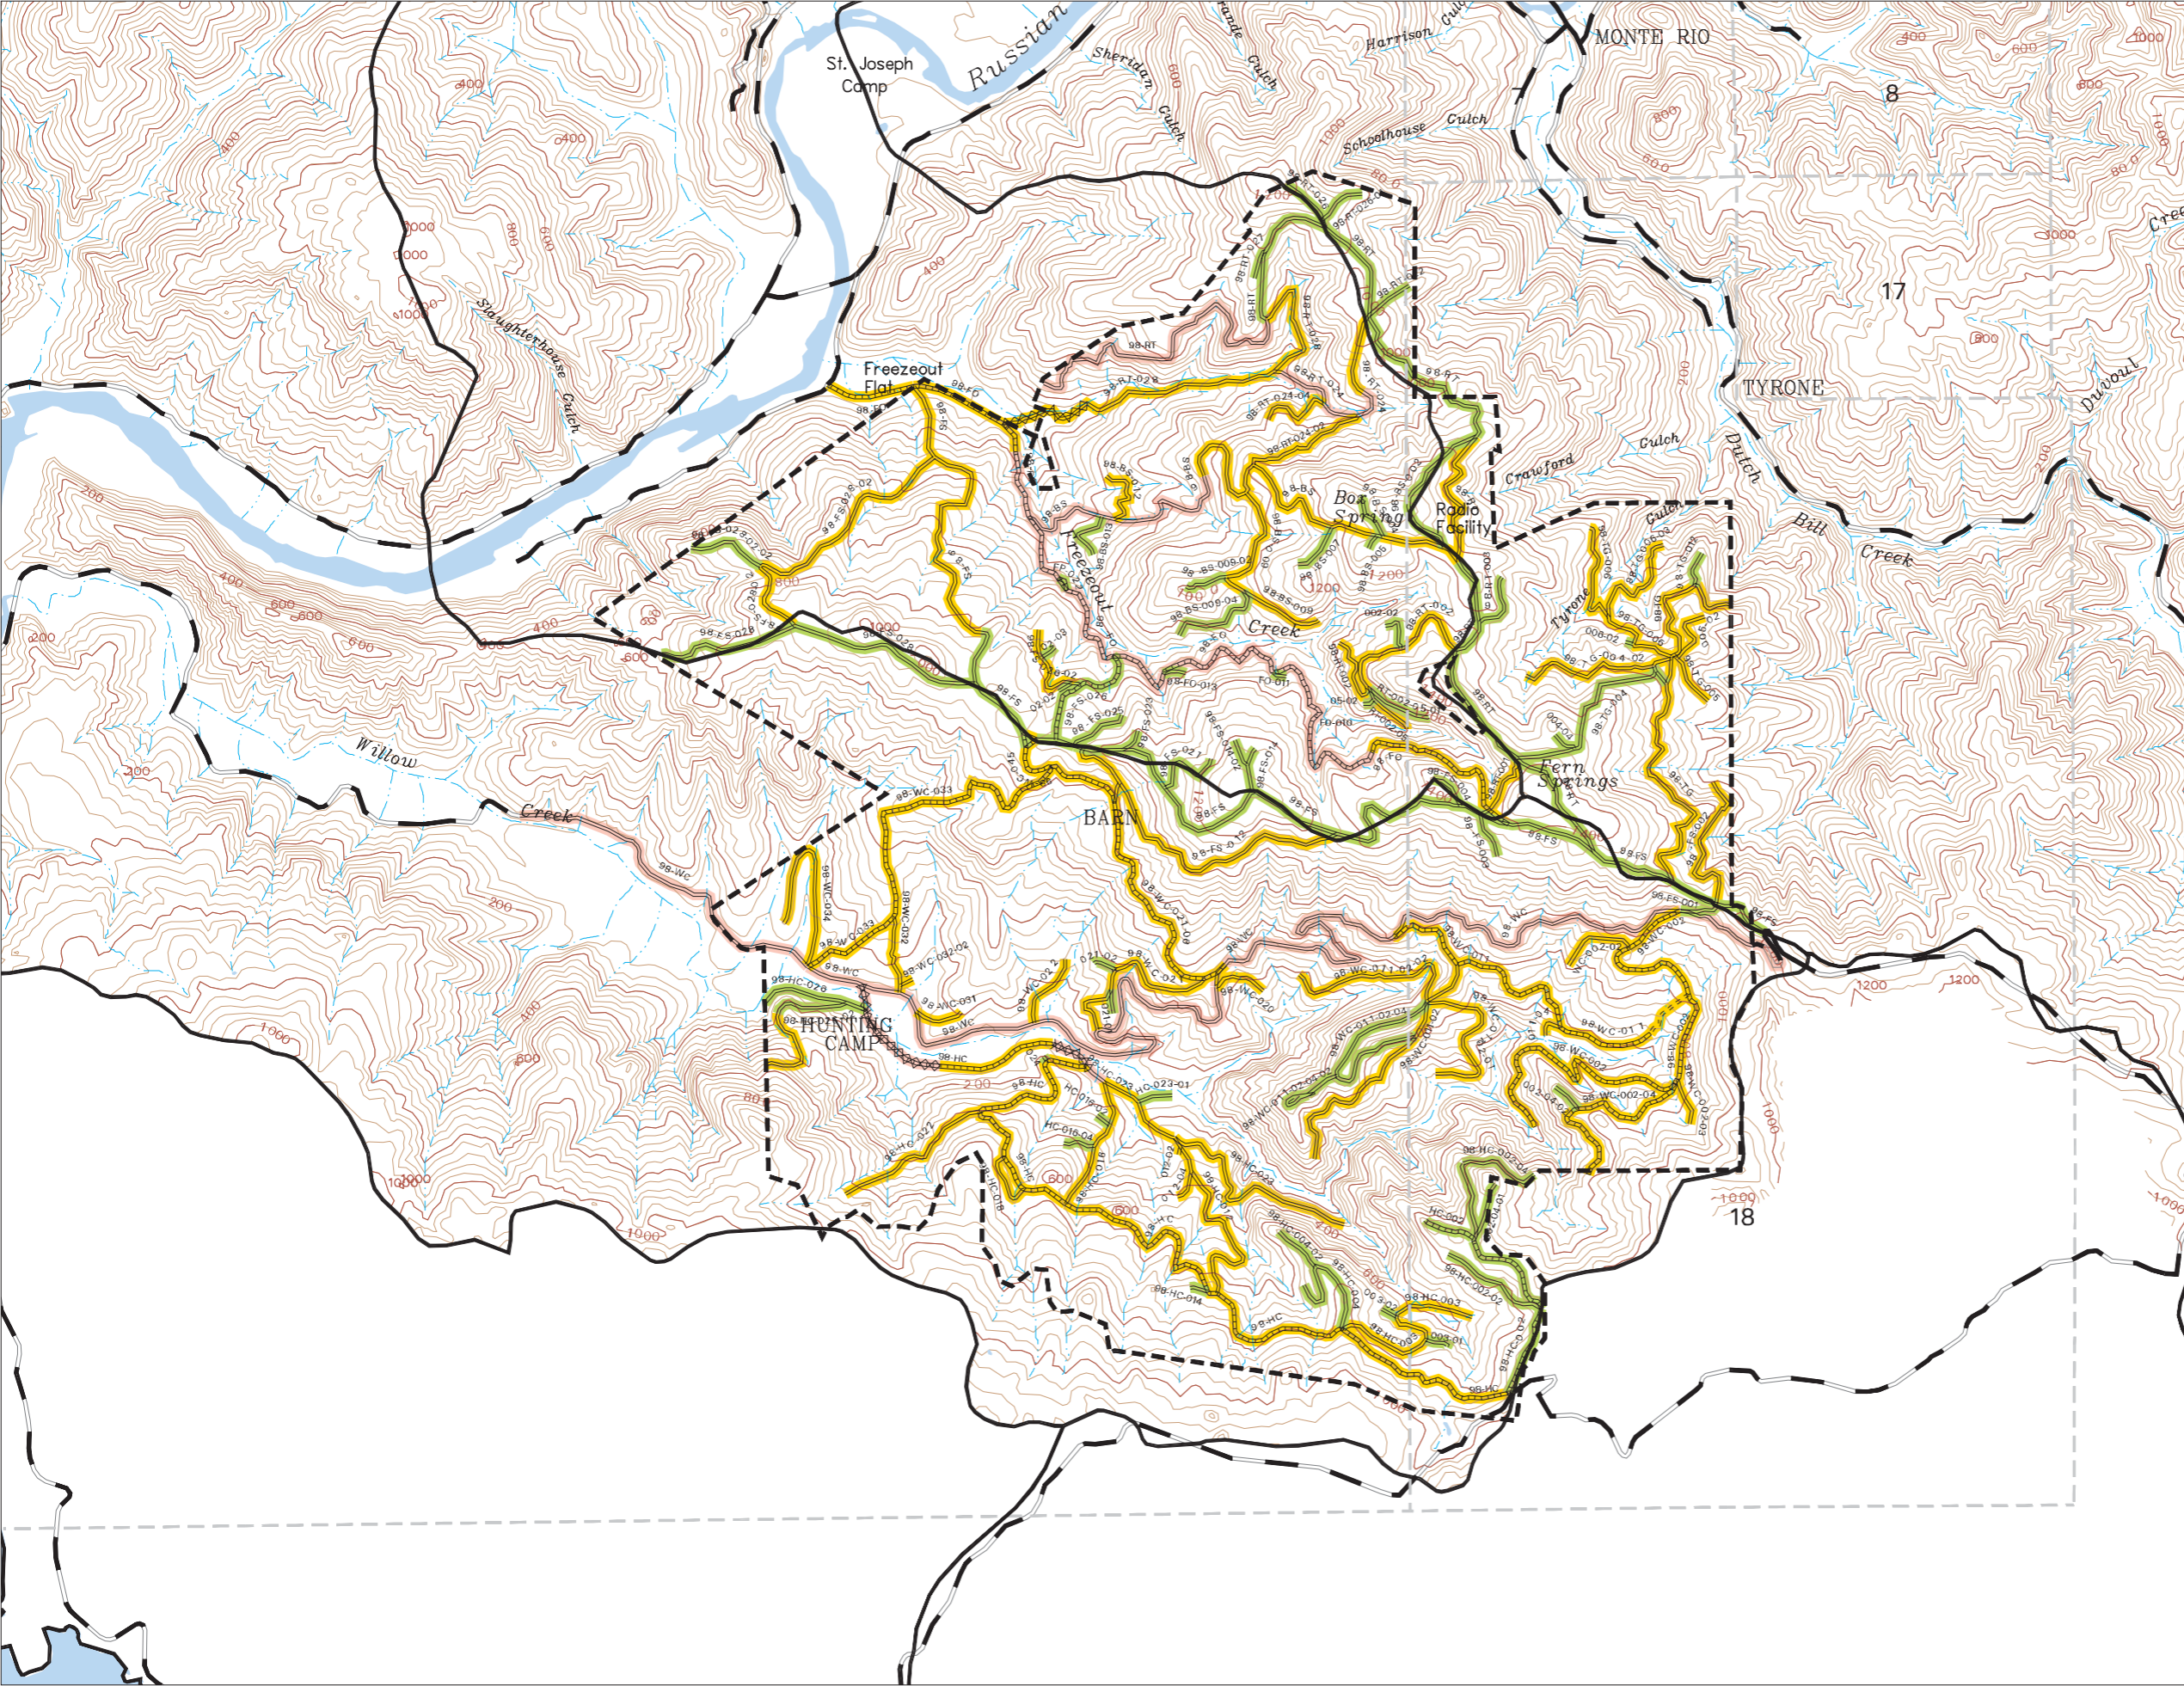
Map B-1 Road Surface Erosion Hazard Ratings

The road erosion hazard classification for each road in the Willow/Freezeout Creeks WAU is presented on Map B-1 and for each individual road in the appendix of this module. The categorizing of roads into hazard classes is intended to identify current problem areas, consider reconstruction and prioritize maintenance. The following are the definitions for each road erosion hazard class.

High Road Erosion Hazard Class - These roads have the highest amount of recent deliverable surface erosion to watercourses and a high potential for future deliverable erosion. These roads can be active, abandoned or closed. Often roads in this class are close to watercourses creating a high sediment delivery potential. Erosion is typically due to long contributing road lengths or native surfaces near watercourses: a result of too few waterbars and/or rolling dips or lack of rock surface. Erosion may also be a product of problem areas such as watercrossing wash-outs, poor road drainage, plugged road watercrossings, water diverted down the road surface, culverts not fitted with downspouts, etc. Active roads in this class should get the highest priority for maintenance or improvements. Closed roads in this class will need improvements before opening again. Opening abandoned roads in this class should be avoided.

Moderate Road Erosion Hazard Class - These roads have moderate amounts of recent deliverable surface erosion to watercourses and potential for future deliverable erosion. These roads can be active, abandoned or closed. Erosion problems on roads in this class can usually be handled with good road maintenance. Erosion is typically from problem areas such as poor road drainage, water diverted down the road surface, culverts not fitted with downspouts, and an occasional plugged culvert or watercourse crossing wash-out. Active roads in this class should be a priority for maintenance. Closed or abandoned roads in this class will need some improvements before opening again.

Low Road Erosion Hazard Class - These roads have low amounts of recent deliverable surface erosion to watercourses and low potential for future deliverable erosion. These roads can be active, abandoned or closed. Active roads in this class do not need to be a priority for maintenance. Closed or abandoned roads in this class will need only some improvements before opening again.

The road network is classified as High, Moderate and Low surface erosion hazard (Map B-1). The roads with the high hazard are the highest priorities for improvements, monitoring or maintenance. The moderate hazard roads are a medium priority for improvements, monitoring or maintenance. The low hazard roads are not much of a concern for sediment delivery.

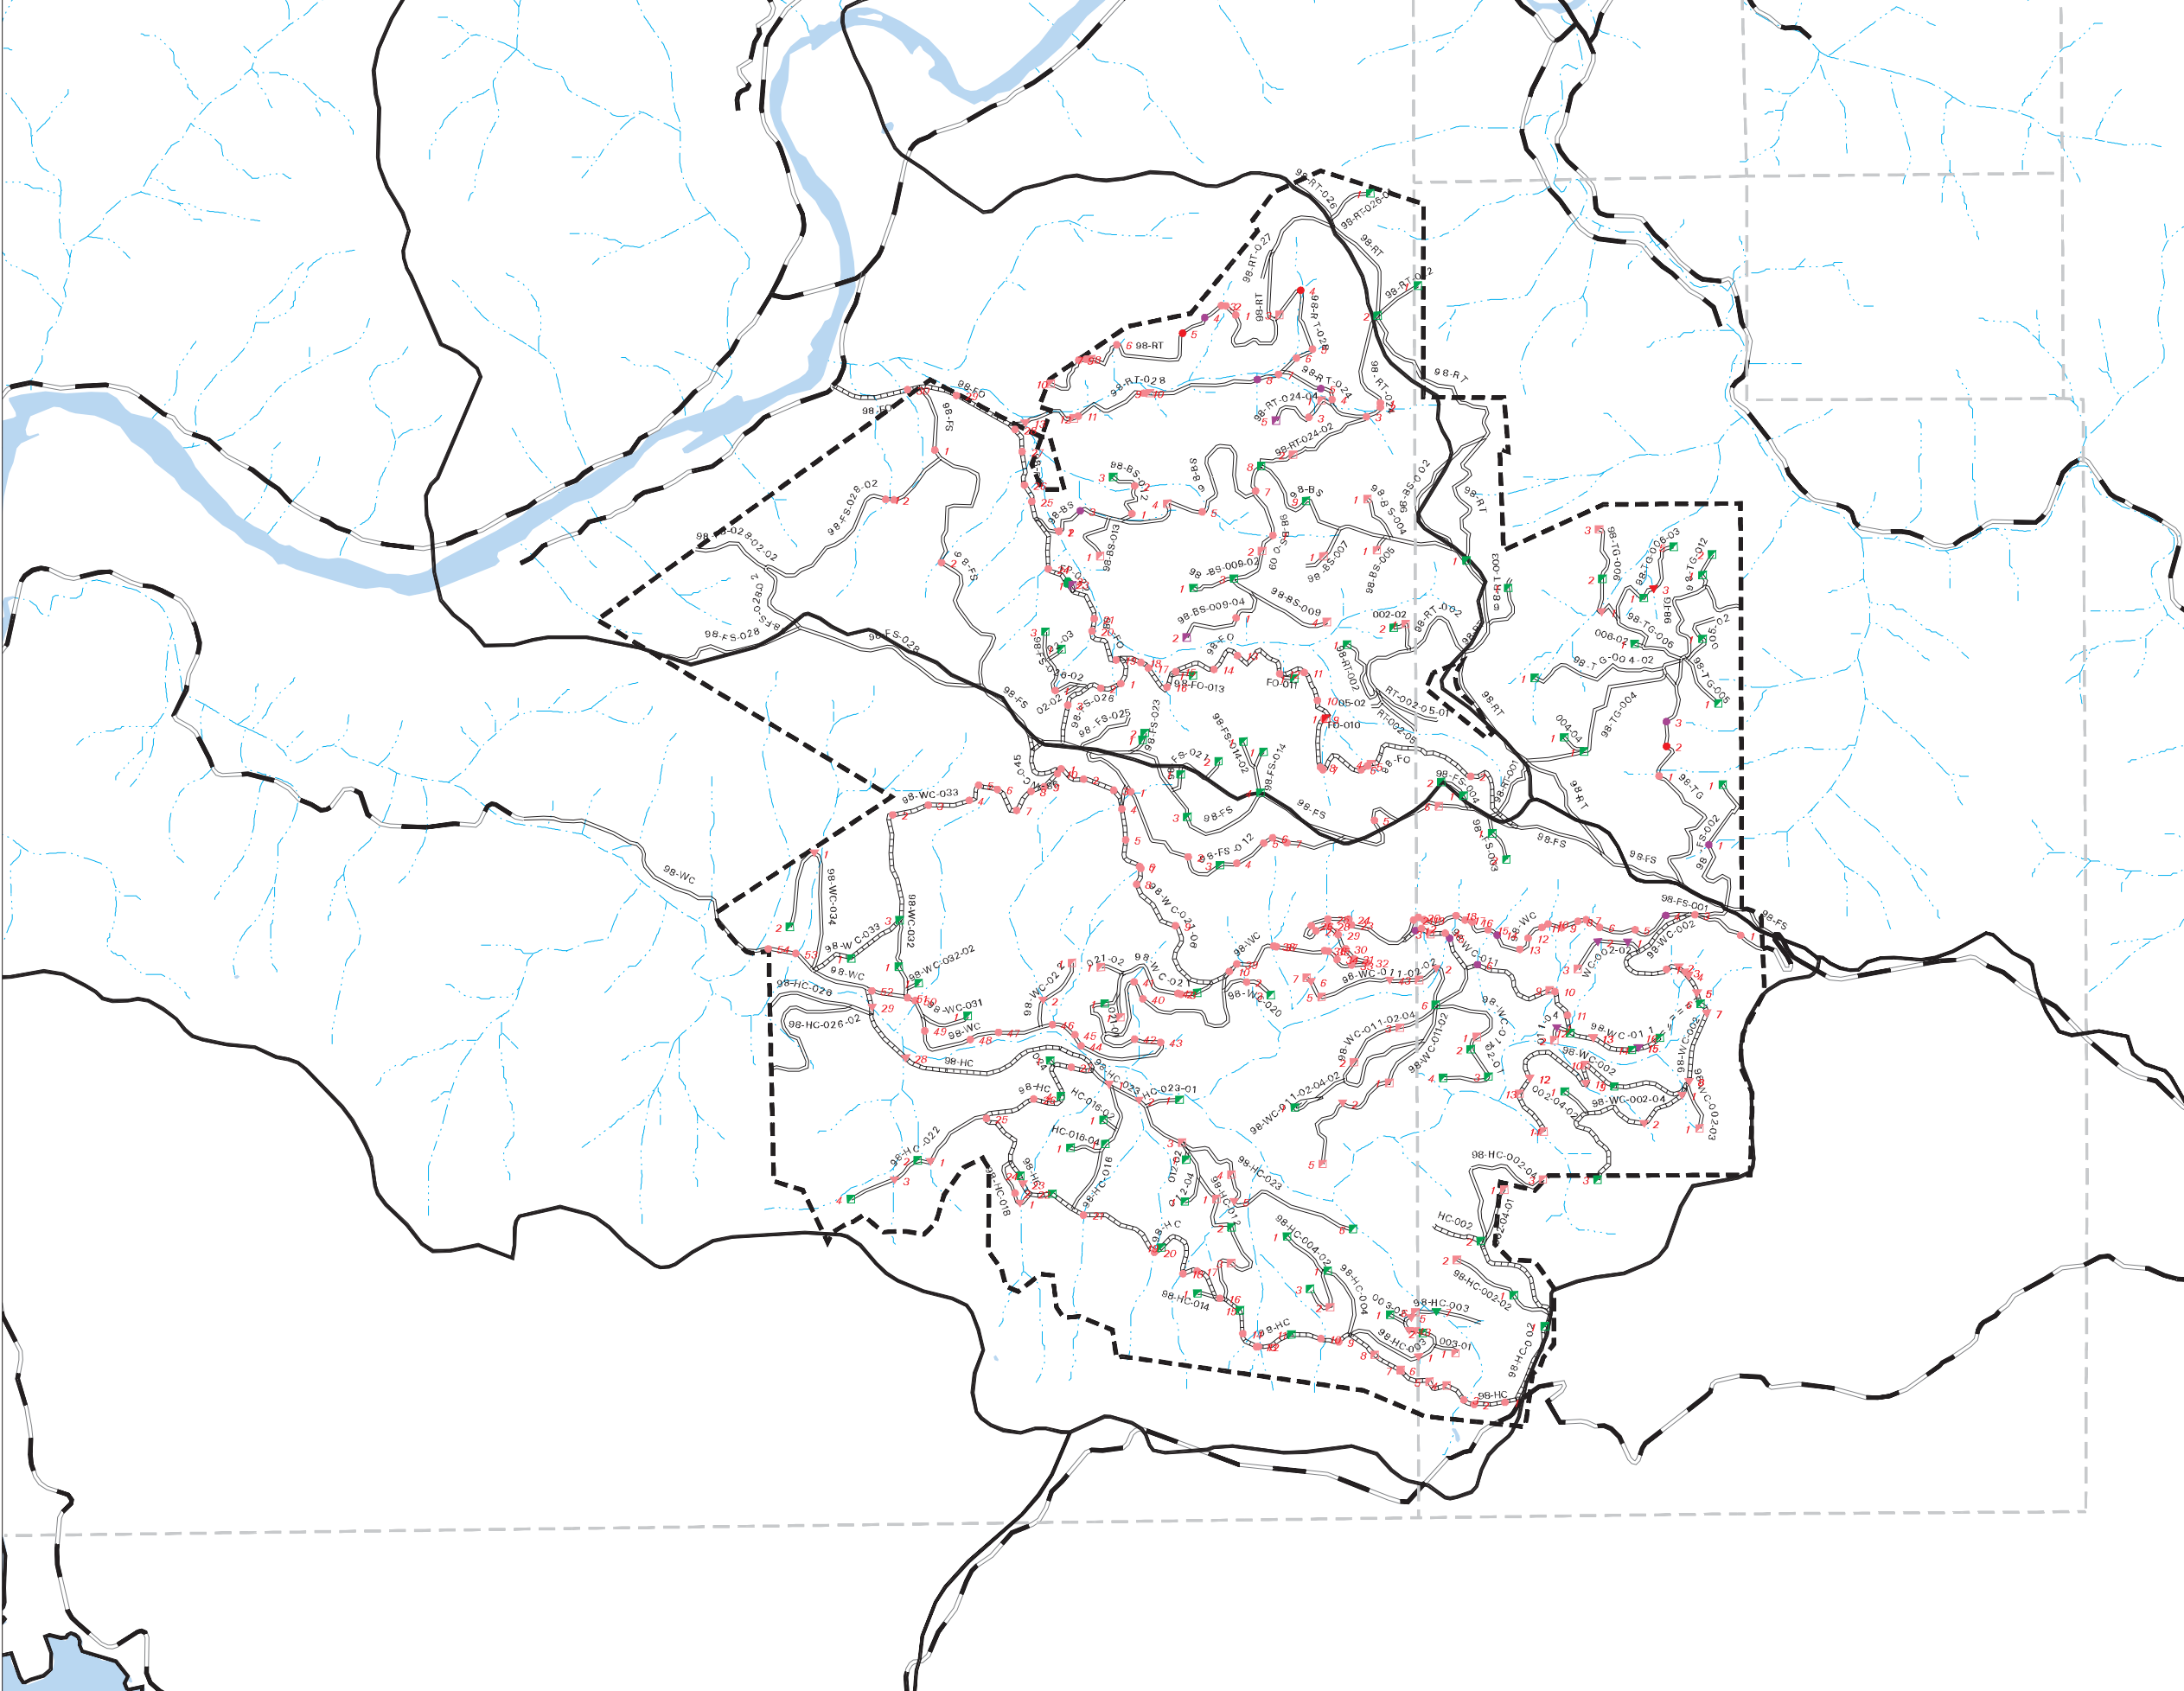
Map B-2 Road Feature Treatment Immediacy

Potential controllable (point source) erosion sites were identified and prioritized in the Willow/Freezeout Creeks WAU. In the Willow/Freezeout Creeks WAU 6 controllable erosion sites have a high treatment immediacy and 20 controllable erosion sites have a moderate treatment immediacy. In addition to these controllable erosion sites 54 culverts in the Willow/Freezeout Creeks WAU have a diversion potential. These diversion potential sites need to be considered a high priority for road improvement as they can represent a significant potential point source erosion hazard. The treatment immediacies, road site numbers and road numbers are found on Map B-2. The road number and site number of each controllable erosion and diversion potential site is in Appendix B of this report.

The culvert size analysis has determined that 26 culverts are likely too small to pass the 50 year flood and an additional 3 culverts will not pass the 100 year flood. These culverts need to be a high priority for upgrade should they indeed be under-sized. The analysis of culvert sizing is only an estimate based on culvert location from the MRC road inventory and area behind the culvert based on MRC GIS topographic data. A field review will be required at each site to determine if the culvert is indeed under-sized, as our confidence in the analysis is low. However, the identification of these culverts as under-sized is a good hypothesis to work from and provides information to address potential road problems in Willow/Freezeout Creeks WAU.

High and moderate treatment immediacy controllable erosion and diversion potential sites were identified along the roads in the Willow/Freezeout Creeks WAU and needs to be a focal point of ongoing forest operations. The Willow/Freezeout Creeks WAU currently has 6 high treatment immediacy sites, 20 moderate immediacy sites and 54 sites with a diversion potential. Potentially 26 culverts are too small to pass the 50

year flood and 3 additional culverts likely will not pass the 100 year flood. These sites will be a priority for improvement of the road network in the Willow/Freezeout Creeks WAU. The road number, site number for each individual site is shown on Map B-2 and in Appendix B of this report.
