# **Mattole River Watershed Analysis**

## **Cumulative Watershed Effects**

*Public Review Draft*

**September 2011**

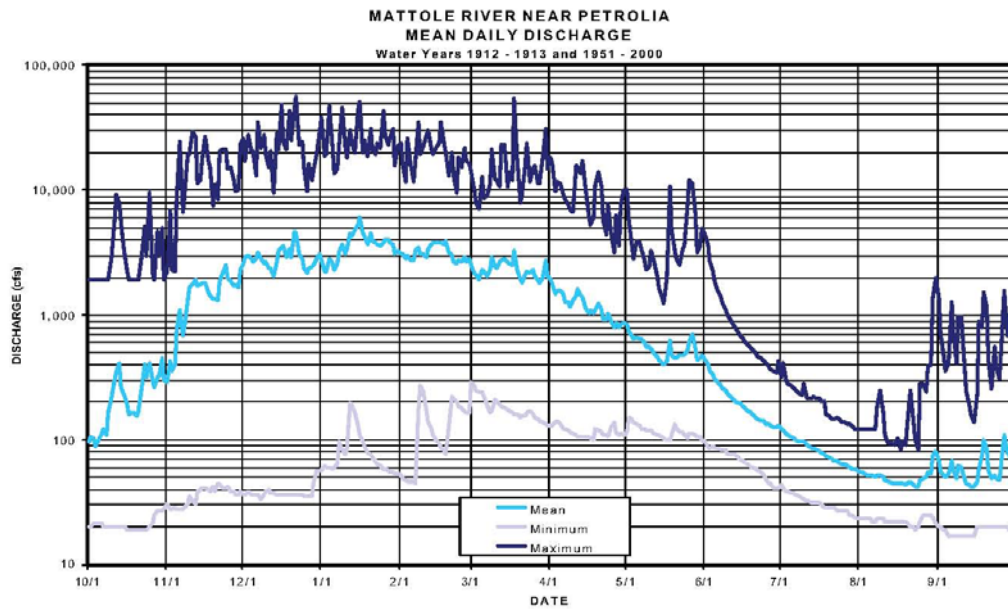
**Figure 3-7. Mean, maximum, and minimum daily discharge for water years 1912-1913 and 1951-2000, USGS station #11469000.**

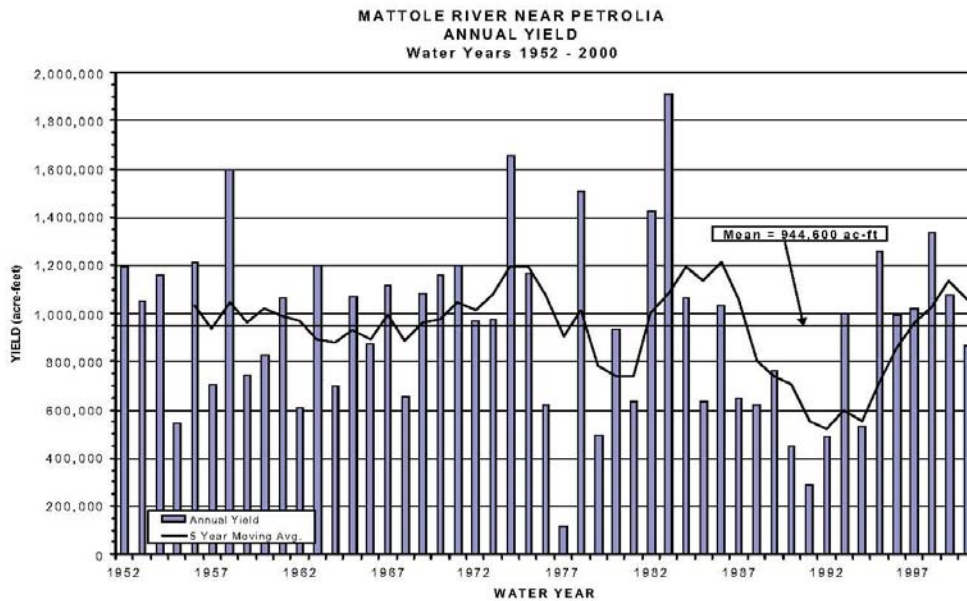
**Figure 3-8. Annual yield and the five-year moving average for water years 1952-2000, USGS station #11469000.**

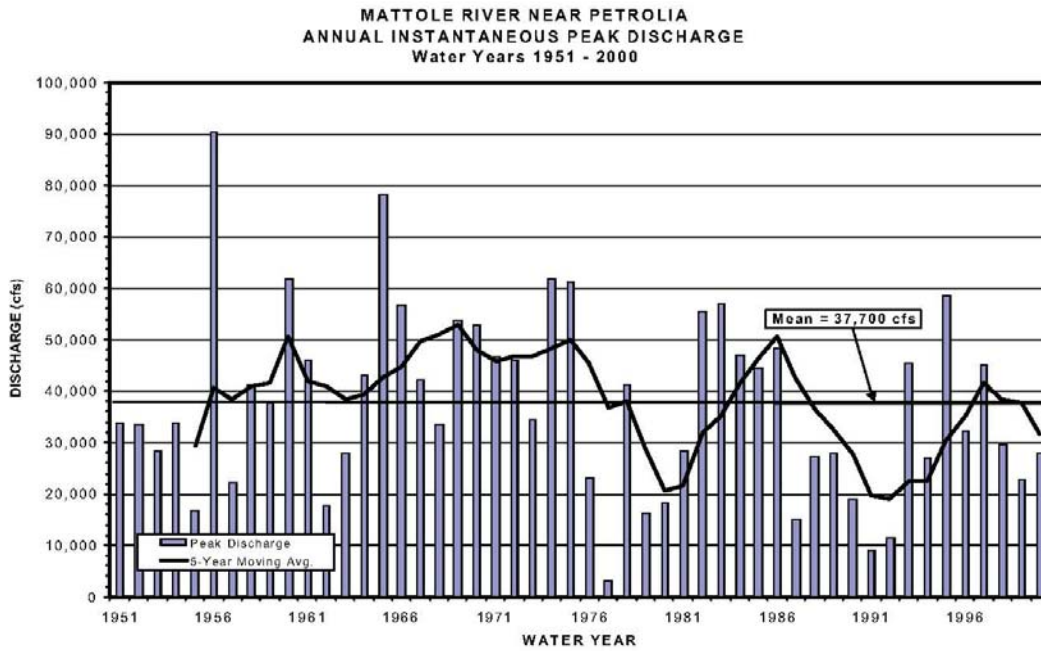
**Figure 3-9. Annual instantaneous peak discharge and the five-year moving average for water years 1951-2000, USGS station #11469000.**

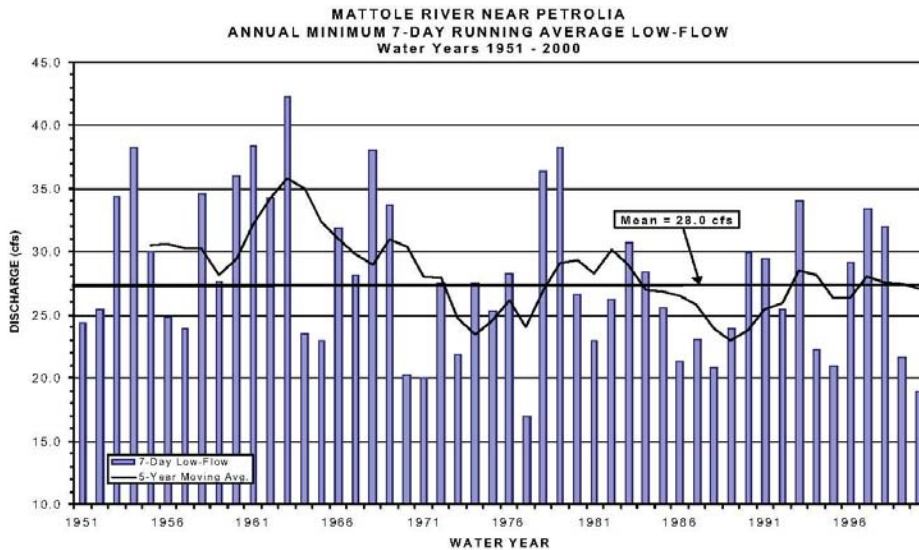
**Figure 3-10. Annual minimum seven-day running average low-flow and the five-year moving average for water years 1951-2000, USGS station #11469000.**

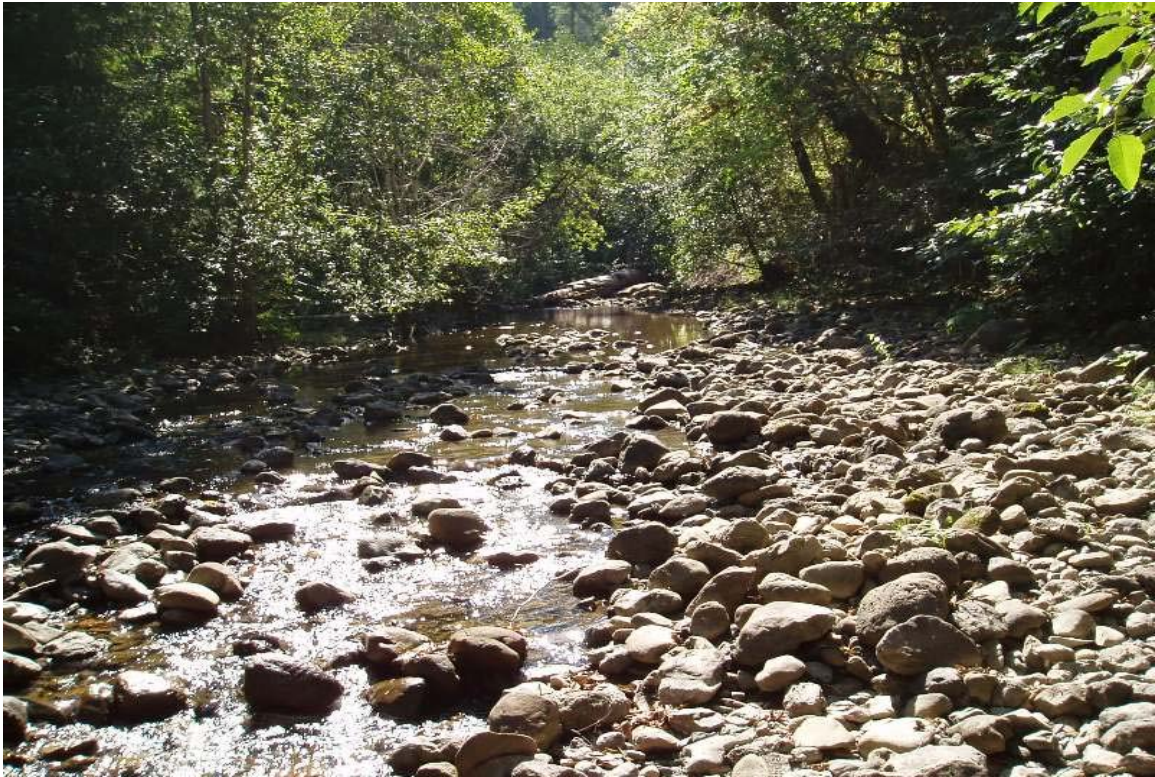
**Photo 3-1. East Branch North Fork Mattole River, fluvial confluence reach downstream of Sulphur Creek, August 2005.**

Stream temperature data are generally lacking and cannot be assessed, though the westerly aspect of the East Branch North Fork Mattole River results in partial topographic shading provided by steep inner gorges, in addition to shade provided by streamside canopy.

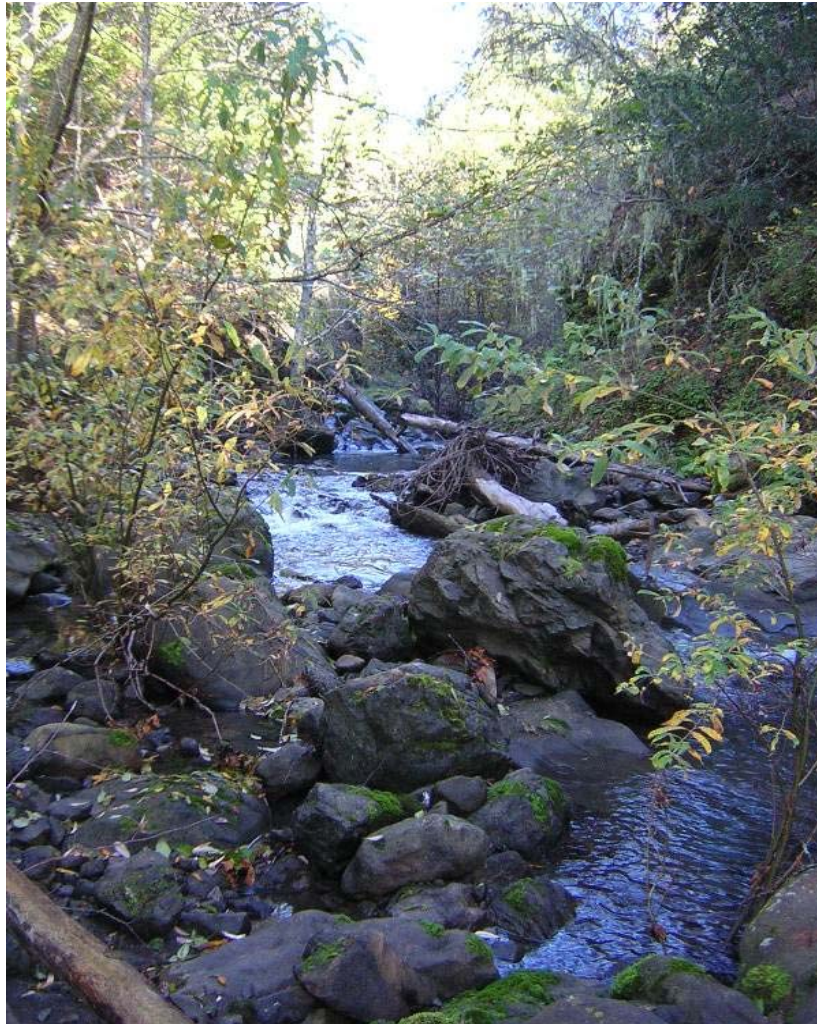
**Photo 3-2. Sulphur Creek, upper end of ATM monitoring reach, September 2005.**

The authors walked segments upstream of the ATM monitoring reach (Photo 3-2) that were characterized (refer to the Channel Module Figures 14 and 15) as “earthflow flats” (low gradient, unconfined with floodplains) and observed high amounts of stored alluvial sediments within narrow floodplains on either side of the active channel. It was evident that the active channel was cutting through this material,

leaving terraces that are 4 to 5 feet high in many locations. These observations were consistent with past observations made by CDFG (1988) that Sulphur Creek was recovering from past floods as indicated by “flood terraces.”

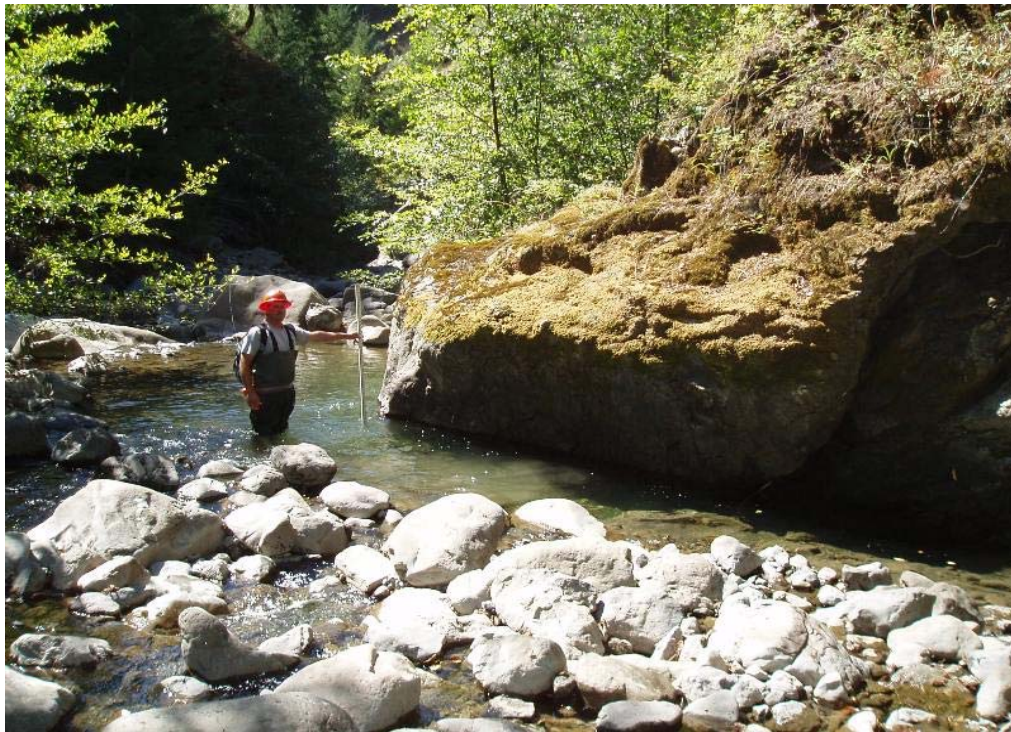
**Photo 3-3. Oil Creek, upper reach, August 2005.**

One of the authors of the Fish Habitat Assessment module walked the lower reach of Oil Creek in 2005 and noted that the active channel was small relative to the bankfull channel, which was structurally controlled by steep eroding banks and inner gorges (Photo 3-3). The active channel was subject to areas of vertical and lateral shifts that periodically cut through large deposits of alluvium stored in the floodplain, which indicated a high sediment supply. The young age of vegetation growing within the bankfull channel coupled with the transient appearance of stored alluvium also indicated that this was a high energy stream with flashy flows in response to storm events.

Wood storage in Oil Creek is generally low and streamside landslides are the dominant delivery mechanism. Pool quantity has increased over time and pool quality is fair (average residual pool depth was 1.6 feet). Pools are more abundant in upper reaches. Although there are few deep pools, the availability of pool habitat does not appear to be a limiting factor for rearing salmonids. Pool spacing is controlled by bedrock and boulders and these permanent structures form the primary pools in upper reaches. Unstable eroding banks in lower reaches transition to bedrock banks in upper reaches, which are

stable and contribute only small amounts of sediment during runoff. Lower reaches have erosive, steep banks that are subject to failure during bankfull events.

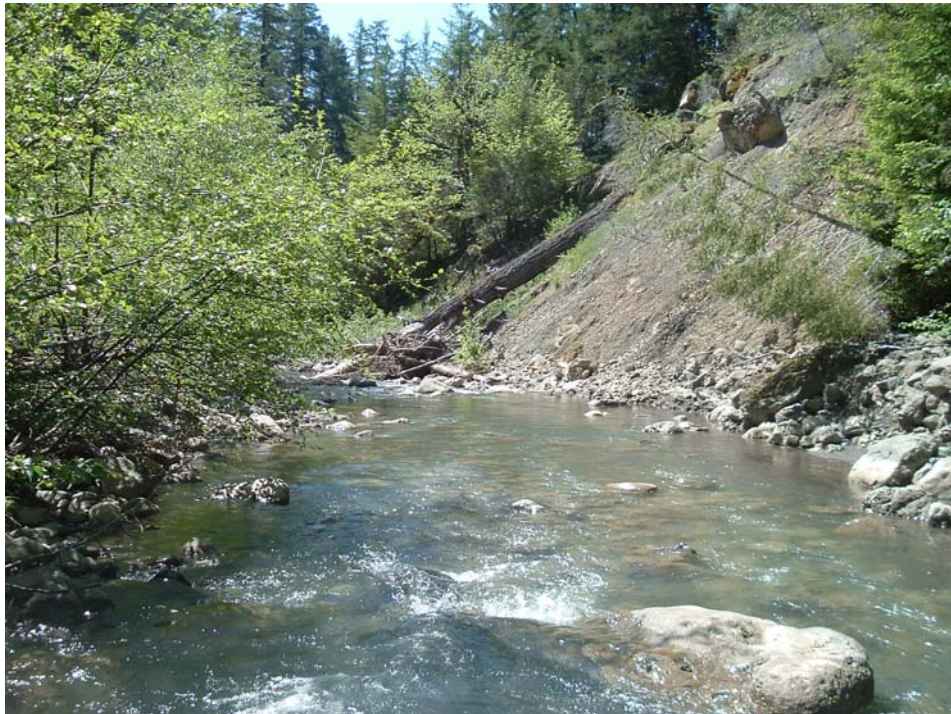
**Photo 3-4. Rattlesnake Creek, streamside landslide, May 2005.**

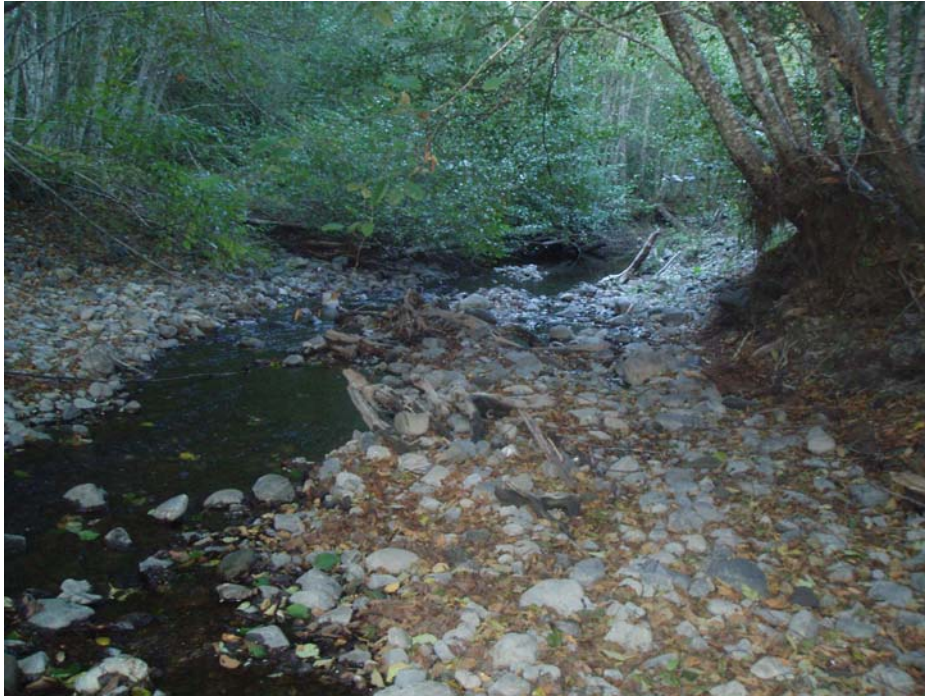
**Photo 3-5. McGinnis Creek, lower reaches, October 2010.**

McGinnis Creek is a major tributary to the Mattole River draining approximately 4,700 acres and providing 5 miles of perennial fish-bearing stream habitat (Downie et al., 2003). HRC owns and manages approximately 2,200 acres of the watershed including 3.6 miles of fish-bearing habitat. While the authors could find no record of documented detections, McGinnis Creek appears the most likely stream on HRC's Mattole ownership to provide readily accessible habitat for Chinook and coho salmon. Several habitat typing surveys of McGinnis Creek have been conducted from 1966 to 2005, and HRC maintains a recently established (2005) permanent ATM station approximately 0.5 miles upstream from the mouth (ATM Station 219). The system appears to have a moderate to high sediment supply as evidenced by depositional features such as point bars and aggraded channel conditions (see Photo 3-5). The channel is susceptible to shifts in both lateral and vertical stability associated with changes in flow and sediment regimes. Streambanks in lower reaches are susceptible to accelerated bank erosion and rates of lateral adjustment (meandering) appeared to be influenced by the presence, condition, and maturity of riparian vegetation.

During the 2010 field visit, the biologists observed that habitat complexity appeared to have improved during the preceding 5 years. The lower reach was meandering through the alluvial deposits, which resulted in some bank erosion, pool formation, and delivery of alder-dominated large and small woody debris along the outside of the meander bends (Photo 3-5; note exposed woody debris, root mass, and pool with alder woody debris recruitment). Pools were also observed along bedrock exposures. It appeared that pools made up about 40% of the stream length. Pool depths ranged from about 1.5 to 3 feet. Evidence of channel downcutting was present as seen by relatively recent exposures of old alder stumps that were previously buried under alluvium. The majority of pools observed in 2010 resulted from development of the meander pattern and associated scour around the recruited hardwood woody debris. The riparian assessment characterized overstream canopy cover as high (>85%) along much of

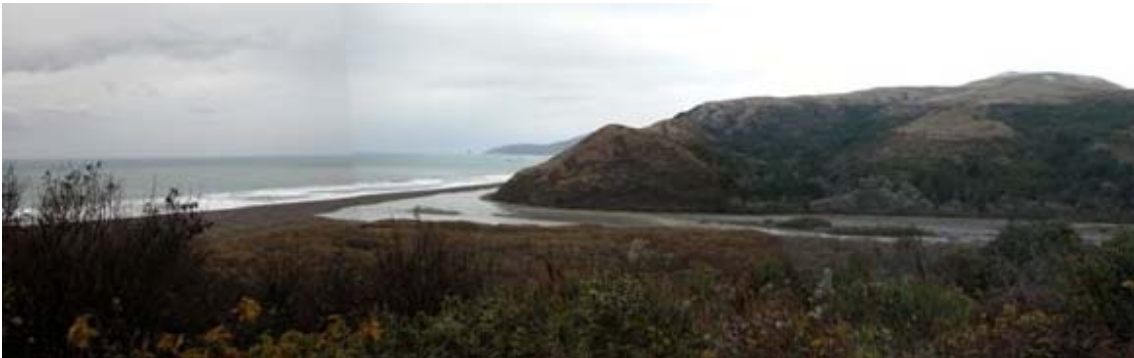
**Photo 5-1. Mattole River estuary.**

Available spawning habitat is generally no longer considered a limiting factor for salmonid production and it appears clear that there is far more suitable spawning habitat available than there are spawning adults to utilize it (MRRP, 2009a). Salmonid rearing habitat on the other hand, appears to be a critical limiting factor, as there is a lack of suitable thermal habitat for all species of juvenile salmonids throughout much of the mid and lower river mainstem. The mainstem Mattole River (particularly the lower 26 miles downstream from Honeydew including the estuary/lagoon at the mouth [Photo 5-1]), along with downstream, lower gradient reaches of tributaries, store significant amounts of sediments contributed from higher gradient tributaries. Lack of deep pools due to persistent stored sediment, and low summer flow leads to this adverse thermal condition, as well as to low levels of dissolved oxygen in late summer.

This sedimentation has also aggraded estuary channels and backwater pools reducing the ability of tides and riverflows to flush the sediments that accumulate in both the estuary and mainstem. As a result, current conditions in the estuary are considered a significant bottleneck to Chinook salmon survival and large numbers of over-summering juveniles have been reported to die off on an annual basis due to lethal water temperatures, limited food sources, and lack of shelter from predators (MRRP, 2009a).

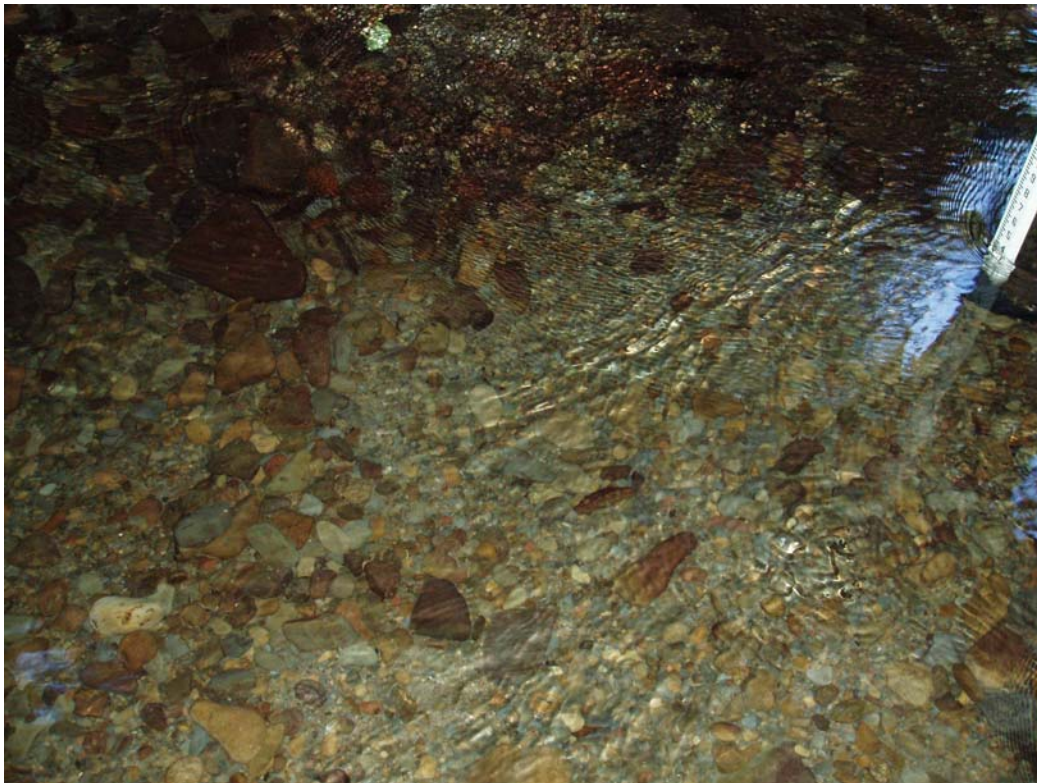
**Photo 5-2. Pool tail-out and suitable spawning habitat.**

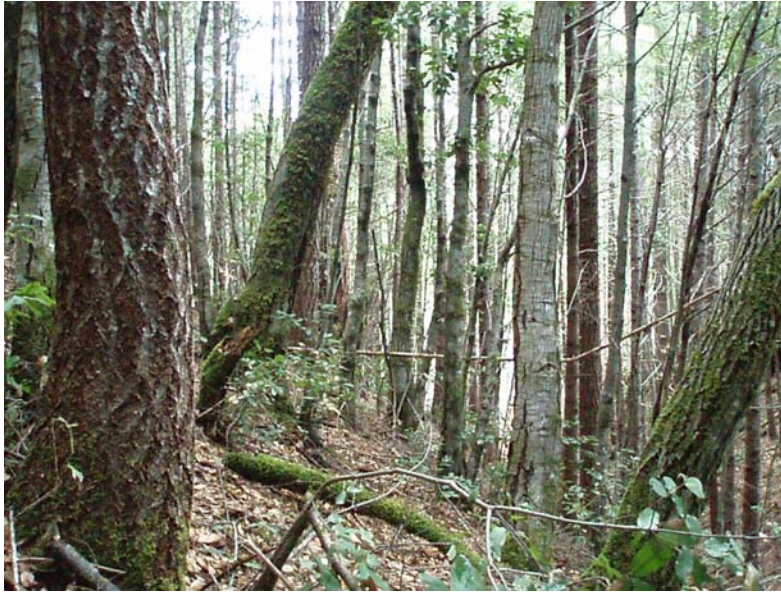
**Photo 5-3. Riparian stand with RCU code MMD.**

The RCU type MMD (mixed conifer–hardwood stand, small trees, moderate/dense canopy) represented approximately 64 percent of all riparian habitat on Mattole River HCP lands (Photo 5-3). The next most-common RCU type CLD (conifer stand, medium to large trees, moderate/dense canopy) represented approximately 8 percent of all riparian habitat on HCP lands, followed by the RCU type HMD (hardwood stand, small trees, moderate/dense canopy) at approximately 5 percent of total riparian habitat.

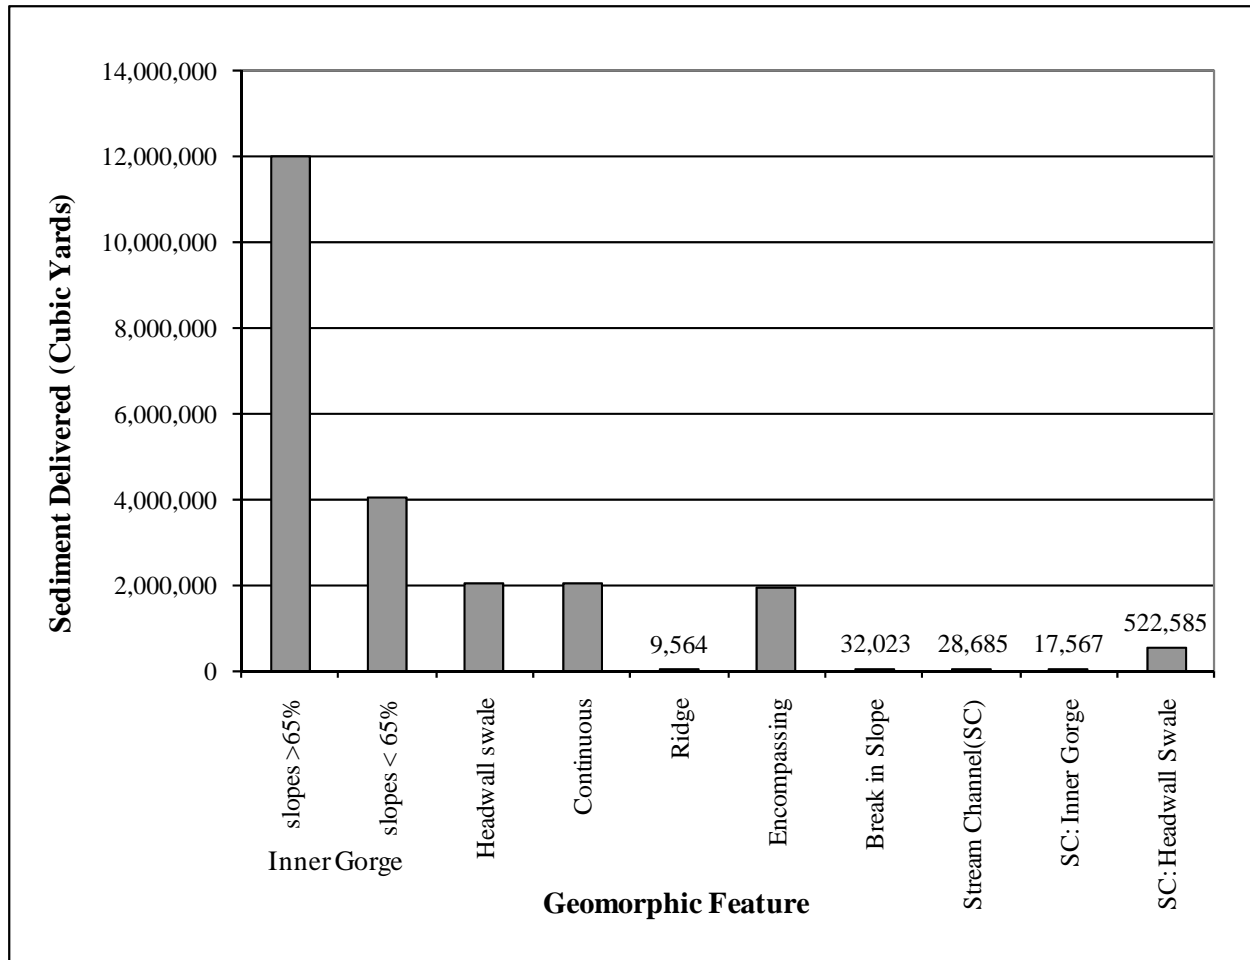
**Figure 5-24. Landslide sediment delivery by geomorphic association.**

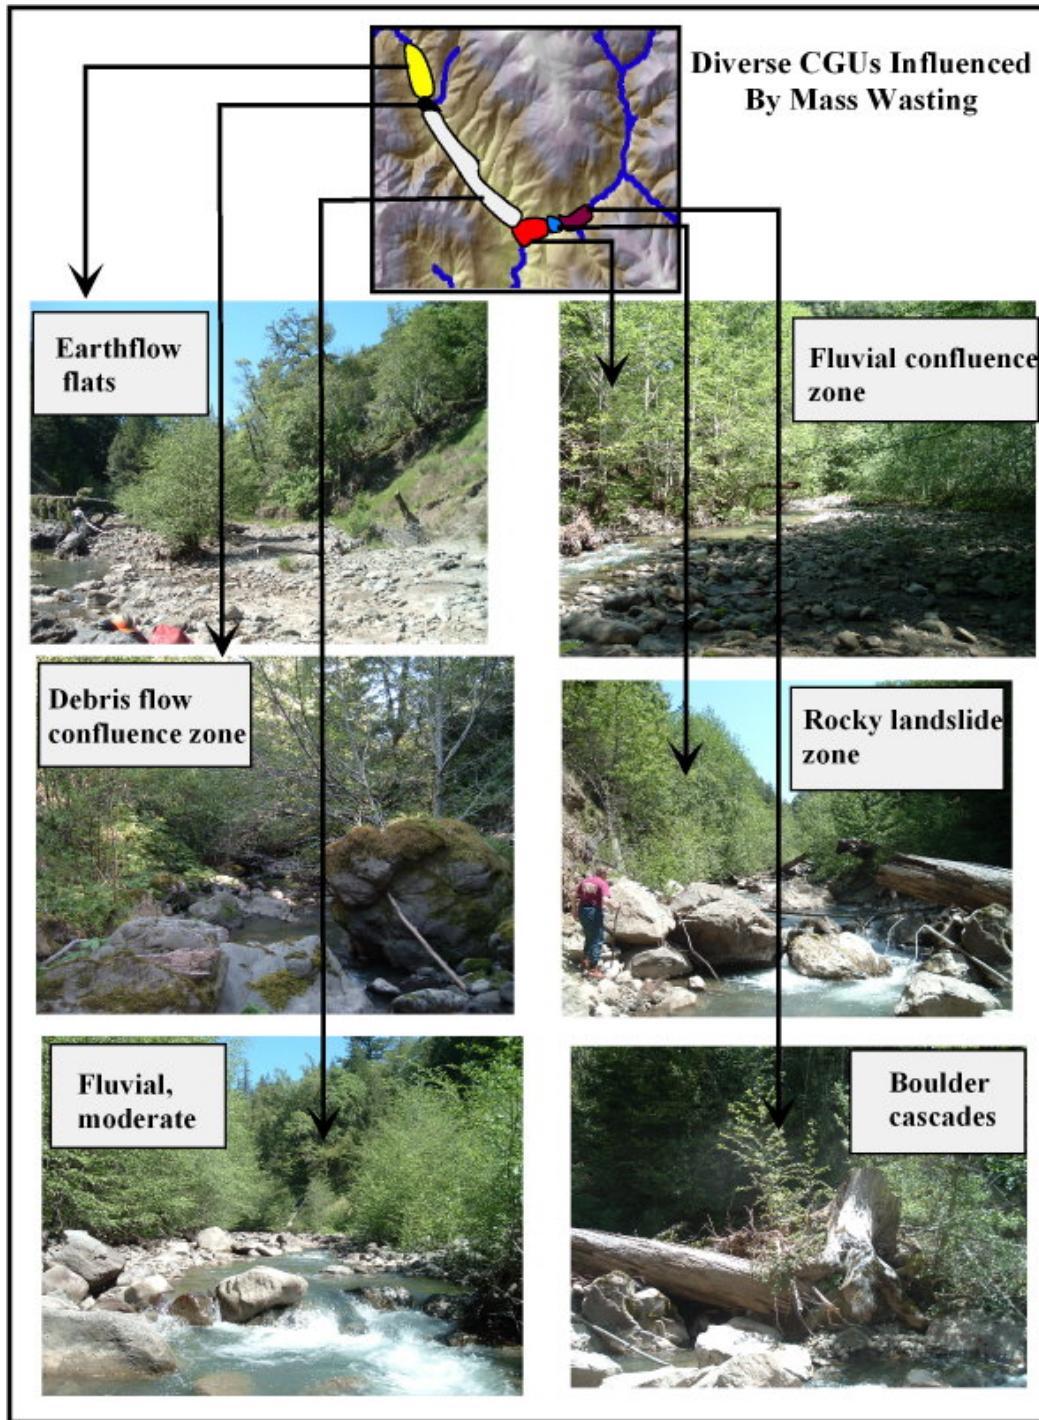
Figure 5-27. Example of the spatial distribution of channel geomorphic units.
