**Upper Eel Watershed Analysis**

**Cumulative Watershed Effects**

*Final Report*

**October 26, 2007**

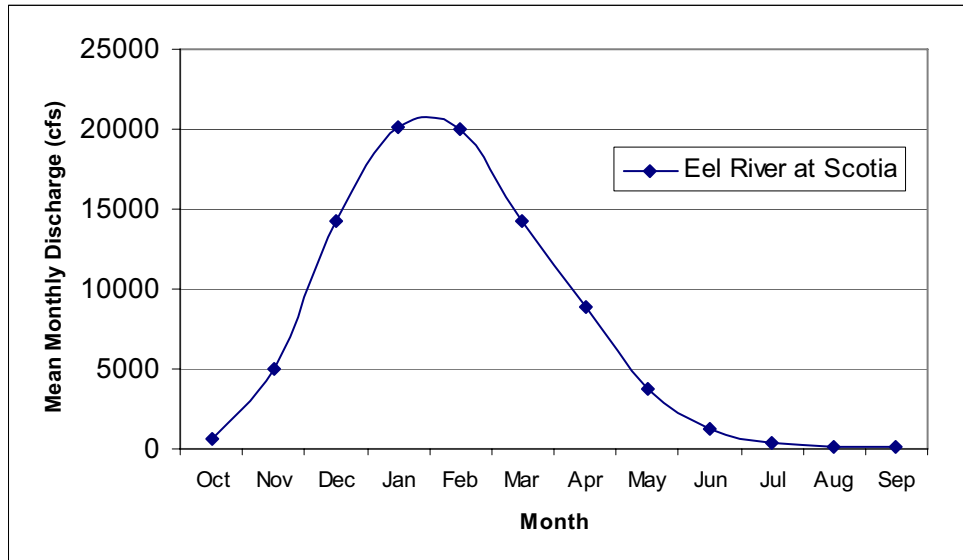
**Figure 3-9. Mean Monthly Discharge for the Eel River at Scotia Gaging Station (1910-2004)**

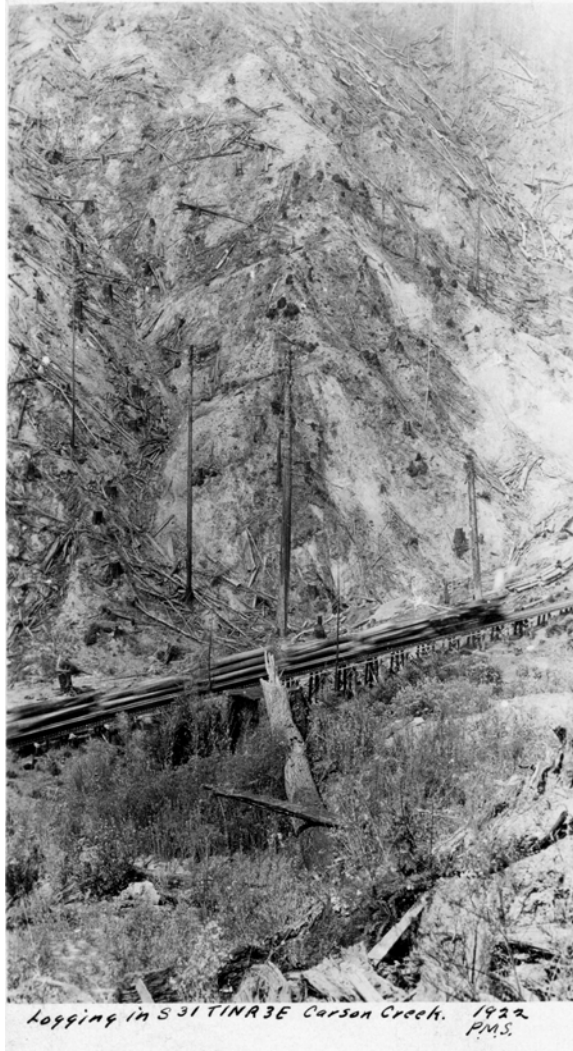
**Photograph 5-1. Early railroad corridor located in stream valley**

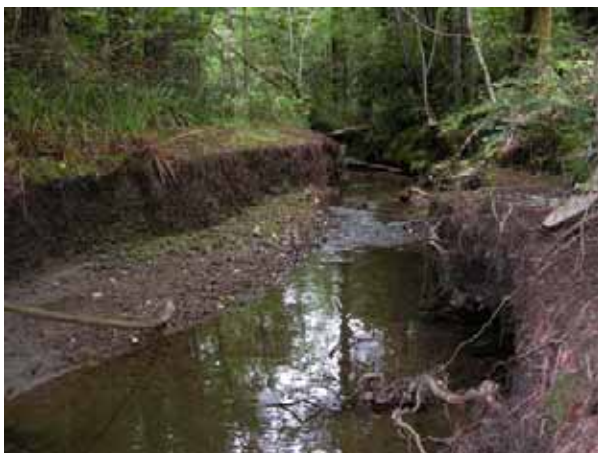
**Photograph 5-2. Response reach channel within Chris Creek showing remnants of channel filling when stream channel was used as skid trail for log hauling**

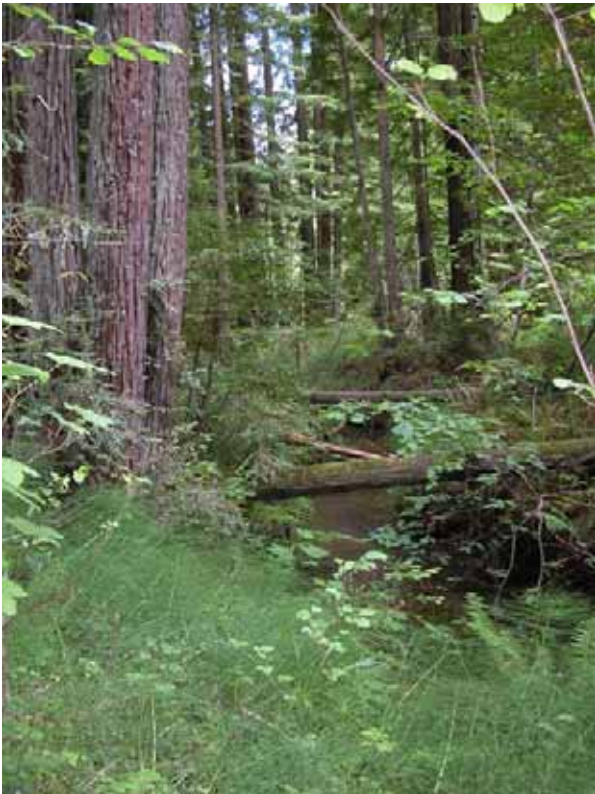
**Photograph 5-5. Riparian forest along the fish-bearing reach of Chris Creek**

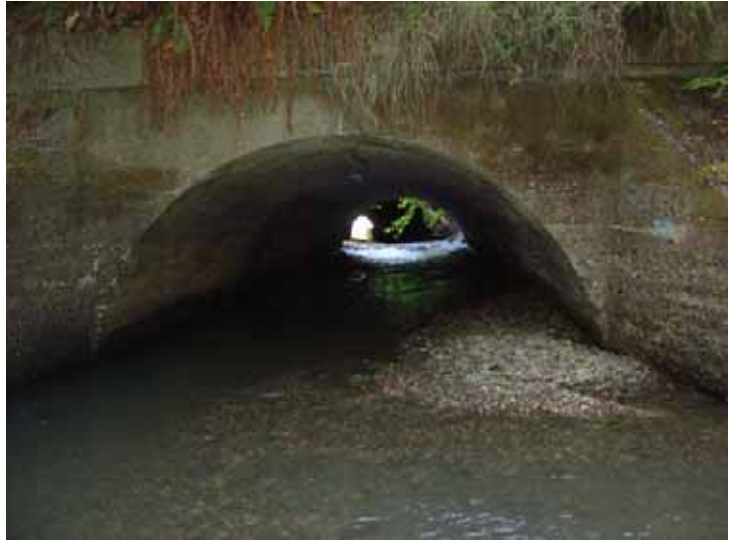
**Photograph 5-11. Lower Poison Oak Creek highway crossing as an example of early construction practices at stream crossings—this culvert is not a barrier to passage during low flows**

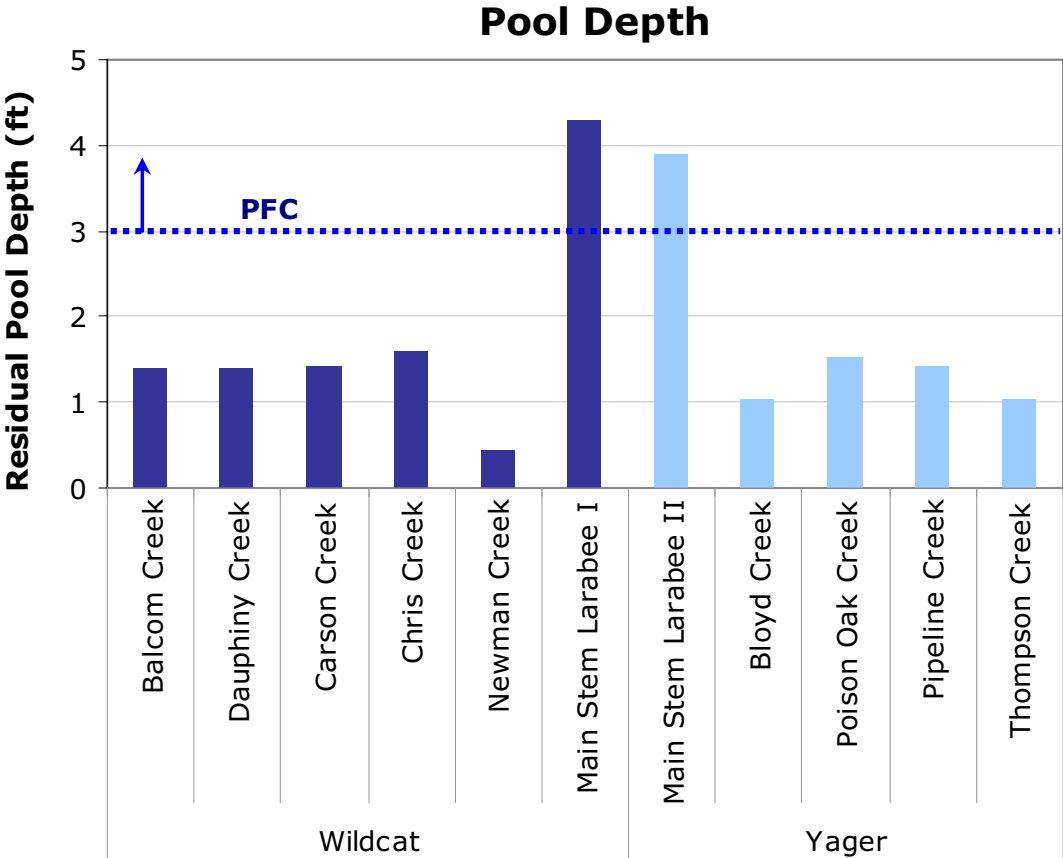
Figure 5-18. Average residual pool depth of streams in the Upper Eel WAU

Larabee Creek pools exceed the PFC target pool depths easily due to stream size, but also despite the influx of sediment documented following the 1964 event. The channel planform assessment indicates that sediment has been flushing from the system. That interpretation is supported by the presence of relatively deep pools observed in recent surveys.

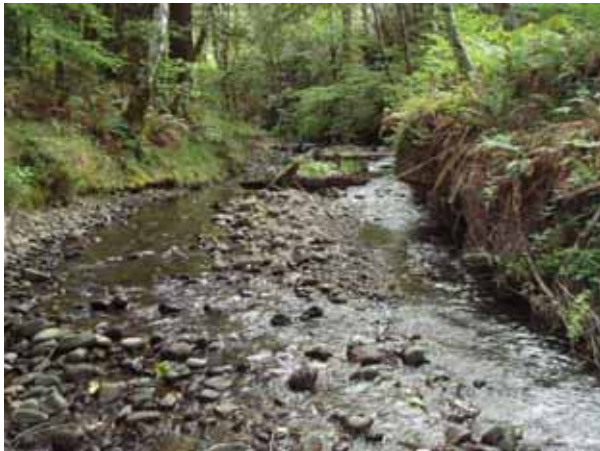
**Photograph 5-14. Newman Creek, higher LWD reach**

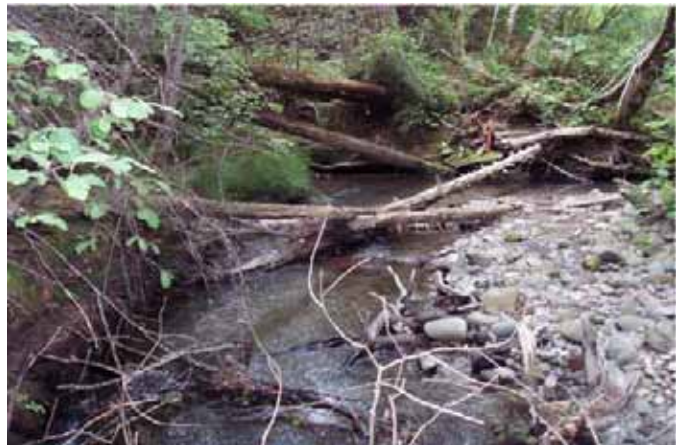
**Photograph 5-15. Dauphiny Creek, low LWD**

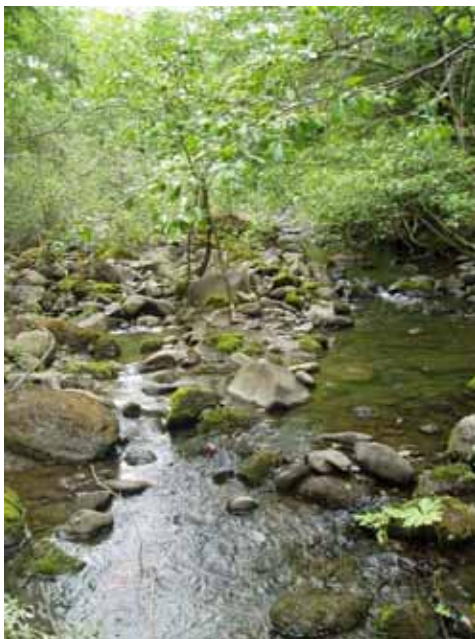
**Photograph 5-16. Carson Creek, high total wood count and abundant key pieces**

Total wood count is only 1 piece per channel width or less in many of the streams. Key pieces were not found in many streams. Carson Creek (Photograph 5-16) is the only stream in the WAU that currently has adequate key piece wood frequency.

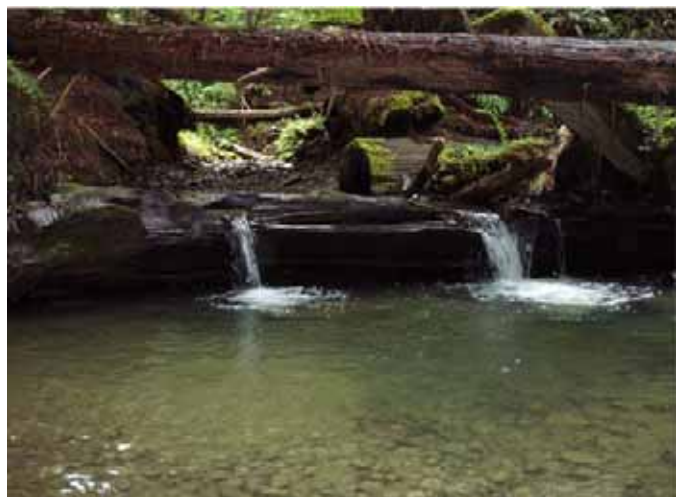
**Photograph 5-17. Larabee Creek in tightly constrained canyon reach upstream**

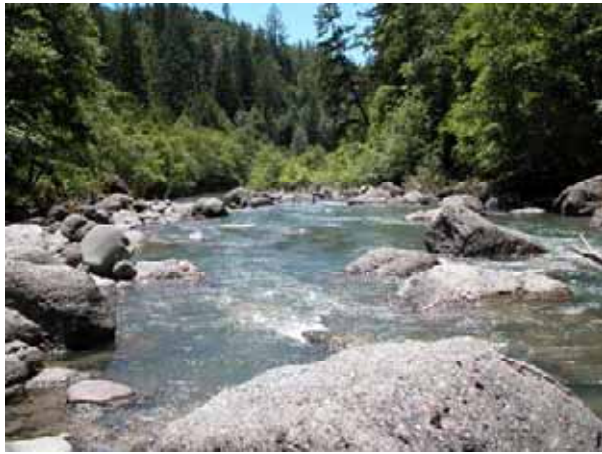
**Photograph 5-18. Larabee Creek at upper end of lower reach at PALCO bridge**

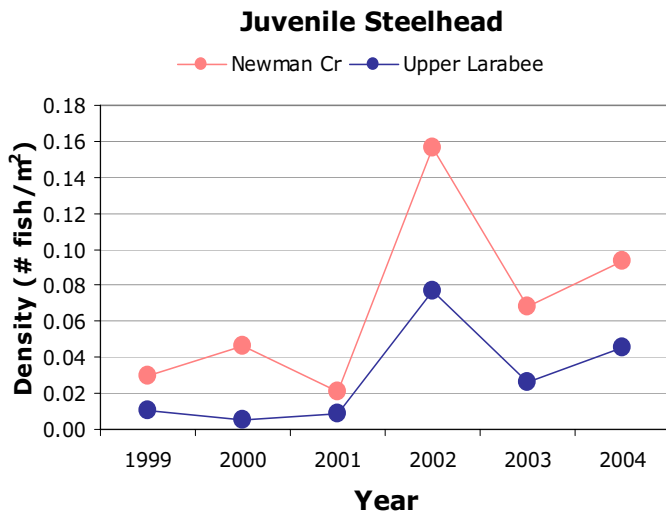
**Figure 5-27. Density of juvenile steelhead populations in Newman Creek and upper Larabee Creek**

A limited amount of fish population data is available from Newman Creek and Upper Larabee Creek. PALCO sampled populations during the summer months using electro-fishing 3-pass methods in Newman Creek and in the upper reach of Larabee Creek from 1999 to 2004 (Figure 5-27). Juvenile steelhead were the only salmonids occurring at either site. The density of the salmon population measured as the number of individuals per unit area (grams per square meter [g/m<sup>2</sup>]) is relatively low. The populations increased significantly in each stream from 1999 to 2004.

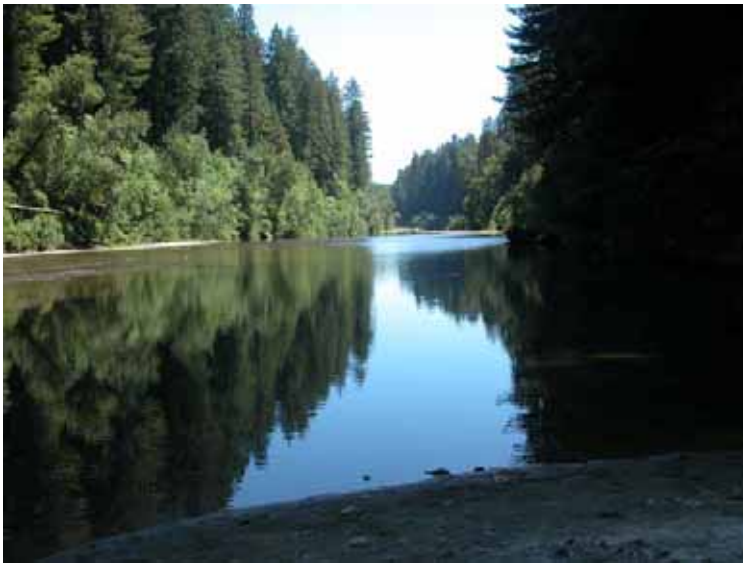
**Photograph 5-19. South Fork Eel River at junction with mainstem showing effective shade of redwood old growth stand**
