**Class I Stream Aquatic Habitat Trends
Monitoring
2017 Annual Report**

June 30, 2018

Title: Class I Stream Aquatic Habitat Trends Monitoring

Purpose: Habitat Conservation Plan Aquatic Monitoring

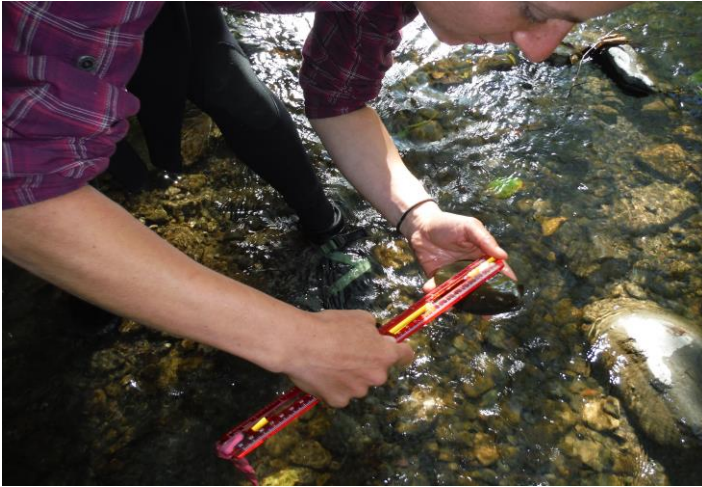
Figure 3. Measuring particle size (mm) of the streambed surface

Pebble count measurements collected at riffles are used to assess the APFC matrix target for D_{50} (diameter of the median [50th of 100] particle) and three additional parameters (D_5 , D_{16} , D_{85}). These sediment measures can be tracked over time to determine whether bedload sediments in a watercourse are generally becoming coarser or finer, in response to in-channel erosion and changes in sediment loading

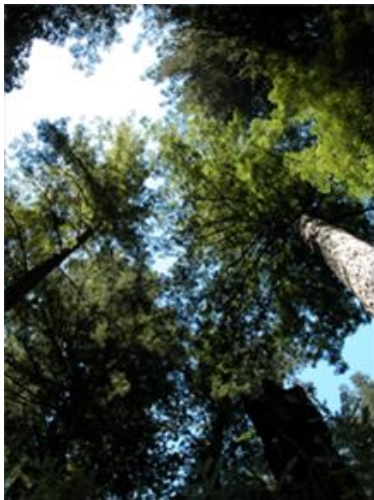
Figure 7. Redwood riparian forest overstory

streams that may be subject to higher thermal loading from sunlight. Canopy cover addresses the APFC matrix target for mid-channel canopy closure (Figure 6) and within the riparian forest (Figure 7). The mid-channel canopy cover is measured as an influence of the forest on maintaining cool water

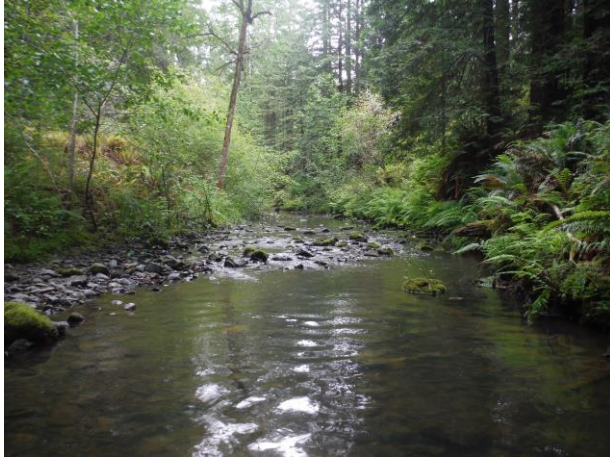
Mainstem Freshwater Creek 034

Data for all ATM parameters at site 034 (Figure 13) are summarized in the APFC report card found in Table 6. The bed surface APFC target was not met at this site in 2017, though the data suggest a coarsening of the substrate across all particle sizes since 2014 (Figure 14). Pool measures suggest a slight improvement since 2014 with an increase in the percentage of pools associated with LWD, while residual pool depth failed to meet the target criterion. Total LWD pieces remained static, as total LWD piece frequency placed short of the target for the seventh time since 2003. Water temperature met the target for the third consecutive year since 2015, though mid-channel canopy cover placed short of the target for the sixth straight year.

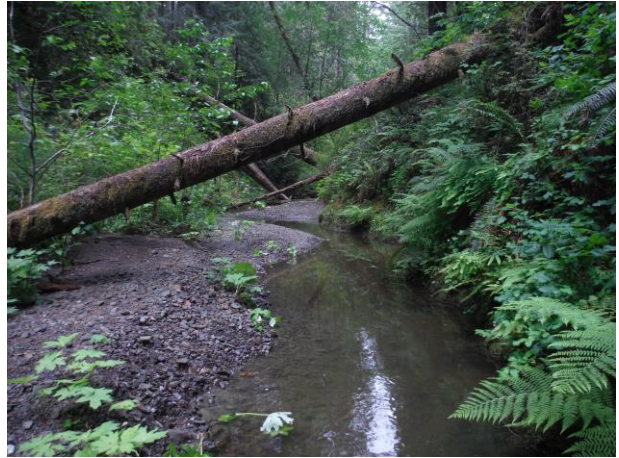
SF Freshwater Creek 015

Data for all ATM parameters at site 015 (Figure 13) are summarized in the APFC report card found in Table 7. The bed surface APFC target was not met at this site in 2017, though the data suggests a coarsening of most of the particle size classes since 2014 (Figure 15). Pool measures indicate a general decline in habitat quality, with pool area (%) and pools associated with wood (%) meeting their respective targets. The total piece frequency within the surveyed reach fell short of the APFC target, with total LWD pieces decreasing by 39% since 2014. Water temperature met the target goal for the fifteenth consecutive year on record, and mid-channel canopy cover met the target for the fourth time in the last six survey years.

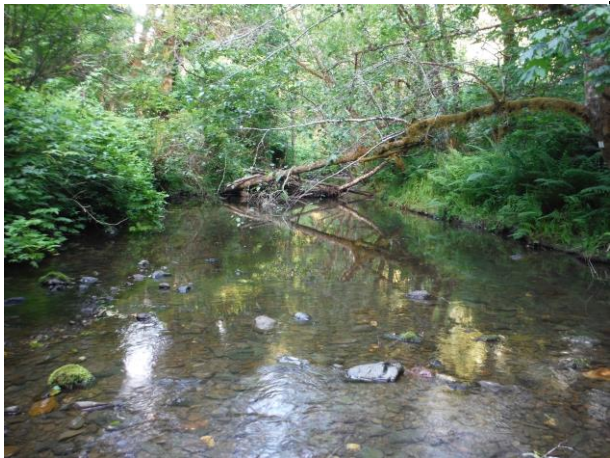
Mainstem Freshwater Creek 200

Data for all ATM parameters at site 200 (Figure 13) are summarized in the APFC report card found in Table 8. The bed surface APFC target was not met in 2017, though the data suggest a coarsening of the substrate across most particle size classes (Figure 16). Pool measures remained static since 2014, with residual pool depth failing to meet the target for the second year straight. The total piece frequency within the surveyed reach failed to meet the APFC target, and total LWD pieces decreased by 17% since 2014. Water temperature and mid-channel canopy cover each met the target goal for another consecutive survey year since 2005.

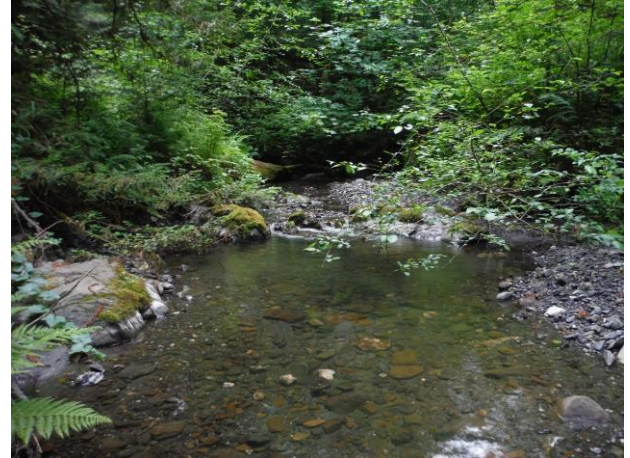
Graham Gulch 019

Data for all ATM parameters at site 019 (Figure 13) are summarized in the APFC report card found in Table 9. The bed surface APFC target was not met in 2017, though the data suggest a coarsening of the substrate across all particle size classes (Figure 17). Pool measures indicate a slight improvement in habitat quality, with only residual pool depth failing to meet the target for the seventh consecutive survey year. The total piece frequency within the surveyed reach remained short of the APFC target, while total LWD pieces increased 19% since 2014. Water temperature met the target for the fifteenth consecutive year, and mid-channel canopy cover met the target for the third consecutive year.

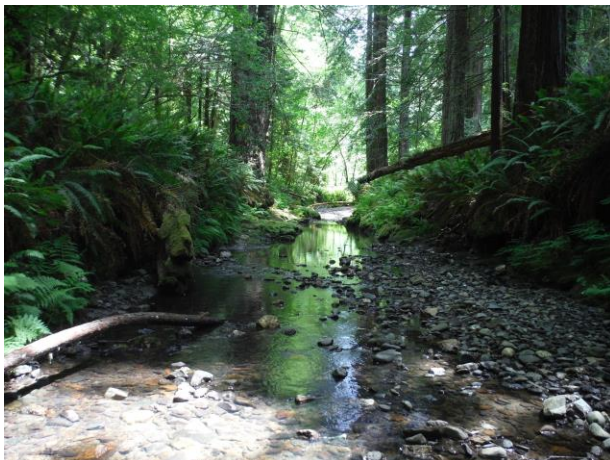
Cloney Gulch 092

Data for all ATM parameters at site 092 (Figure 13) are summarized in the APFC report card found in Table 10. The bed surface APFC target was not met in 2017, though the data suggest a coarsening of the substrate across all particle size classes since 2014 (Figure 18). Pool measures indicate a slight increase in habitat quality, though residual pool depth failed to meet the target for the fourth consecutive year. The total piece frequency within the surveyed reach failed to meet the APFC target, while total LWD pieces increased 37% since 2014. Water temperature met the target for the twelfth consecutive survey year, and mid-channel canopy cover met the target for the third consecutive survey year.

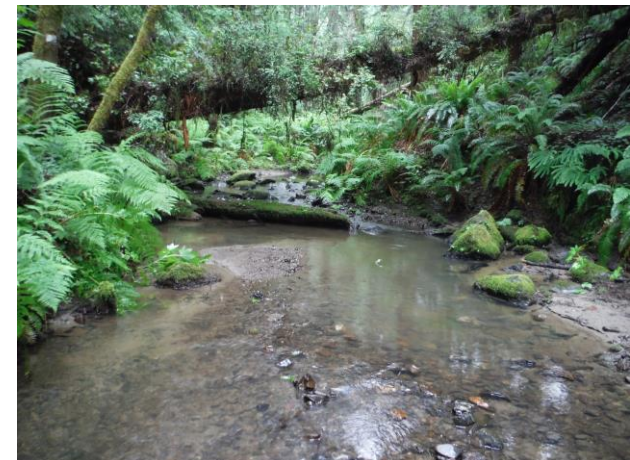
McCready Gulch 202

Data for all ATM parameters at site 202 (Figure 13) are summarized in the APFC report card found in Table 11. The bed surface APFC target was not met in 2017, though the data suggest a coarsening of the substrate across all particle size classes (Figure 19). Pool measures indicate a slight decline in habitat quality, with pool spacing and residual pool depth failing to meet their respective targets. The total piece frequency within the surveyed reach did not meet the APFC target, and total LWD pieces decreased 86% since 2014. Water temperature met the target for the thirteenth consecutive year, and mid-channel canopy cover met the target for the third consecutive survey year.

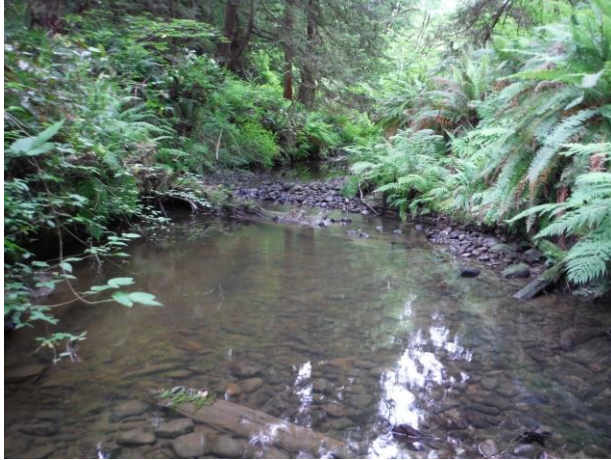
Little Freshwater Creek 018

Data for all ATM parameters at site 018 (Figure 13) are summarized in the APFC report card found in Table 12. The bed surface APFC target was met for the first time in 2017, as the data suggest a coarsening of the substrate across all particle size classes (Figure 20). Pool measures indicate a general improvement in habitat quality, though residual pool depth fell short of the target for the seventh consecutive survey year. The total LWD piece frequency within the surveyed reach failed to meet the APFC target, although total LWD pieces increased 38% since 2014. Water temperature met the target for the fifteenth consecutive year, and mid-channel canopy cover met the target for the third consecutive survey year.

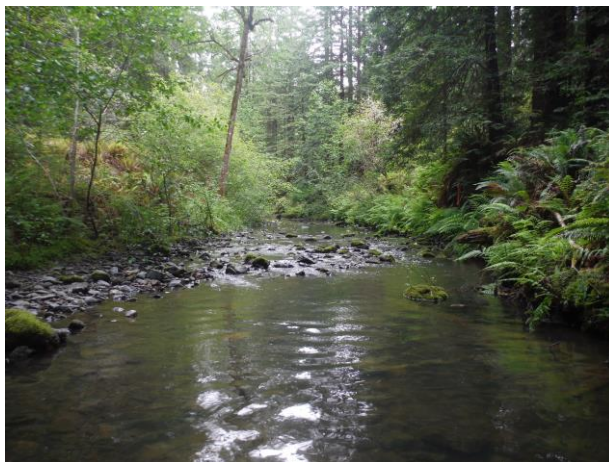
NF Elk River 167

Figure 23. ATM stations within the Elk River WAU

Data for all ATM parameters at site 167 (Figure 23) are summarized in the APFC report card found in Table 14. The bed surface target was not met in 2017, though the data suggest a slight coarsening of the D_{50} and D_{16} substrate particle size classes (Figure 24). Pool characteristics indicate generally static habitat conditions, though residual pool depth did not reach its target for the thirteenth consecutive survey year. The total LWD piece frequency within the surveyed reach met the APFC target, as total LWD pieces increased 14% since 2014. Water temperature met the target for the twelfth consecutive year, and mid-channel canopy cover met its target the fifth consecutive survey year since 2010.

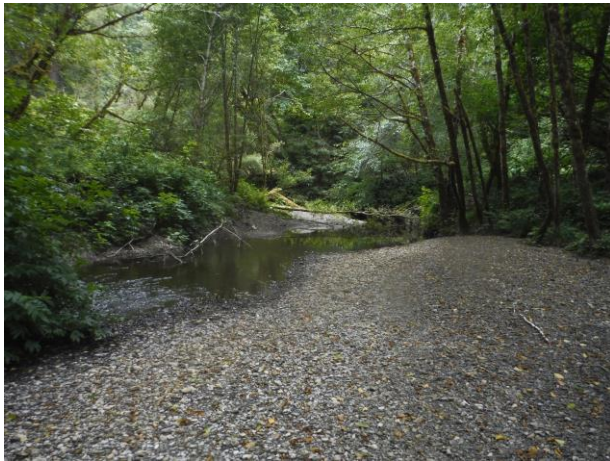
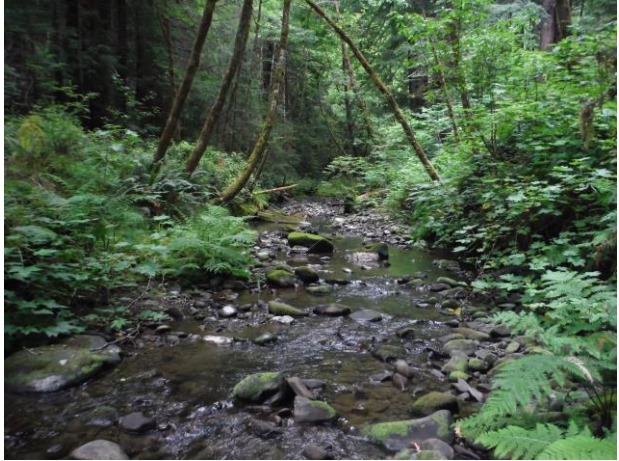
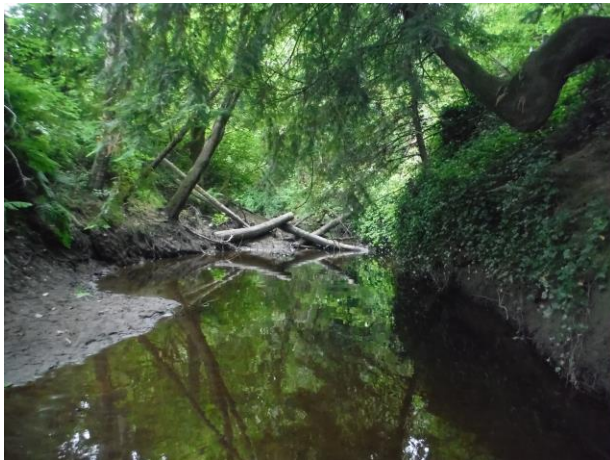
Figure 22 shows the location of the 7 active ATM stations in Elk River. Figure 23 shows typical site conditions at each of the seven stations surveyed in 2017. Variation and influence of underlying geology, and the presence of Holocene age alluvium at the lower monitoring reaches (ATM 166 and 175), can be seen in the photographs.

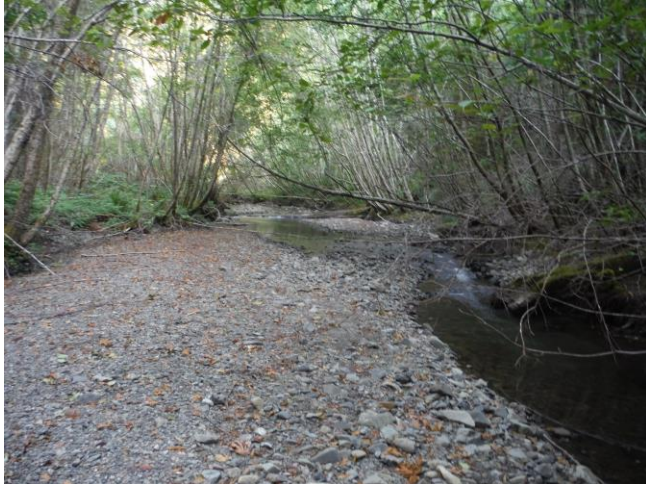
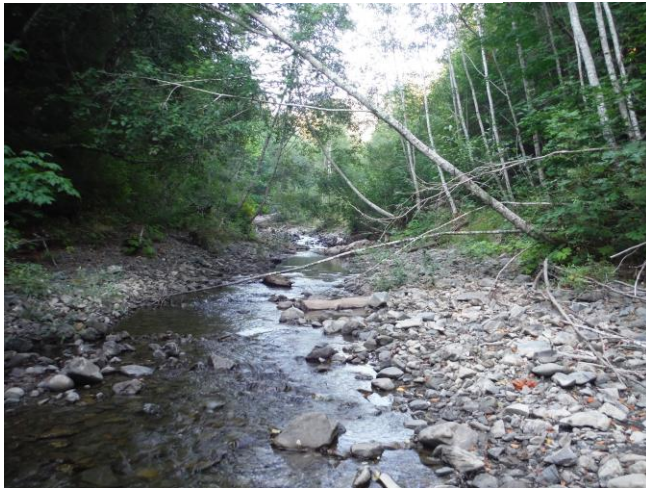
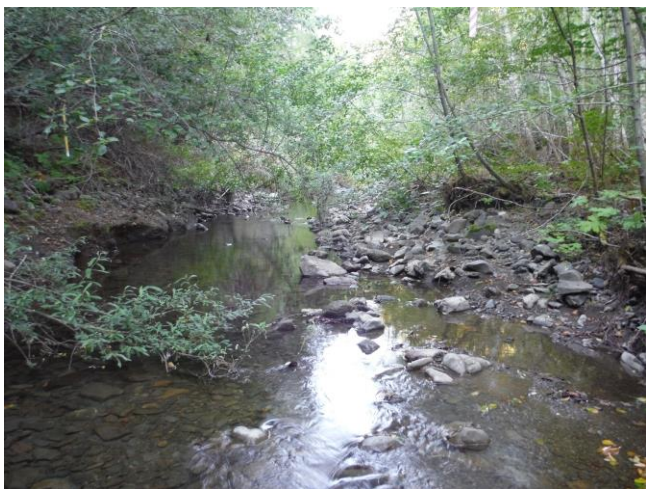
Figure 41. Bear Creek ATM stations within the Lower Eel River WAU

There are eight (8) ATM sites in the Lower Eel WAU, including three in Bear Creek, two in Jordan Creek, and one each in Monument Creek, Shively Creek, and Atwell creek (Figure 40). Habitat characteristics at the Bear Creek sites are measured annually at the request of the NCRWQCB. Habitats at all other sites are measured every three years. Typical site conditions are shown in Figure 41.
