**Class I Stream Aquatic Habitat Trends
Monitoring
2020 Annual Report**

June 30, 2021

Title: Class I Stream Aquatic Habitat Trends Monitoring

Purpose: Habitat Conservation Plan Aquatic Monitoring

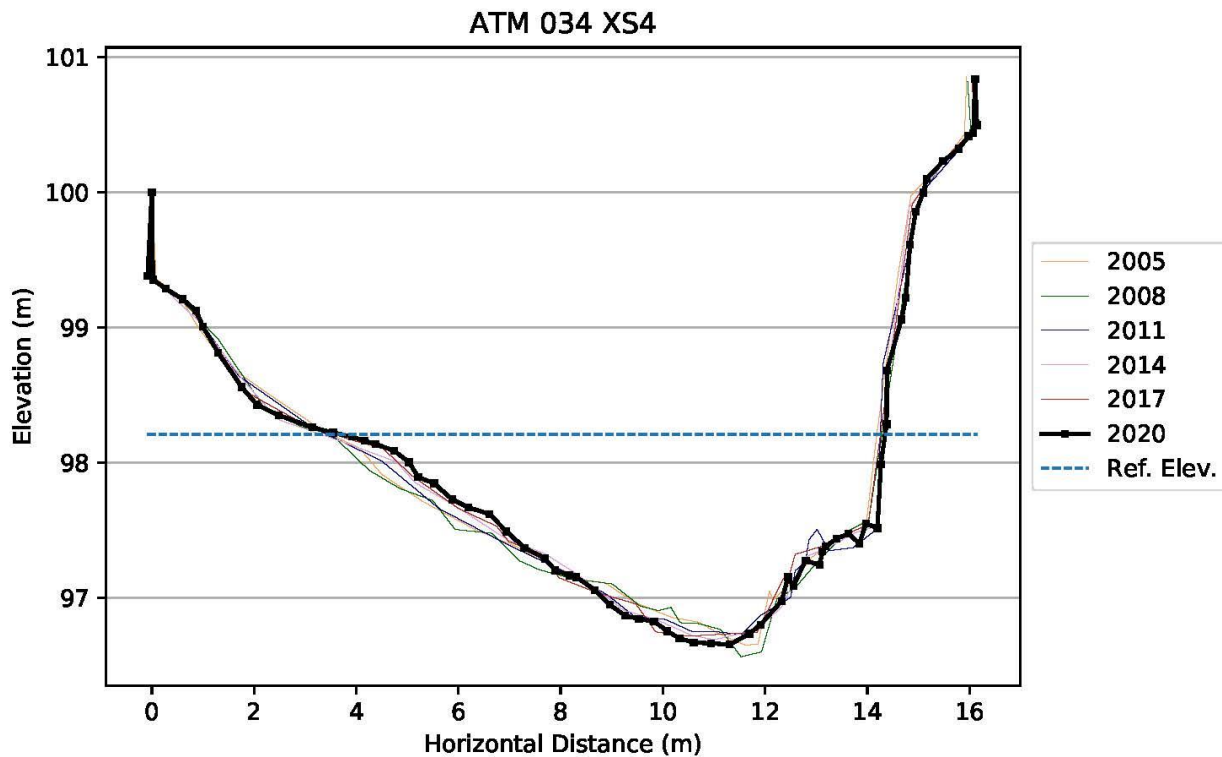
Figure 5. Example of a typical cross-sectional profile within an ATM survey reach

Data processing has been streamlined with electronic data collection, transfer, and processing. HRC has developed an Excel® spreadsheet to process cross-section data from x, y, z coordinates into standard measurements in the x-z plane. An additional spreadsheet computes channel area (m²), width (m) and depth (m).

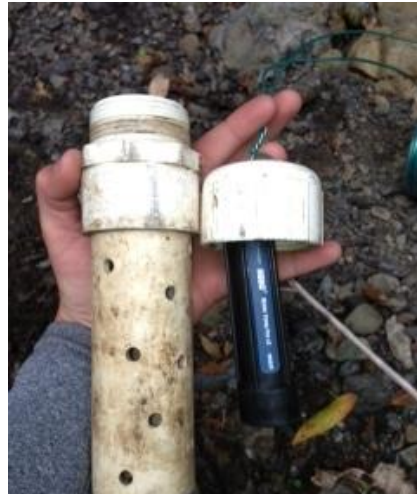
Figure 8. Stream temperature logger with protective PVC case

Stream temperature (°C) is tracked during the warmest part of the year (typically June through September). Temperature is monitored with continuous recording data loggers (Onset HOBO® Water Temp Pro v2). Temperature data loggers are inserted into protective PVC cases (Figure 8) and placed in the stream at a location that meets requirements for sufficient mixing, adequate cover, and consistent flows during the summer months to ensure data integrity by reducing the likelihood of thermal stratification. Temperature data are used to calculate the maximum weekly average temperature

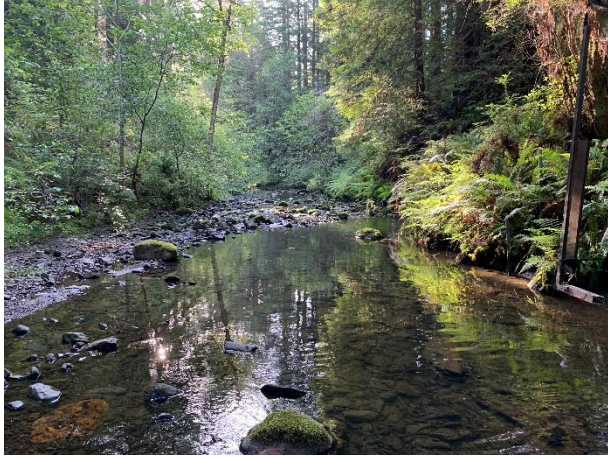
Mainstem Freshwater Creek 034

Figure 13. ATM stations within the Freshwater Creek WAU

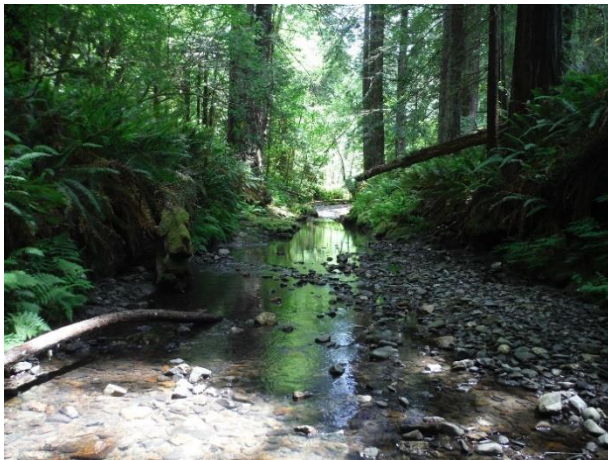
Cloney Gulch 092

Data for all ATM parameters at site 092 (Figure 13) are summarized in the APFC report card found in Table 10. The bed surface APFC target was not met in 2020, as the data suggest a fining of the substrate across all particle size classes since 2017 (Figure 22). Pool characteristics suggest stable habitat conditions despite residual pool depth failing to meet the target for the fifth consecutive survey year. Total LWD piece frequency within the survey reach failed to meet the APFC target, as total LWD pieces decreased 126% since 2017. Water temperature met the target for the fourteenth consecutive survey year, and mid-channel canopy cover met the target for the fourth straight survey year.

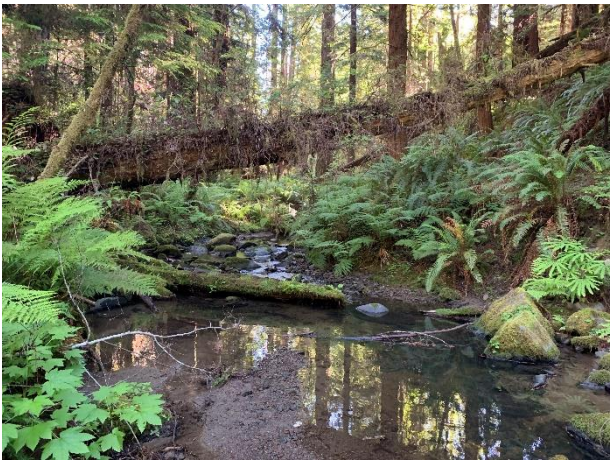
McCready Gulch 202

Data for all ATM parameters at site 202 (Figure 13) are summarized in the APFC report card found in Table 11. The bed surface APFC target was not met in 2020, though the data suggest a coarsening of the substrate across all particle size classes (Figure 24). Pool characteristics suggest stable habitat conditions despite half of the parameters remaining below their respective targets. Total LWD piece frequency within the survey reach remained below the APFC target, as total LWD pieces decreased 250% since 2017. Water temperature met the target for the sixteenth consecutive year, as mid-channel canopy cover met the target for the fourth straight survey year.

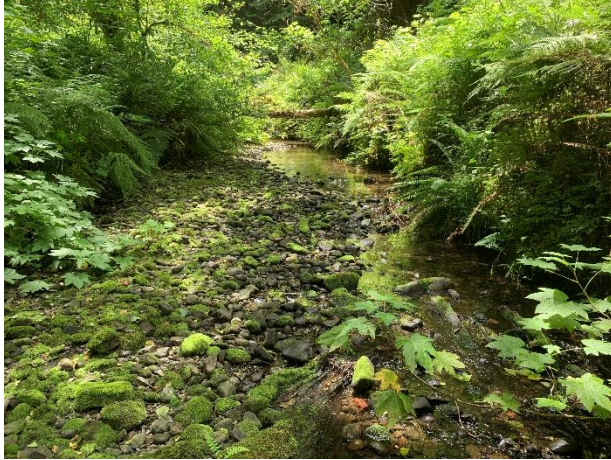
Little Freshwater Creek 018

Data for all ATM parameters at site 018 (Figure 13) are summarized in the APFC report card found in Table 12. The bed surface APFC target was not met in 2020, as the data suggest a fining of the substrate across most particle size classes (Figure 26). Pool characteristics suggest stable habitat conditions despite residual pool depth remaining below the target for the eighth consecutive survey year. Total LWD piece frequency within the surveyed reach remained below the APFC target, as total LWD pieces decreased 230% since 2017. Water temperature met the target for the eighteenth consecutive year, as mid-channel canopy cover met the target for the fourth straight survey year.

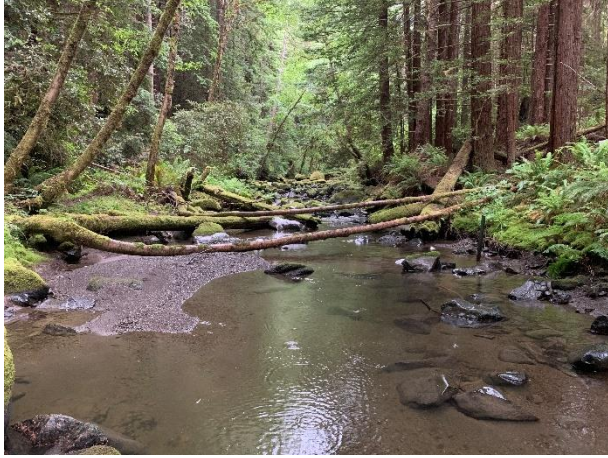
NF Elk River 167

Figure 29 shows the location of the 7 active ATM stations in Elk River. Figure 30 shows typical site conditions at each of the seven stations surveyed in 2020. Variation and influence of underlying geology, and the presence of Holocene age alluvium at the lower monitoring reaches (ATM 166 and 175), can be seen in the photographs.

Data for all ATM parameters at site 167 (Figure 30) are summarized in the APFC report card found in Table 14. The bed surface target was not met in 2020, though the data suggest a slight coarsening of the D_{50} and D_{84} substrate particle size classes (Figure 31). Pool characteristics suggest stable habitat conditions since 2014 despite residual pool depth failing to meet its target for the fourteenth consecutive survey year. Total LWD piece frequency within the surveyed reach did not meet the APFC target, as total LWD pieces decreased 100% since 2017. Water temperature met the target for the fourteenth consecutive survey year, as mid-channel canopy cover met its target the sixth consecutive survey year since 2010.

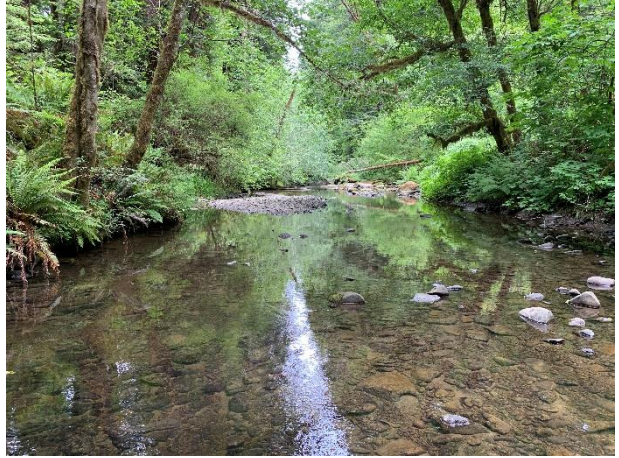
NF Elk River 162

Data for all ATM parameters at site 162 (Figure 30) are summarized in the APFC report card found in Table 15. The bed surface target was met in 2020 for the first time since 2003, as the data suggest a coarsening of the substrate across all particle size classes (Figure 33). Pool characteristics suggest stable habitat conditions despite residual pool depth failing to reach its target for the seventh consecutive survey year. Total LWD piece frequency within the surveyed reach did not meet the APFC target, as total LWD pieces decreased 144% since 2017. Water temperature met the target for the seventh consecutive year, as mid-channel canopy cover met its target for the second straight survey year.

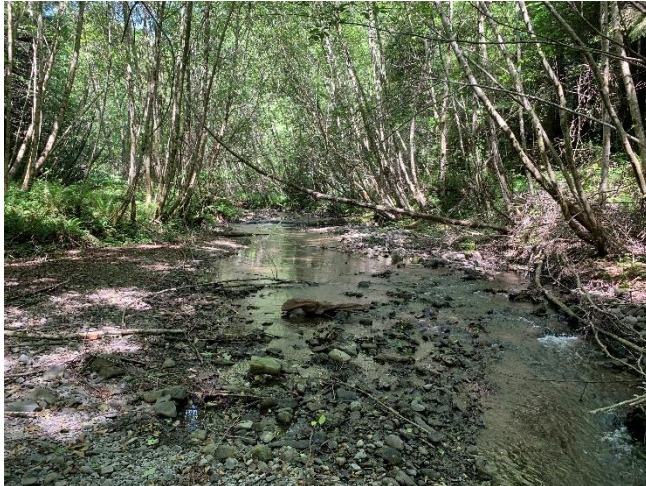
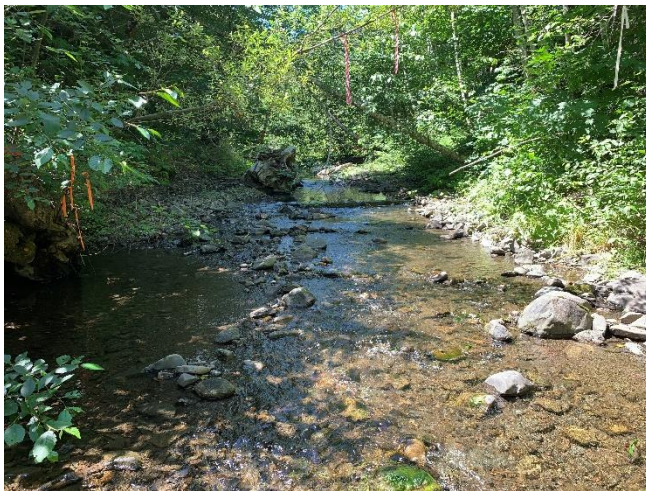
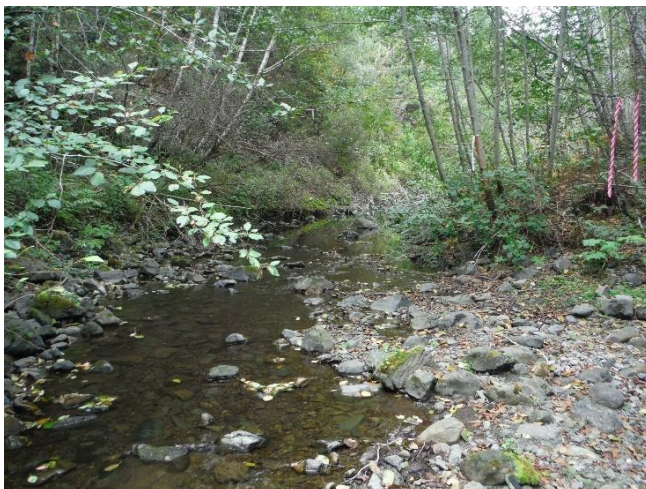
Figure 58. ATM Stations within Bear Creek in the Lower Eel River WAU

There are nine (9) ATM sites in the Lower Eel WAU, including three in Bear Creek, two in Jordan Creek, and one each in Monument Creek, Stitz Creek, Shively Creek, and Atwell Creek (Figure 57). Habitat characteristics at the Bear Creek sites are measured annually at the request of the NCRWQCB. Habitats at all other sites are measured every three years. Typical site conditions are shown in Figure 58.

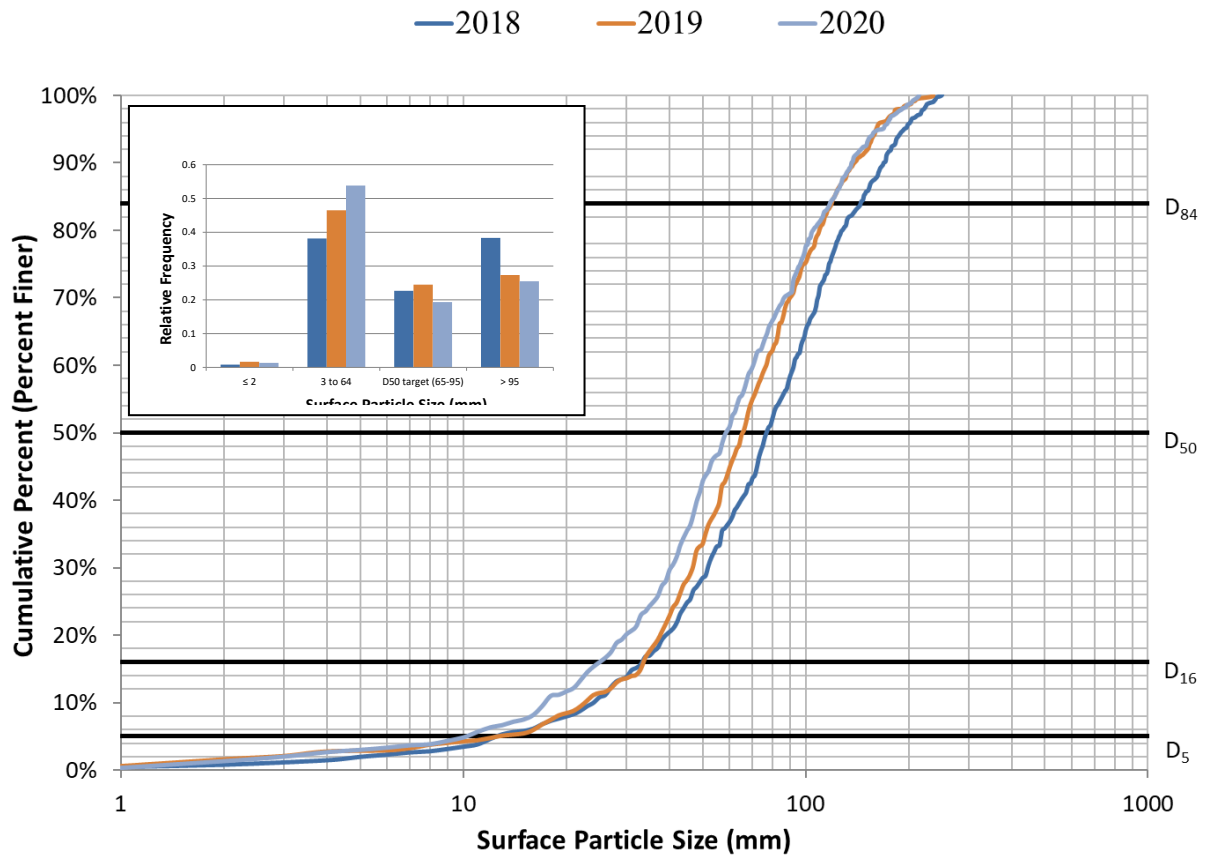
Figure 61. Cumulative frequency plot of the mean surface particle size of three riffles measured within the Bear Creek ATM 204 survey reach (2018-2020)

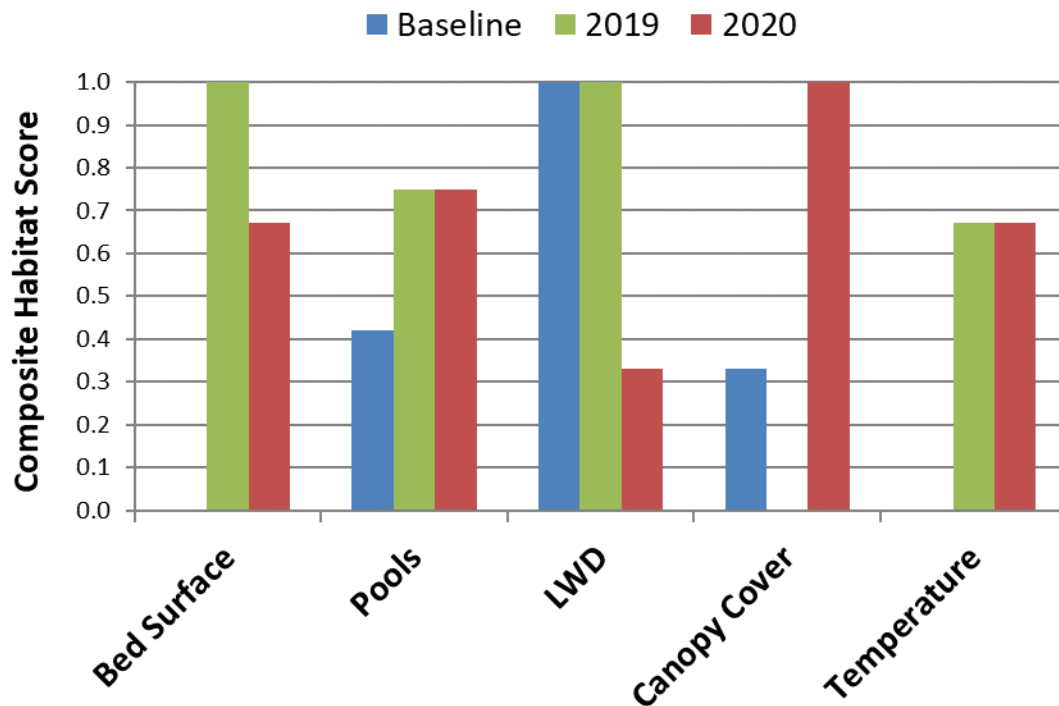
Figure 65. The composite scores for habitat characteristics in Bear Creek (Lower Eel River WAU) in 2019 and 2020 relative to baseline (2004) data
