# Class I Stream Aquatic Habitat Trends Monitoring 2021 Annual Report

June 30, 2022

**Title:** Class I Stream Aquatic Habitat Trends Monitoring

**Purpose:** Habitat Conservation Plan Aquatic Monitoring

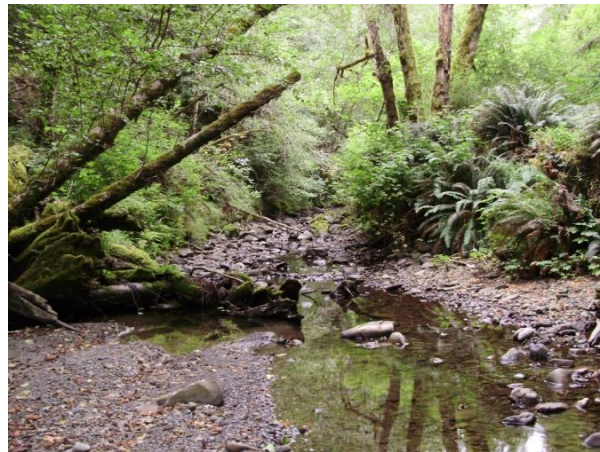
**Figure 1. Class I stream, Elk River**

A sampling site is a stream reach that is at least 30 channel widths long. The sampling length of most sites is approximately 200 to 400 meters (approximately 600 to 1200 feet) in length. The location of the sampling reach is permanently benchmarked to facilitate repeated measurement.

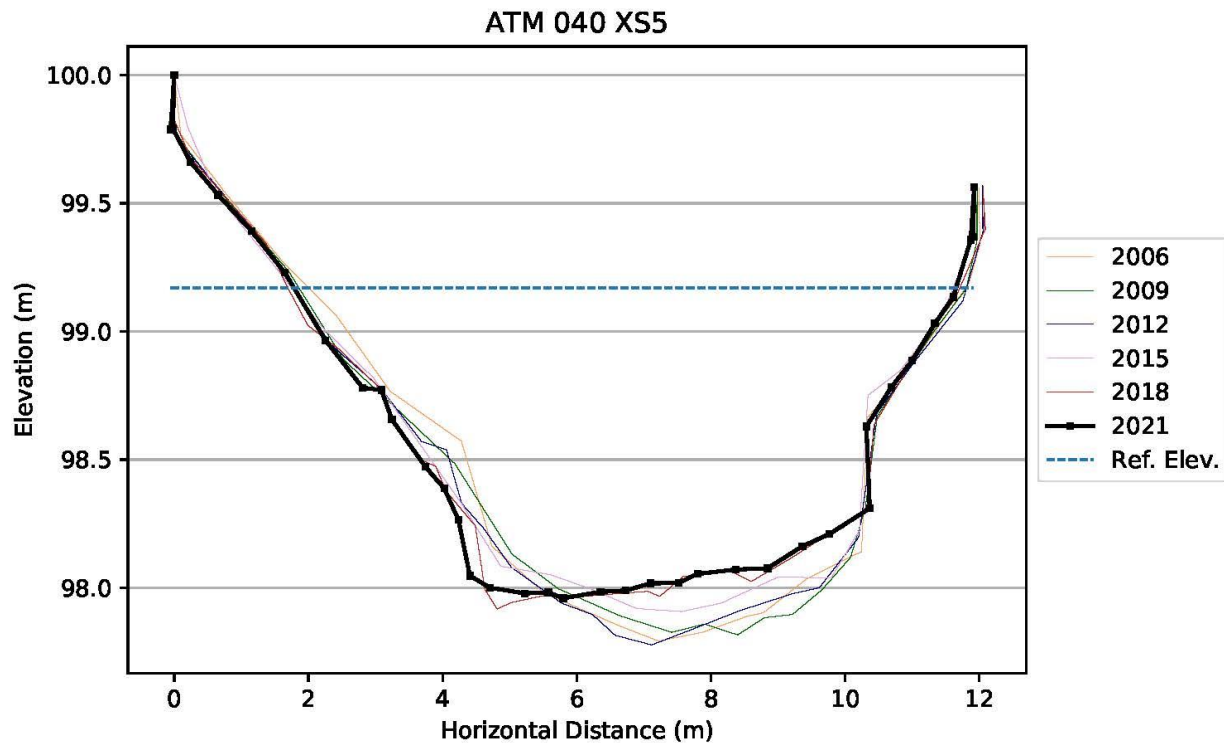
Figure 5. Example of a typical cross-sectional profile within an ATM survey reach

Data processing has been streamlined with electronic data collection, transfer, and processing. HRC has developed an Excel® spreadsheet to process cross-section data from x, y, z coordinates into standard measurements in the x-z plane. An additional spreadsheet computes channel area (m<sup>2</sup>), width (m) and depth (m).

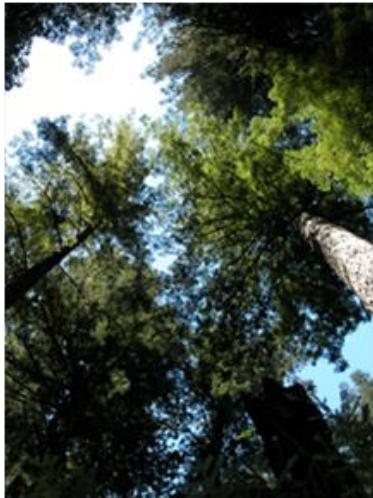
**Figure 7. Redwood riparian forest overstory**

streams that may be subject to higher thermal loading from sunlight. Canopy cover addresses the APFC matrix target for mid-channel canopy closure (Figure 6) and within the riparian forest (Figure 7). The mid-channel canopy cover is measured as an influence of the forest on maintaining cool water

Overstory canopy closure data in the riparian forest adjacent to the stream channel is also collected using the densiometer on a systematic grid pattern. While overstream canopy closure is measured every ATM survey cycle, beginning in 2015, no riparian forest canopy measurements are required in stands where  $\geq 85\%$  riparian forest closure was documented in the prior ATM survey *unless* significant disturbance (i.e. timber harvest, blow down, landslide, high mortality, fire) is evident.

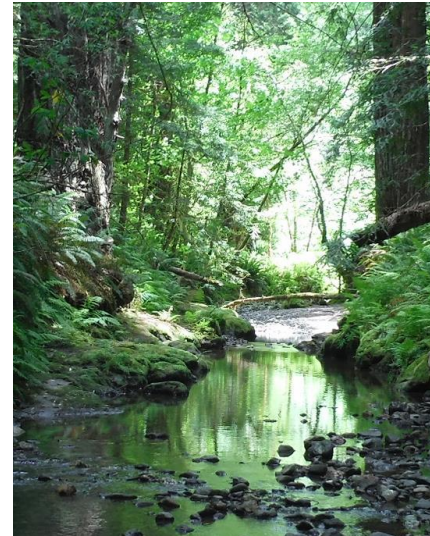
**Figure 6. Pool habitat with overhead canopy**

temperatures, taken mid-channel at 25m intervals throughout the sampling reach using a convex spherical densiometer (model A).

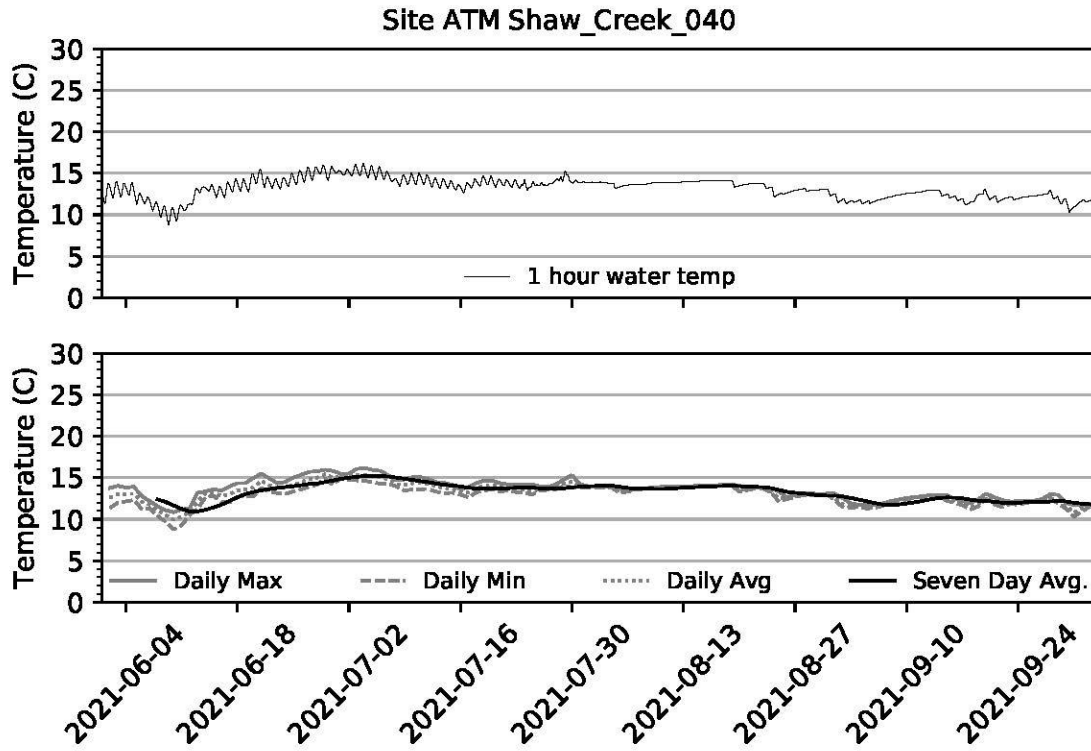
Figure 9. Example of a stream temperature profile generated from a continuously-recording temperature data logger deployed at most ATM stations annually

Stream temperature (°C) is tracked during the warmest part of the year (typically June through September). Temperature is monitored with continuous recording data loggers (Onset HOBO® Water Temp Pro v2). Temperature data loggers are inserted into protective PVC cases (Figure 8) and placed in the stream at a location that meets requirements for sufficient mixing, adequate cover, and consistent flows during the summer months to ensure data integrity by reducing the likelihood of thermal stratification. Temperature data are used to calculate the maximum weekly average temperature (MWAT), or the average of the daily mean temperature measured during the warmest seven consecutive days each year. The APFC target value for MWAT at all ATM stations is  $\leq 16.8^{\circ}\text{C}$ . Figure 9 illustrates a typical temperature profile as measured at ATM stations property wide.

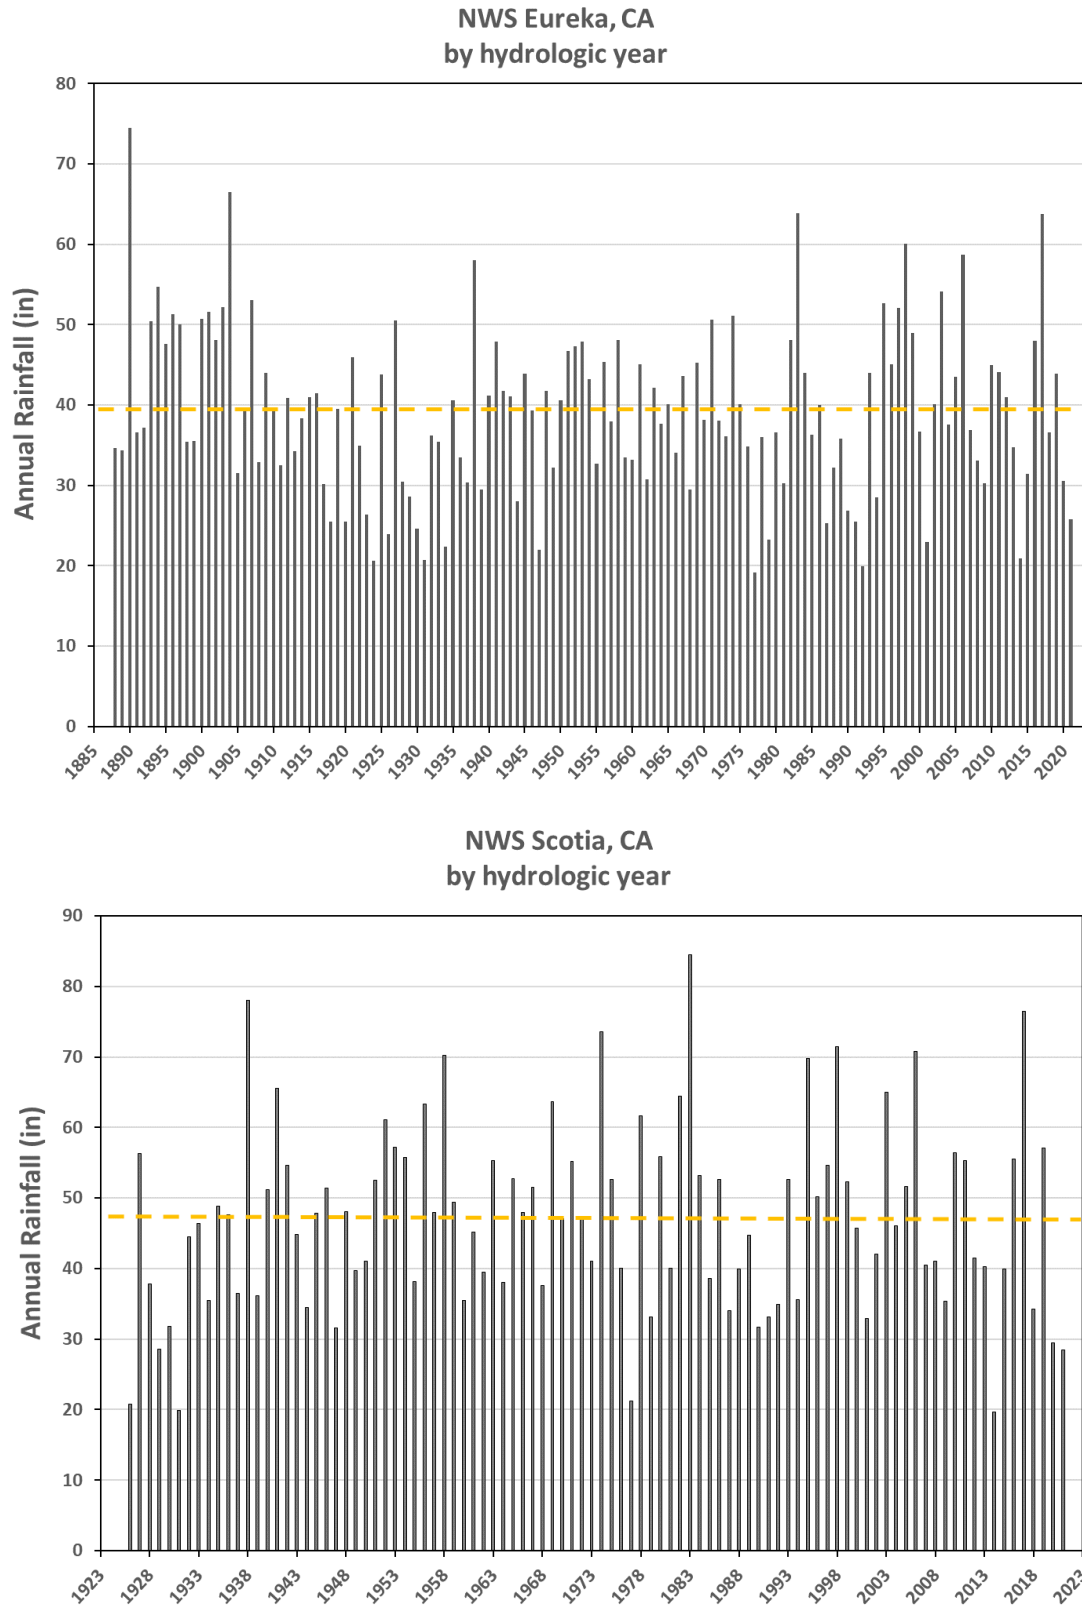
**Figure 10. Annual rainfall by hydrologic year at Eureka and Scotia, CA. Dotted lines represent the running averages (all years)**

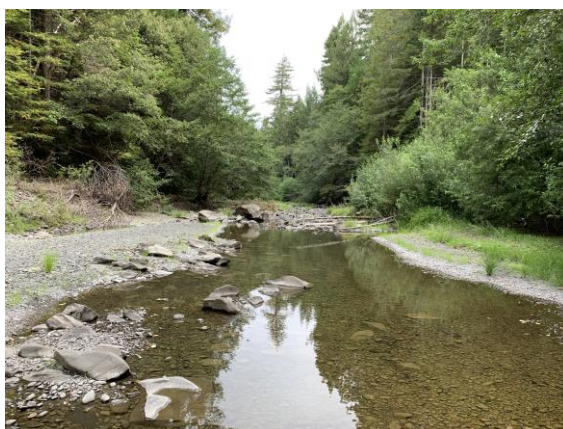
**ATM 046 Yager Creek**

Data for all ATM parameters at site 046 (Figure 14) are summarized in the APFC report card (Table 10). The  $D_{50}$  particle size class met the bed surface target for a second straight survey year, as the data suggest relative stability across all size classes (Figure 25). Pool measurements suggest favorable habitat conditions, while only pools associated with wood fell below target in 2021. LWD piece frequency met its target in 2021, as the total number of pieces increased nearly threefold since 2018. Over stream canopy also met the target, as stream temperature exceeded 20 °C for the seventeenth consecutive year.

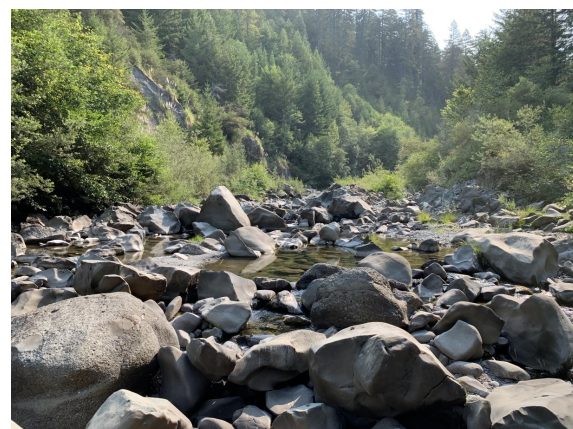
**ATM 005 Yager Creek**

Data for all ATM parameters at site 005 (Figure 14) are summarized in the APFC report card (Table 9). The D<sub>50</sub> particle size class remained well short of APFC targets in 2021, even as all particle size classes showed a slight coarsening (Figure 23). Pool characteristics suggest a slight improvement in habitat quality, as pool area met the target value in 2021. LWD piece frequency remained well below the targets in this reach for the eight consecutive survey year. Both stream temperature and over stream canopy cover did not meet their respective targets.

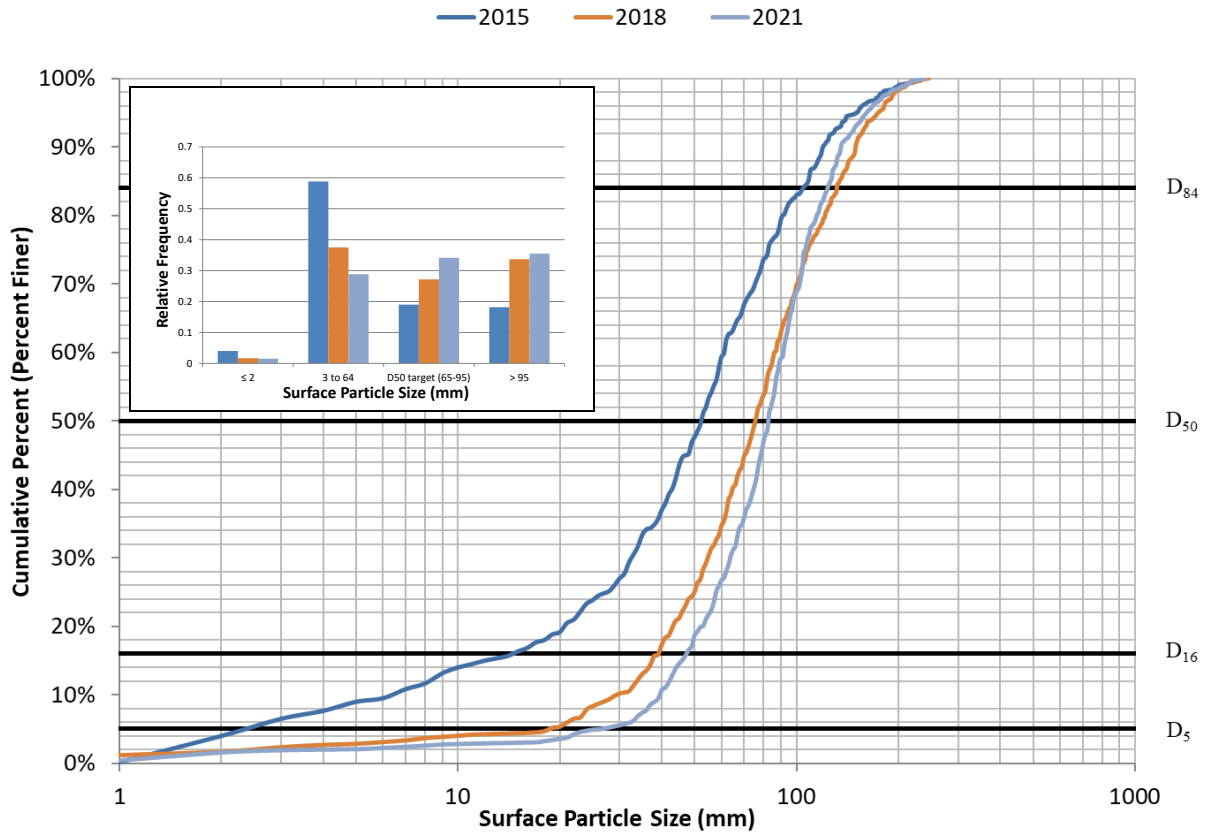
**Figure 21. Cumulative frequency plot of the mean surface particle sizes of three riffles measured within the Yager Creek ATM 007 monitoring reach**

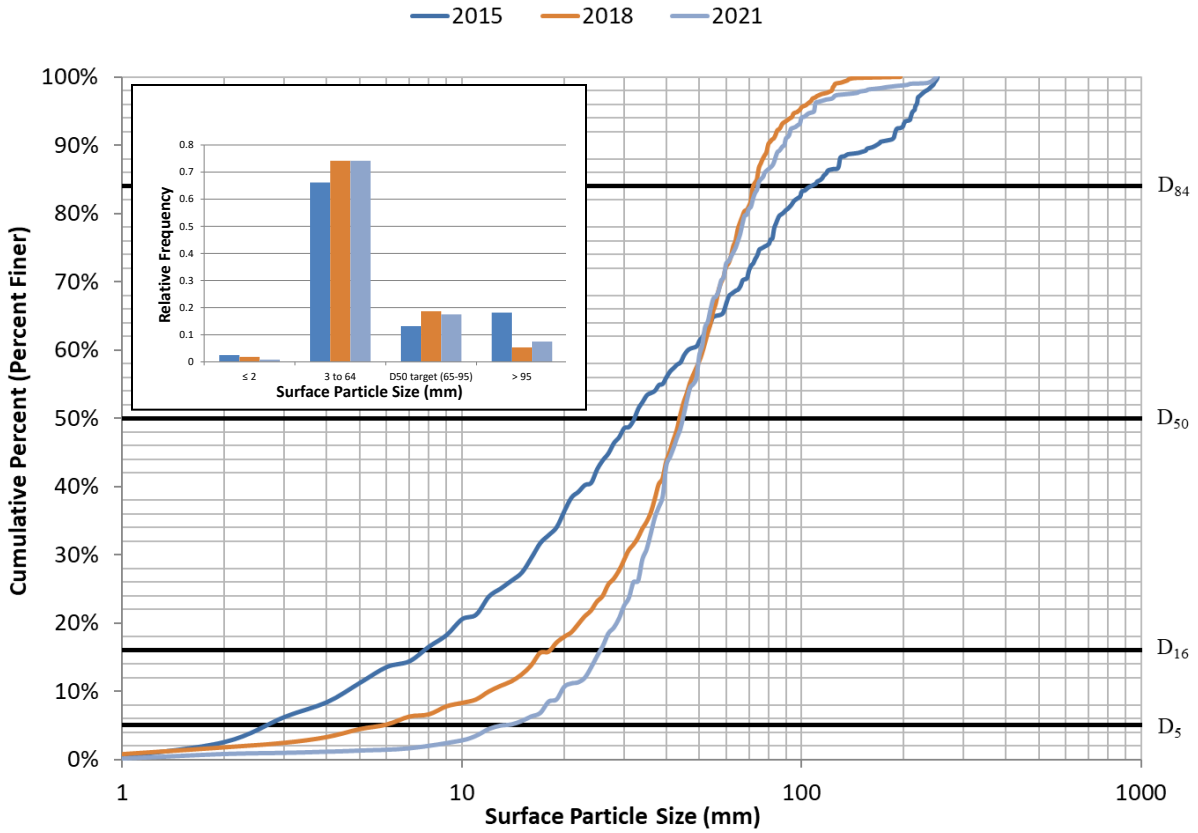
**Figure 23. Cumulative frequency plot of the mean surface particle sizes of three riffles measured within the Yager Creek ATM 005 monitoring reach**

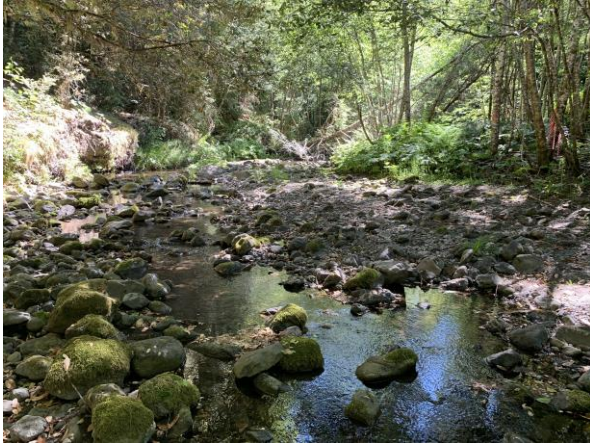
**ATM 133 Sulphur Creek**

Data for all ATM parameters at site 133 (Figure 29) are summarized in the APFC report card (Table 12). The bed surface  $D_{50}$  target was not met in 2021, as the data suggest a fining of the substrate across most particle size classes (Figure 30). Pool characteristics remained stable with 3 of 4 measured parameters meeting their target values. LWD piece counts in 2021 rose slightly but did not meet the target for the eighth consecutive survey year. Canopy cover and stream temperature each met their target values four survey years in a row.

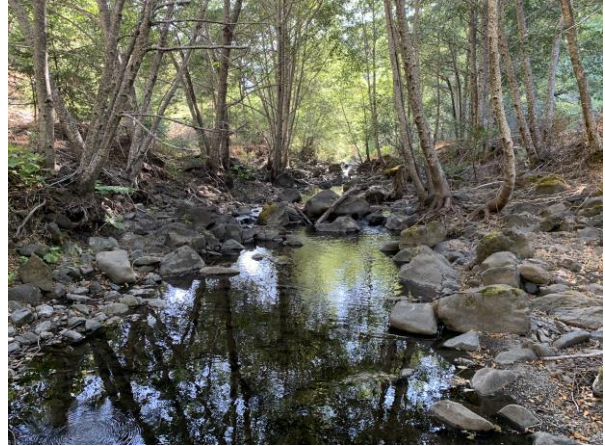
**ATM 169 Rattlesnake Creek**

Data for all ATM parameters at site 169 (Figure 29) are summarized in the APFC report card (Table 13). The bed surface  $D_{50}$  target was not met in 2021, even as the data suggest a coarsening of the substrate across most particle size classes (Figure 32). Pool characteristics suggest a slight decline in habitat conditions in 2021, with only half the parameters meeting the target values. LWD frequency has been historically very low in this reach, with parameters measuring well below target each survey year. Stream temperature continued to place short of the target for the tenth consecutive survey year, despite over stream and riparian canopy cover showing improvements in 2021.

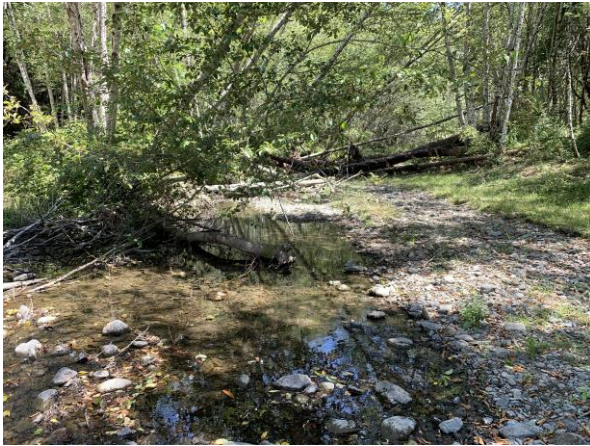
**ATM 219 McGinnis Creek**

Data for all ATM parameters at site 219 (Figure 29) are summarized in the APFC report card (Table 14). The bed surface  $D_{50}$  target was not met in 2021, as the data suggest a fining of the substrate across all particle size classes (Figure 34). Pool characteristics suggest stability in habitat conditions, with 3 of 4 parameters meeting their target values in 2021. LWD piece frequency met its target in 2021 for the first time on record, nearly tripling the number of pieces that were in the reach during the last survey year. Over stream canopy cover sufficiently met the target, as stream temperature missed the target for the third year in a row.

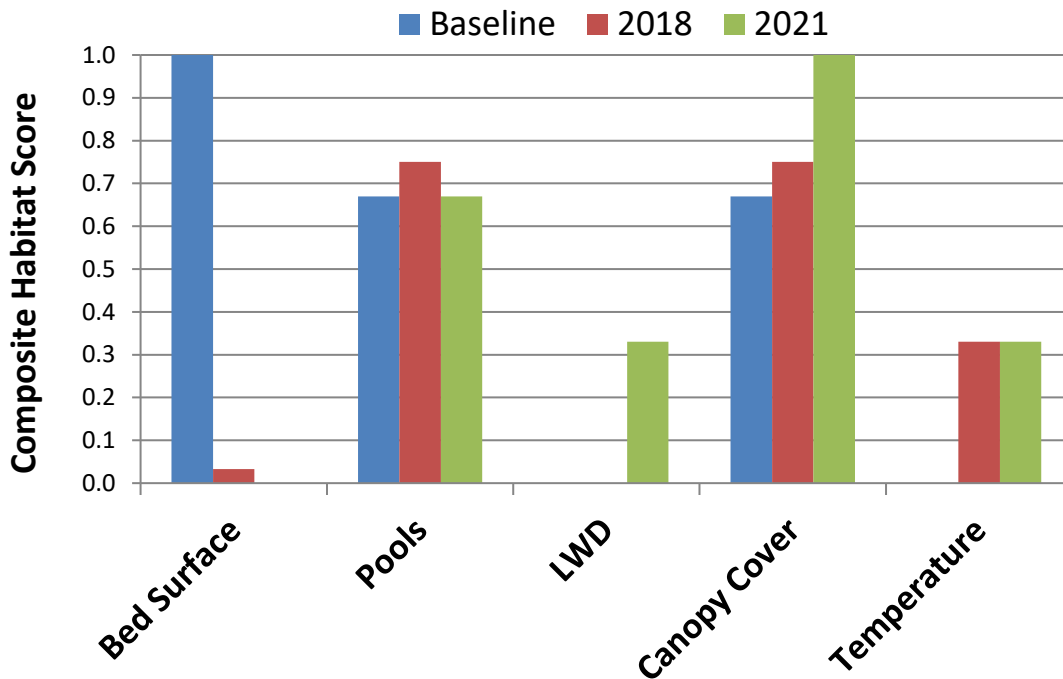
**Figure 36. The composite scores for habitat characteristics in the Mattole River WAU in 2018 and 2021 relative to baseline (2003) data**

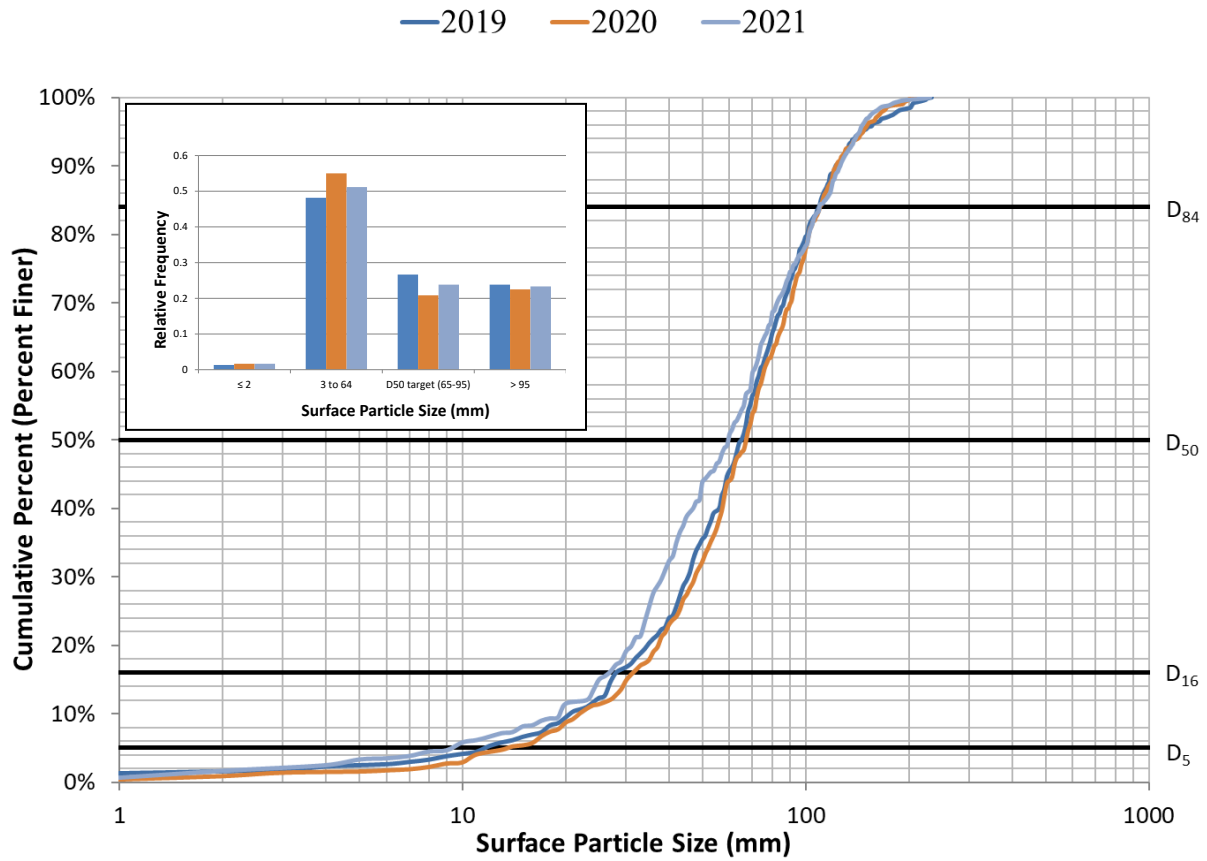
**Figure 39. Cumulative frequency plot of the mean surface particle sizes of three riffles measured within the Bear Creek ATM 203 monitoring reach**

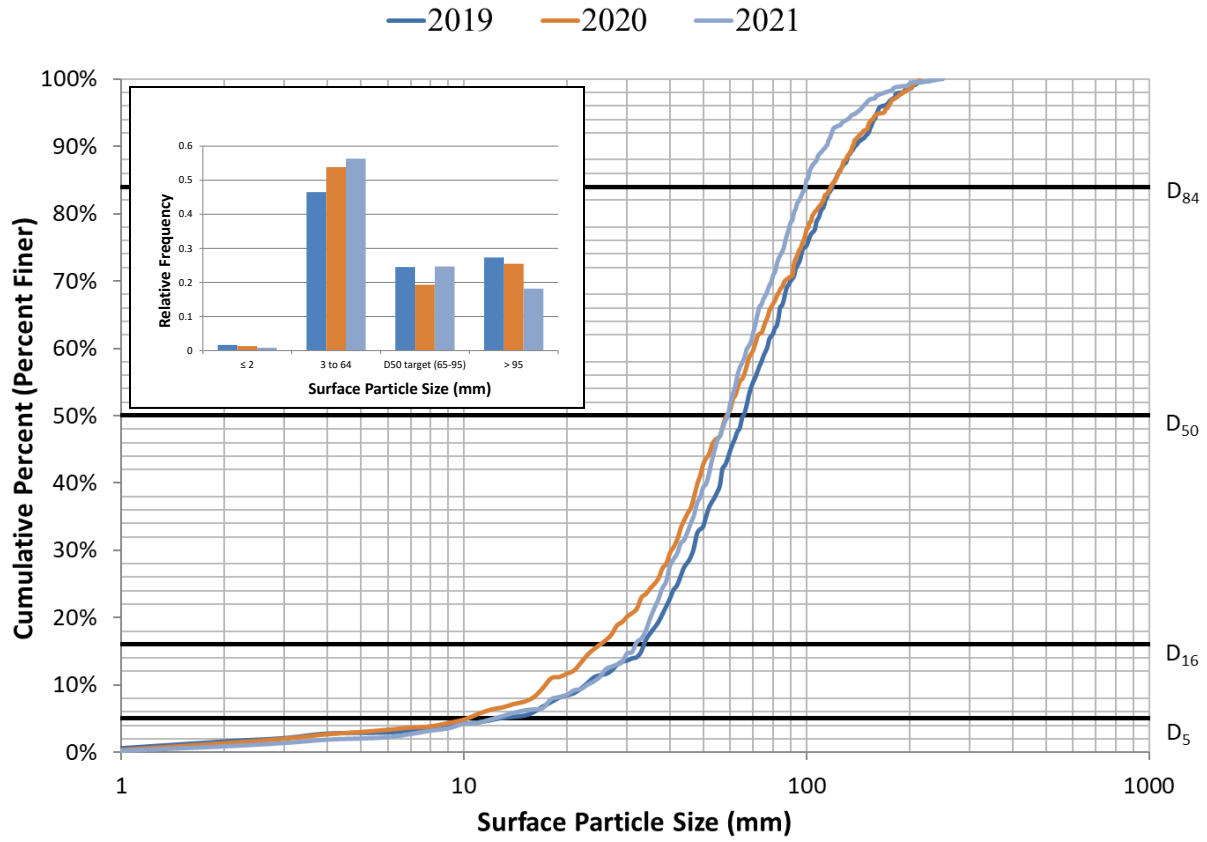
**Figure 43. Cumulative frequency plot of the mean surface particle sizes of three riffles measured at the Bear Creek ATM 204 monitoring reach**
