Section A MASS WASTING

INTRODUCTION

This module summarizes the methods and results of a mass wasting assessment conducted on the Mendocino Redwood Company, LLC (MRC) ownership in the Mallo Pass Creek, Alder Creek, Brush Creek, and Schooner Gulch, the Southcoast Streams Watershed Analysis Unit (Southcoast Streams WAU). California Planning Watersheds included in the Southcoast Streams WAU include portions of Mallo Pass Creek, Lower Alder Creek, North Fork Alder Creek, Lower Brush Creek, Upper Brush Creek, and Point Arena Creeks Planning Watersheds. This assessment was completed by Elias J. Steinbuck, PG 7538, and is part of a watershed analysis initiated by MRC that utilizes modified methodology adapted from procedures outlined in the Standard Methodology for Conducting Watershed Analysis (Version 4.0, Washington Forest Practices Board).

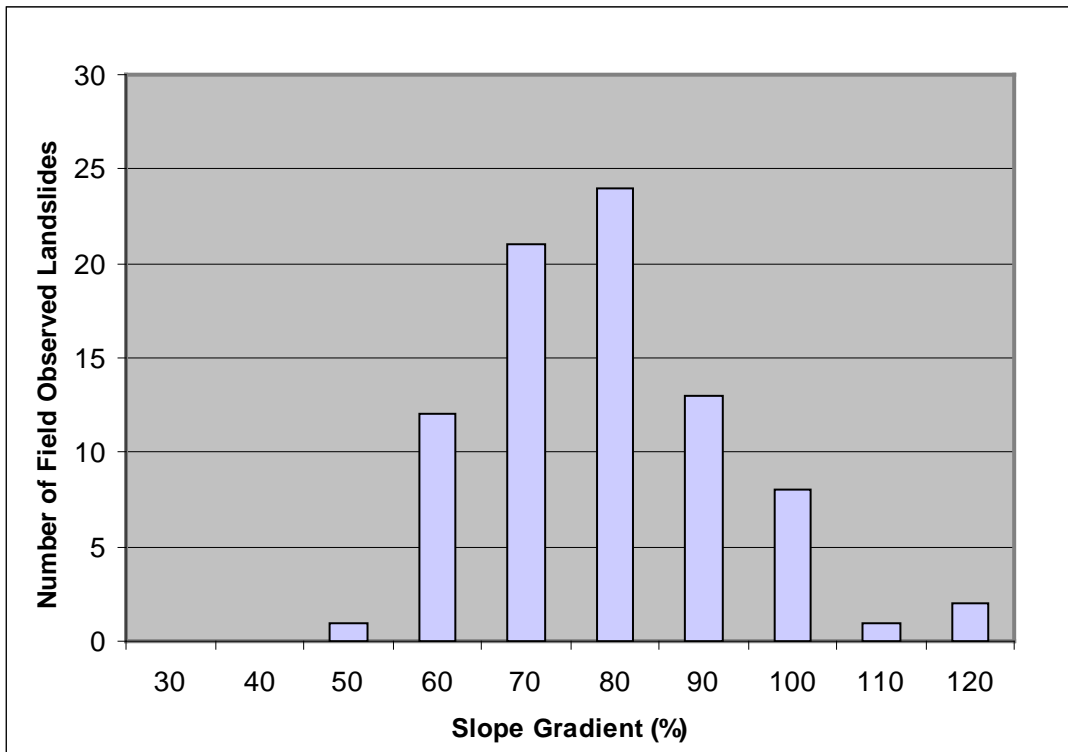
Chart A-1. Slope Gradient Histogram for Shallow-Seated Landslides Occurring on MRC Ownership in the Southcoast Streams WAU.

Of the 82 field observed shallow-seated landslides across the Southcoast Streams WAU, 84% (69/82) were initiated on slopes of 70% gradient or higher (Chart A-1).

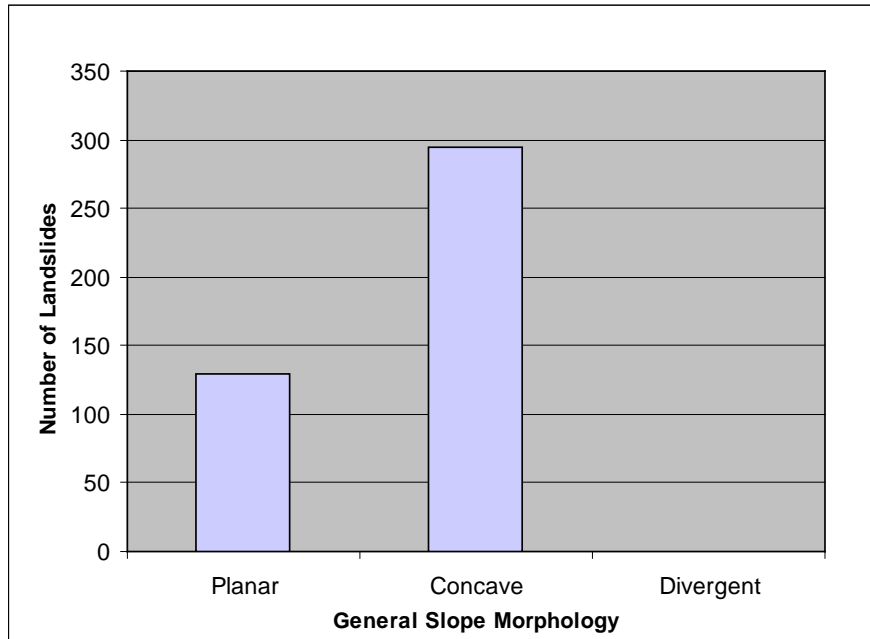
Chart A-2. Slope Morphology Summary for Shallow-Seated Landslides Occurring on MRC Ownership in the Southcoast Streams WAU.

A majority of inventoried landslides originated in convergent topography (294/423, or 70%) where subsurface water tends to concentrate, or on steep, planar topography (129/423, or 30%), where sub-surface water can be concentrated at the base of slopes, in localized topographic depressions, or by local geologic structure. No landslides originated in divergent topography where subsurface water is typically routed to the sides of ridges (Chart A-2).

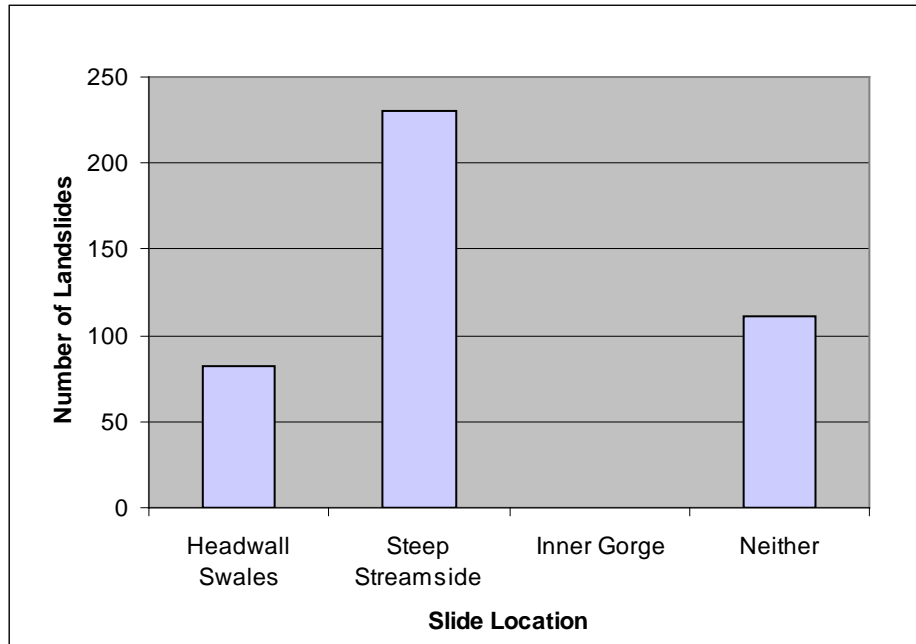
Chart A-3. Slide Location Summary for Shallow-Seated Landslides Occurring on MRC Ownership in the Southcoast Streams WAU.

A majority of the inventoried landslides were discovered along steep streamside slopes (230/423, or 54%), with fewer found in headwall swales (82/423, or 19%), and no inner gorge slopes observed. A significant portion (111/423, or 26%) of the inventoried landslides were observed on open slopes away from any steep streamside slopes, or headwall swales, however, a majority of these slides originated in fill material along the outside edge of roads and skid trails (Chart A-3). Such observations were, in part, the basis for the delineation of the WAU into Terrain Stability Units.

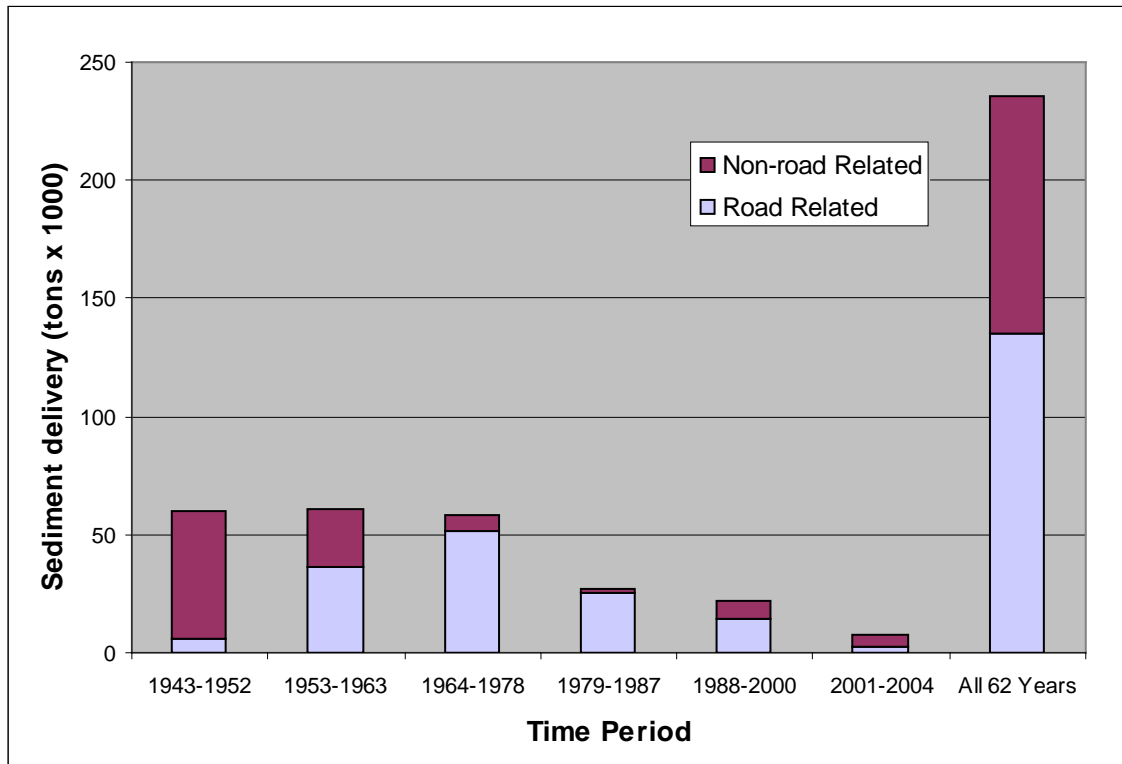
Chart A-4. Sediment Delivery Estimates by Time Period for Shallow-Seated Landslides on MRC Ownership in the Southcoast Streams WAU.

A total of approximately 235,529 tons of mass wasting sediment delivery was estimated for the time period 1943-2004 in the Southcoast Streams WAU. This equates to approximately 176 tons/sq. mi./yr. Of the total estimated amount, 25% delivered from 1943-1952, 25% delivered from 1953-1963, 25% delivered from 1964-1978, 12% delivered from 1979-1987, 10% delivered from 1988-2000, and 3% delivered in the 2001-2004 time period (Chart A-4).

Relatively large amounts of sediment delivered from 1953-1978 is partly the result of intensive road building and ground based yarding on relatively steep slopes. Road and skid trail construction during this era of forest management included the practice of sidecasting excavated fill material, at times onto steep slopes. Additionally, according to local rainfall data, the 1974 storm event produced the wettest days on record at numerous precipitation stations on the northwest coast (Goodridge, 1997). Numerous studies reveal there is a pronounced effect of pore water pressure changes on factor of safety for shallow-seated landslides (Sidle et al., 1985).

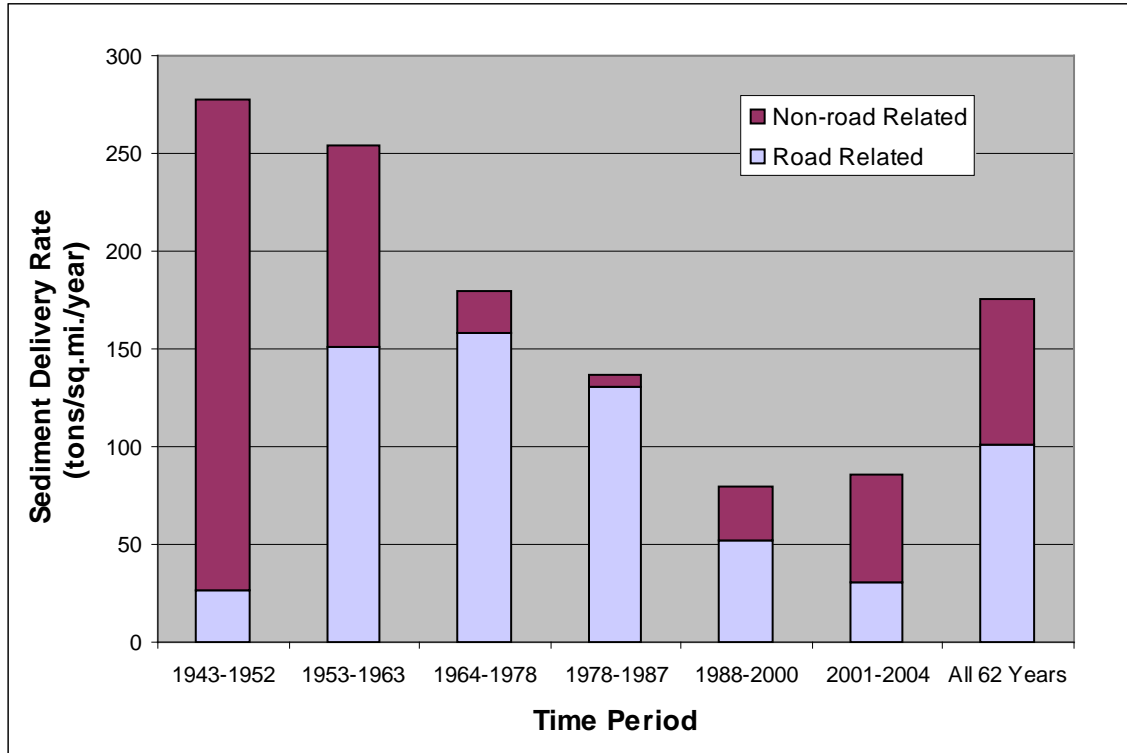
Chart A-5. Mass Wasting Sediment Delivery Rate (tons/sq.mi./year) from Shallow-Seated Landslides on MRC Ownership in the Southcoast Streams WAU.

The sediment delivery estimates were normalized by time (years) and area (square miles) for the purposes of relative comparison between time intervals and planning watershed. The resulting sediment delivery rates in the Southcoast Streams WAU change dramatically over the time period investigated (Chart A-5).
