# **Bear River Watershed Analysis**

## **Cumulative Watershed Effects**

*Public Review Draft*

**December 2008**

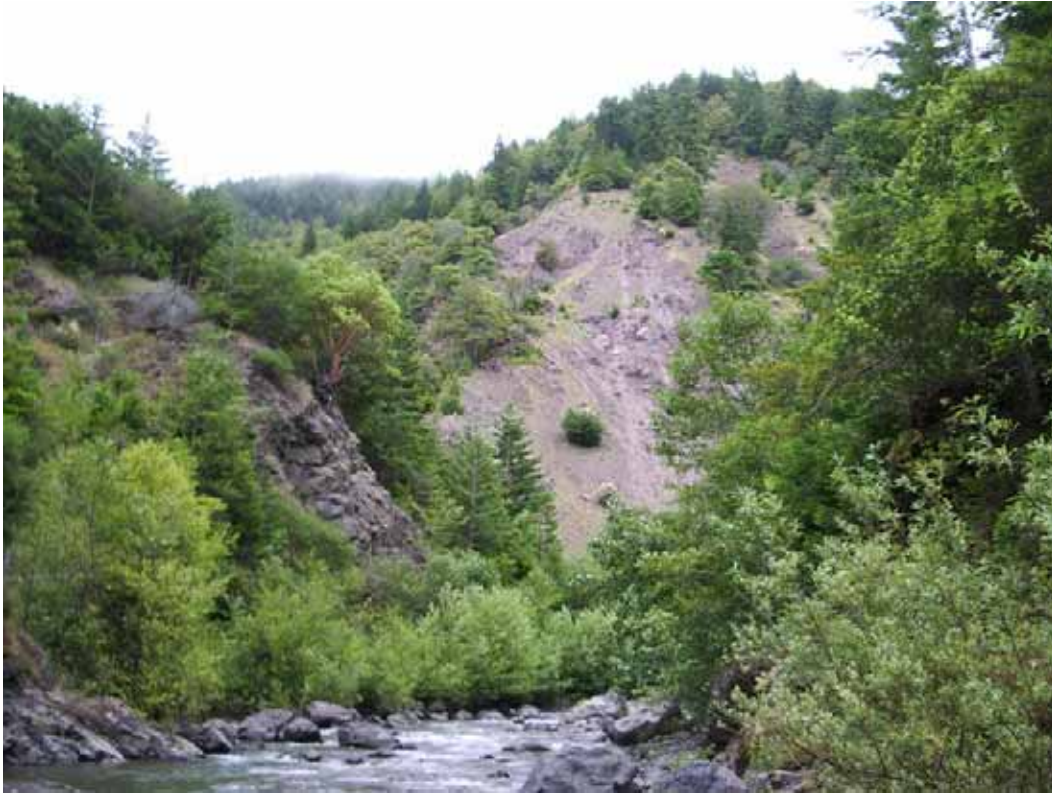
**Photo 3-1. Bear River Downstream from Gorge Creek.**

Bear River is predominantly a deeply incised, low gradient channel (Photo 3-1), characterized by steep, high valley walls, a relatively narrow valley bottom, and bedrock exposed at or near the channel bed. Wide, flat valleys exist in some areas where tributaries join the mainstem. Gentle slopes are present on grassed, south-facing areas and lands near the mouth of Bear River. On HRC lands, located in the upper, eastern portion of the drainage, most of the gently sloping ground is found in the Happy Valley sub-basin and along the mainstem Bear River in the Upper Bear River sub-basin. Within the HCP area, 25 percent of the slopes are less than 35 percent gradient (Table 3-5), based on the LIDAR-based slope analysis depicted on the slope gradient class map shown on Figure 3-2. Slopes steeper than 65 percent account for 28 percent of the HCP area. Approximately half of the land area in the HRC-owned portion of the Bear River WAU has slopes steeper than 50 percent gradient. The Gorge Creek Complex, Harmonica Creek, and Brushy Creek sub-basins collectively contain more than 40 percent of the HCP land area with slopes steeper than 65 percent gradient.

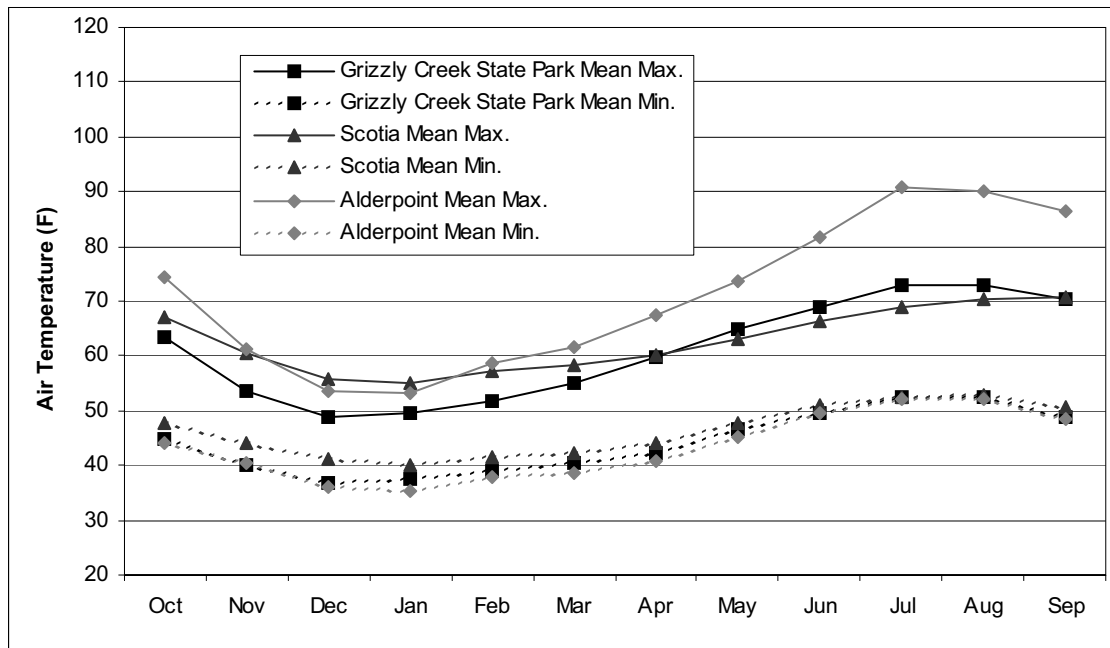
**Figure 3-6. Mean Minimum and Maximum Monthly Air Temperatures in the Vicinity of the Bear River WAU.**

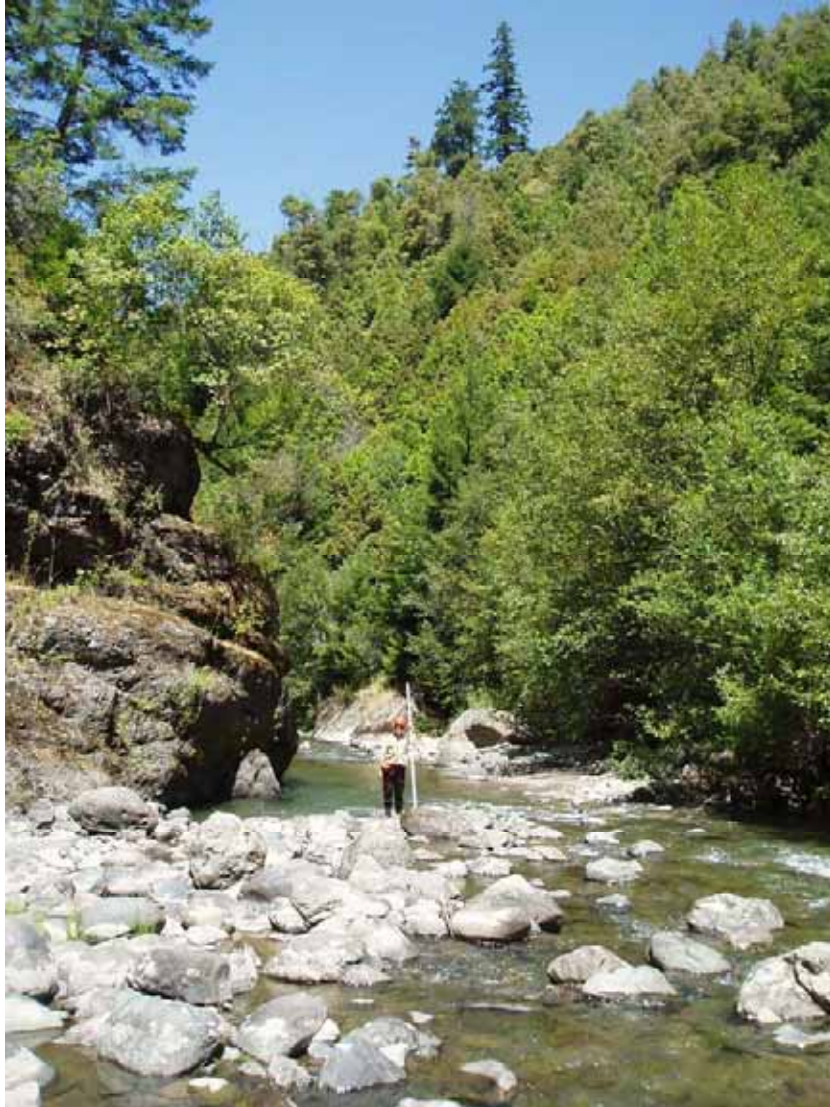
**Photo 3-3. Confined Reach of Bear River between Beer Bottle and Nelson Creek.**

Between Beer Bottle Creek and Nelson Creek (the fourth reach, Photo 3-3), the channel becomes more confined and gradients increase dramatically. Canopy cover also increases and the stream temperatures are cooler. Between Nelson and the confluence of the Bear River and Harmonica Creek (the fifth reach), the channel widens and alluvial deposits dominate the valley bottom. Gradients average between 1-3 percent and canopy cover decreases. Large woody debris is more abundant. Upstream of Harmonica

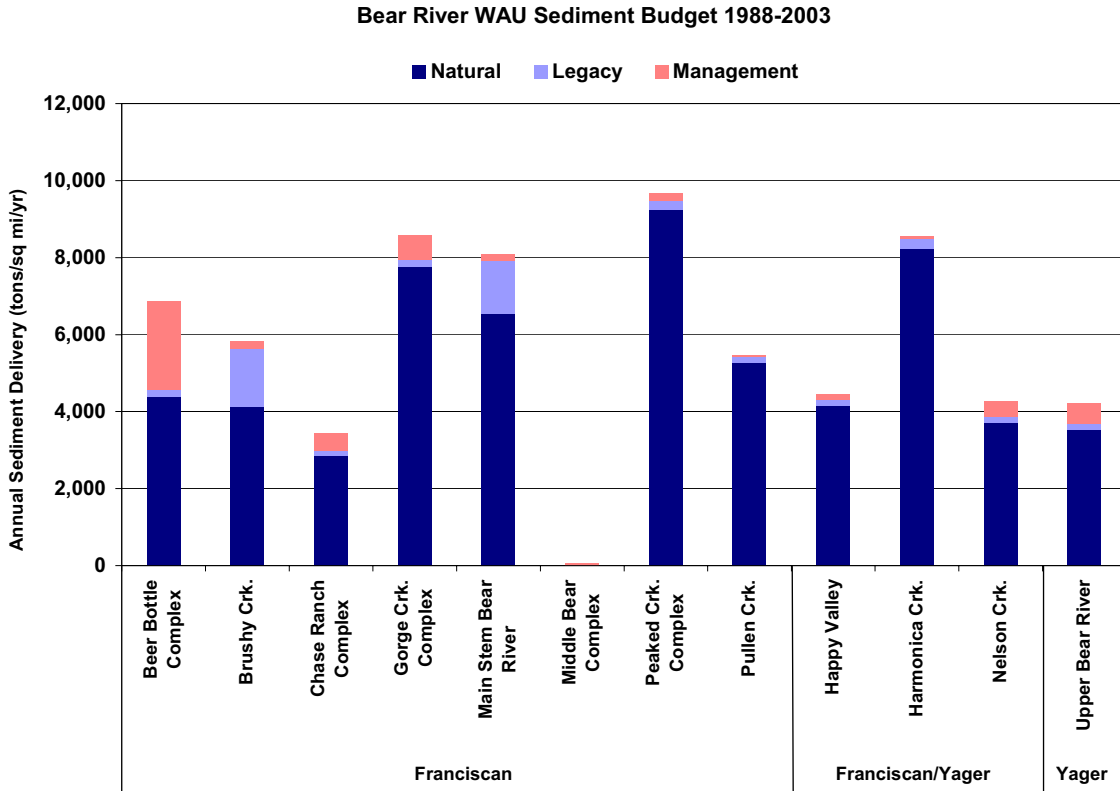
**Figure 5-1. Annual sediment budget for sub-basins in the Bear River WAU for the period 1988-2003.**

Figure 5-1 illustrates the extent to which ‘natural’ sources control sediment input to the Upper Bear River watershed, as well as the proportion to which contemporary delivery originates from lingering legacy effects versus more recent management activities. For comparison, Figure 5-2 shows HCP watershed analysis-derived sediment delivery rates for portions of other watersheds owned and managed by PALCO for the same or similar time period. Different rates are a result of these watersheds varying from one another with regard to composition of the bedrock, proximity to faults and earthquake zones, topography, precipitation and climate, and harvest history. In general, the results show substantially higher contributions from the Bear River area as compared to other watersheds, with notably larger contributions from natural sources. This observation is expected based on the significance of contributions from large landslides in the Bear River HCP area, which account for the vast majority of the total sediment delivery volume from all sources in the 1988-2003 sediment budget.

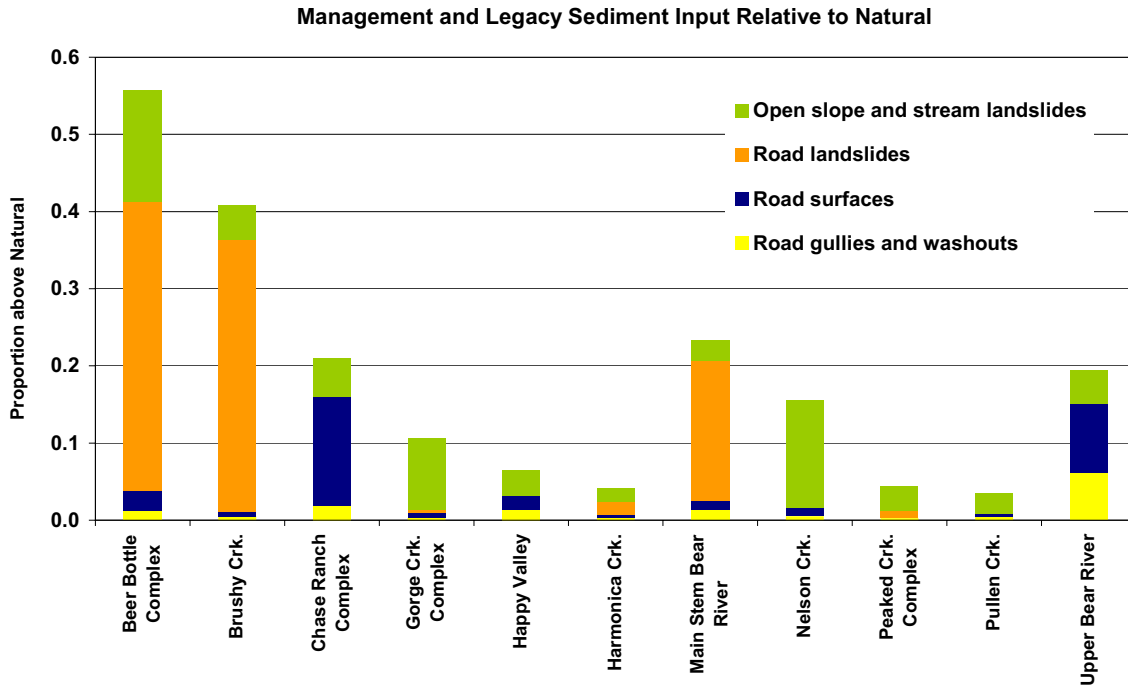
**Figure 5-3. Relative importance of management-related and legacy sediment sources by sub-basin in the Bear River WAU (HCP lands).**

Seven out of the eleven sub-basins analyzed were reported to have an overall management- and legacy-associated sediment delivery rate of less than 20 percent over background for the 1988-2003 time period. Beer Bottle exceeds 50 percent and Brushy Creek 40 percent. With the exception of the Nelson Creek and Gorge Creek Complex sub-basins, roads were identified as the primary management-related sediment source for all sub-basins. Another key finding is that regardless of road or harvest area association, large to very large landslides, rather than numerous small ones or surface erosion, are responsible for the vast majority of sediment delivery linked to forestry operations. Four large road-associated landslides drive the sediment delivery shown for the Beer Bottle, Brushy Creek, and Mainstem Bear River sub-basins, with the largest of these slides delivering an estimated 36,000 cubic yards in the 1988 to 1997 photo analysis period. A similar situation exists with the open-slope, harvest related landslides, with two landslides in the Beer Bottle Complex, two in the Gorge Creek Complex, and one in Nelson Creek responsible for the vast majority of sediment delivery in this category. Relative to the other sub-basins, fine sediment delivery from road surfaces is high in the Chase Ranch Complex and Upper Bear River sub-basins. For the Chase Ranch Complex sub-basin, this results from the fact the Bear River mainline runs through the sub-basin and, therefore, road use is very high. While the mainline is a rocked road,

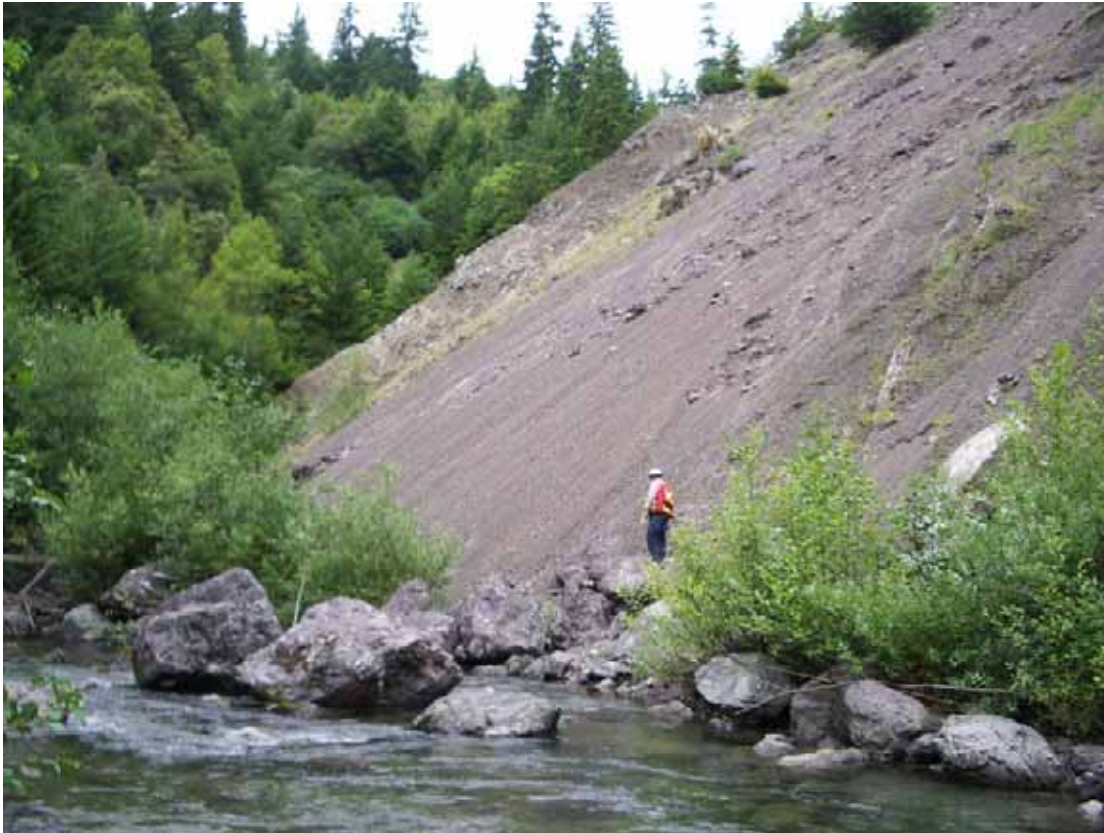
**Photo 5-3. Bear River and Exposed Bedrock from mid-1960s Landslide Downstream of Gorge Creek.**

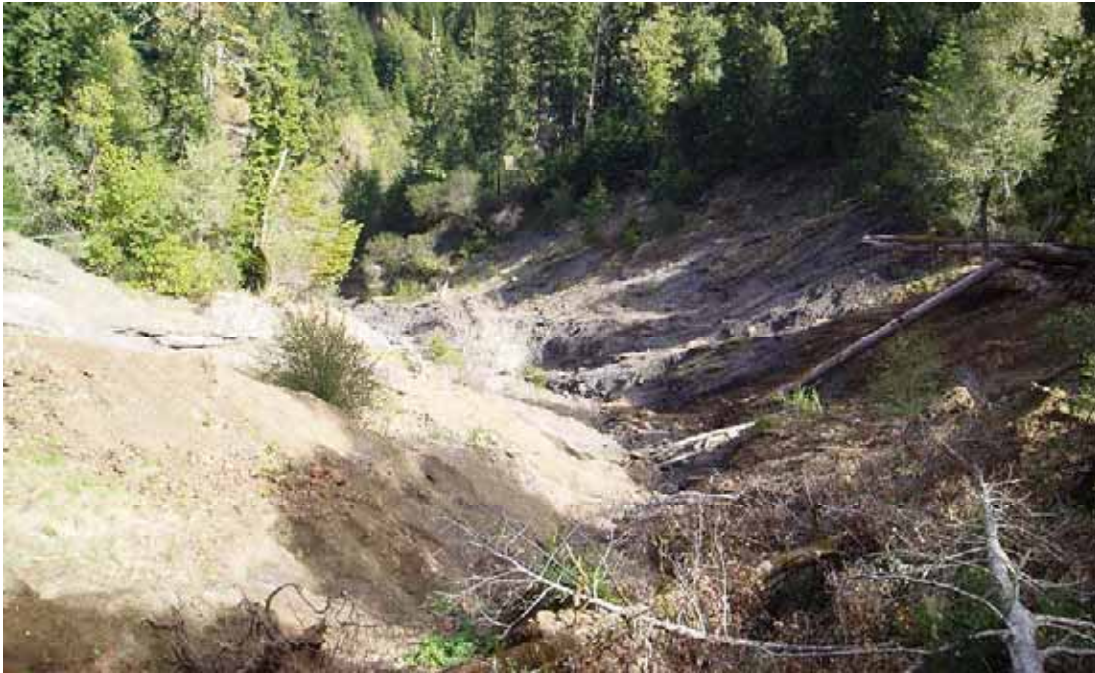
**Photo 5-4. Large 1997 Landslide Downstream of Beer Bottle Creek.**

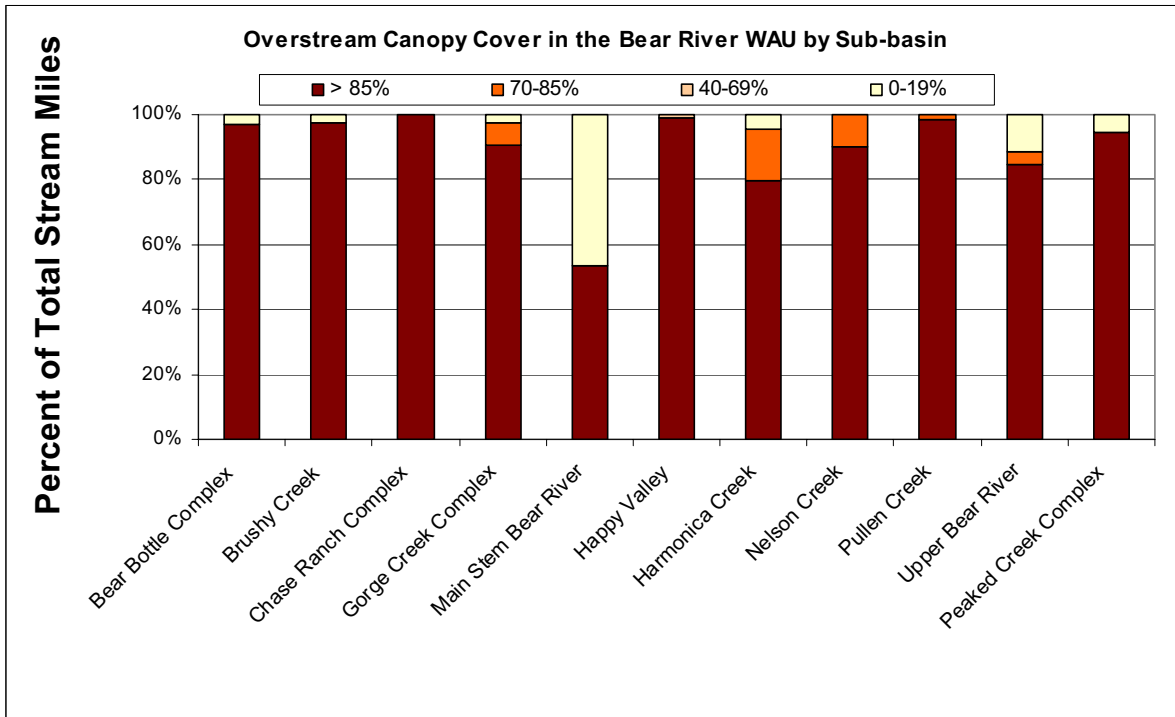
Figure 5-5. Overstream Canopy Cover by Sub-Basin

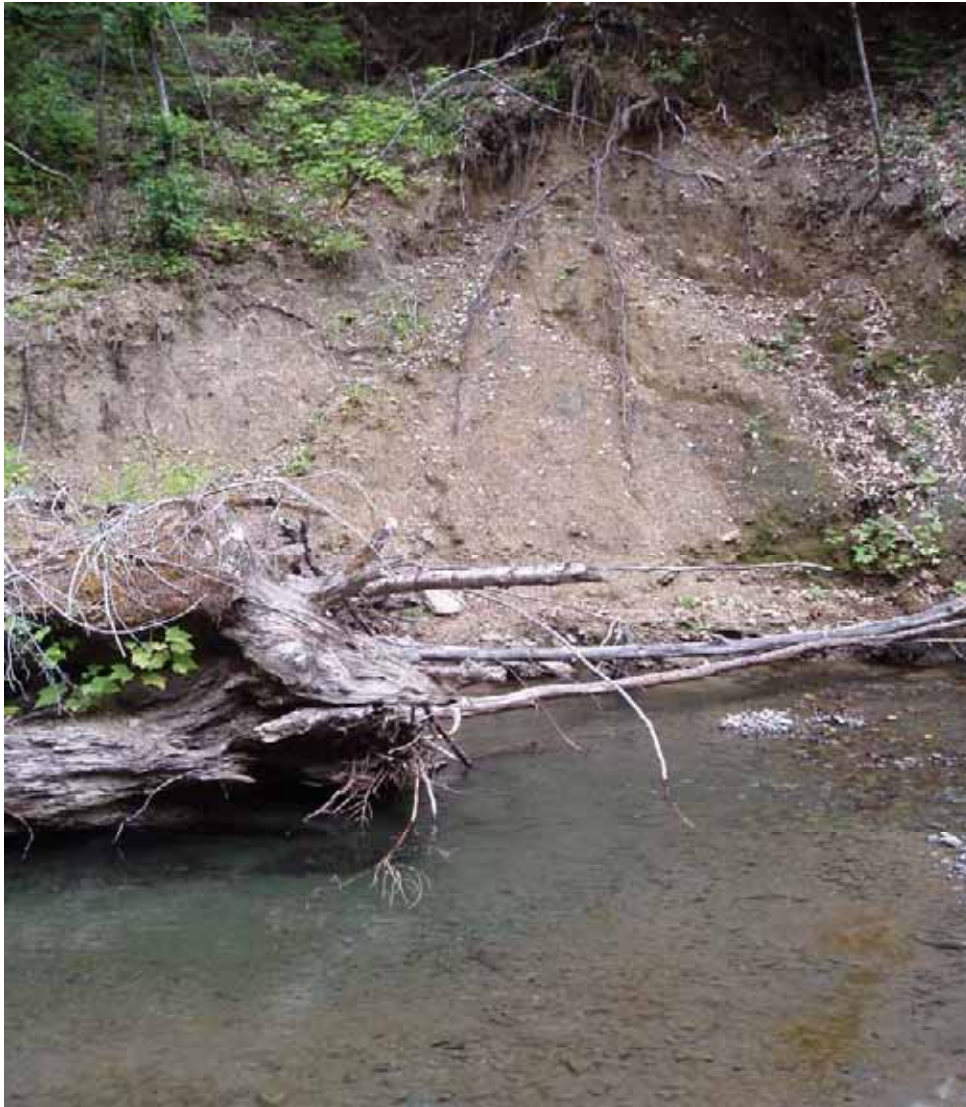
**Photo 5-6. Bank Erosion with Delivered LWD and Sediment**

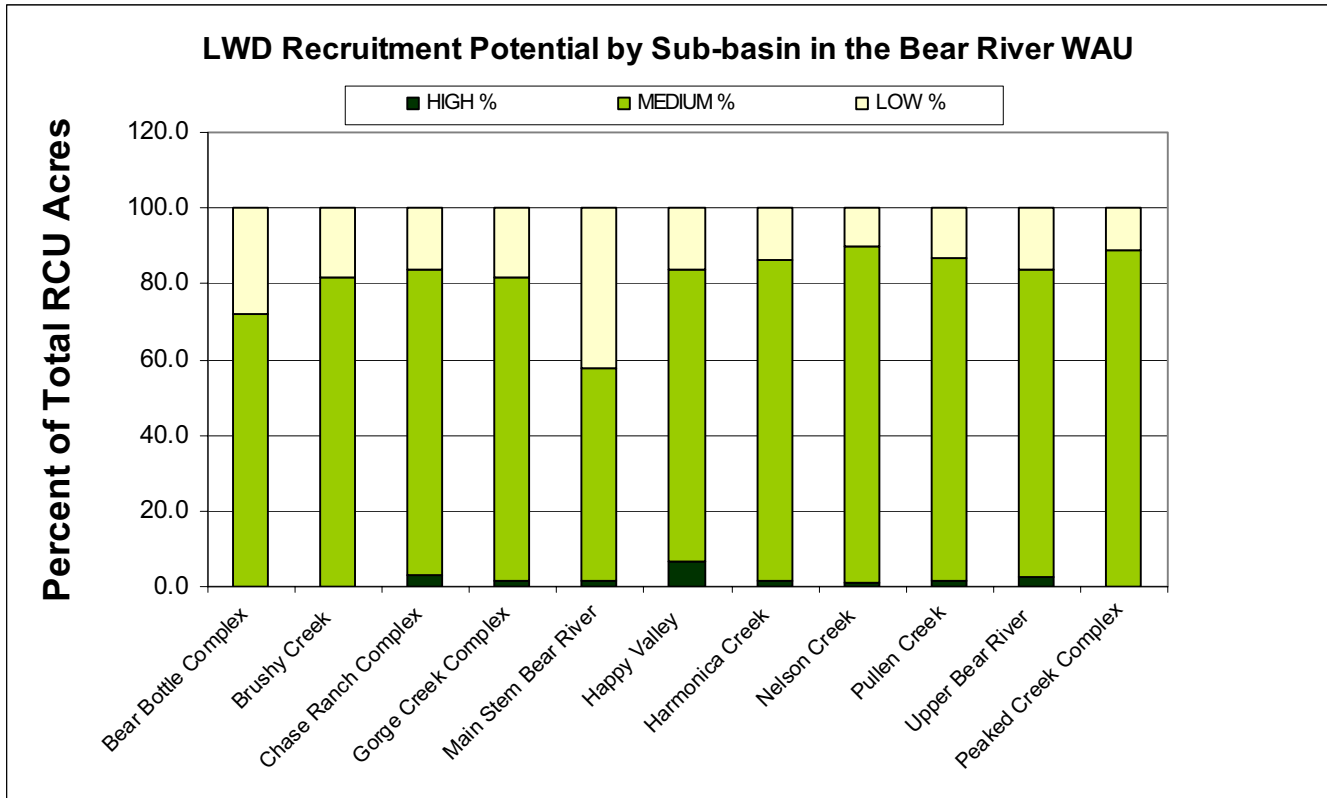
Figure 5-7. Percent of LWD Recruitment by Sub-basin in the Bear River WAU

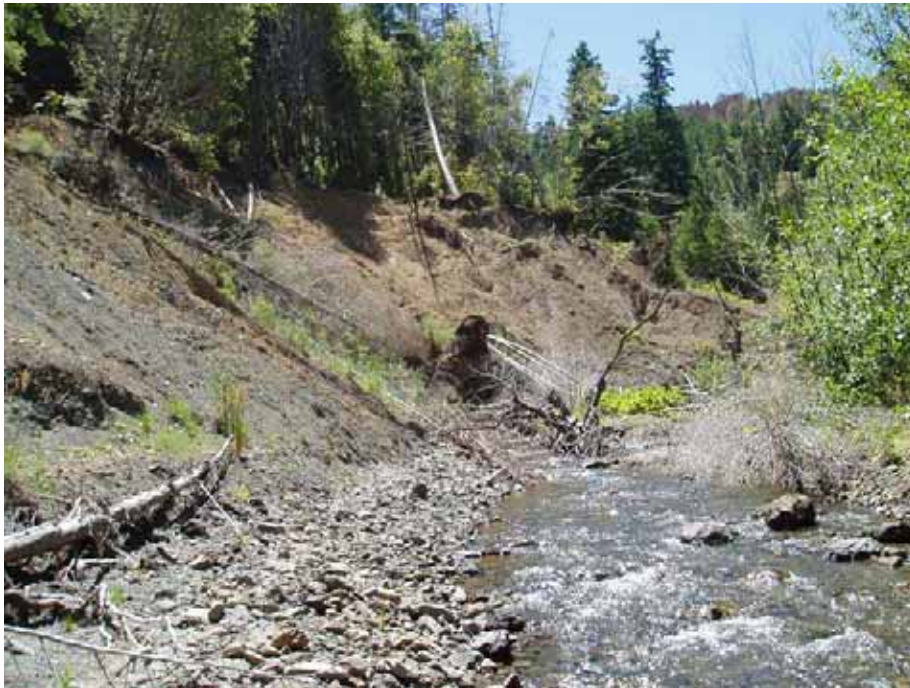
**Photo 5-10. Streamside Mass Wasting along Harmonica Creek.**

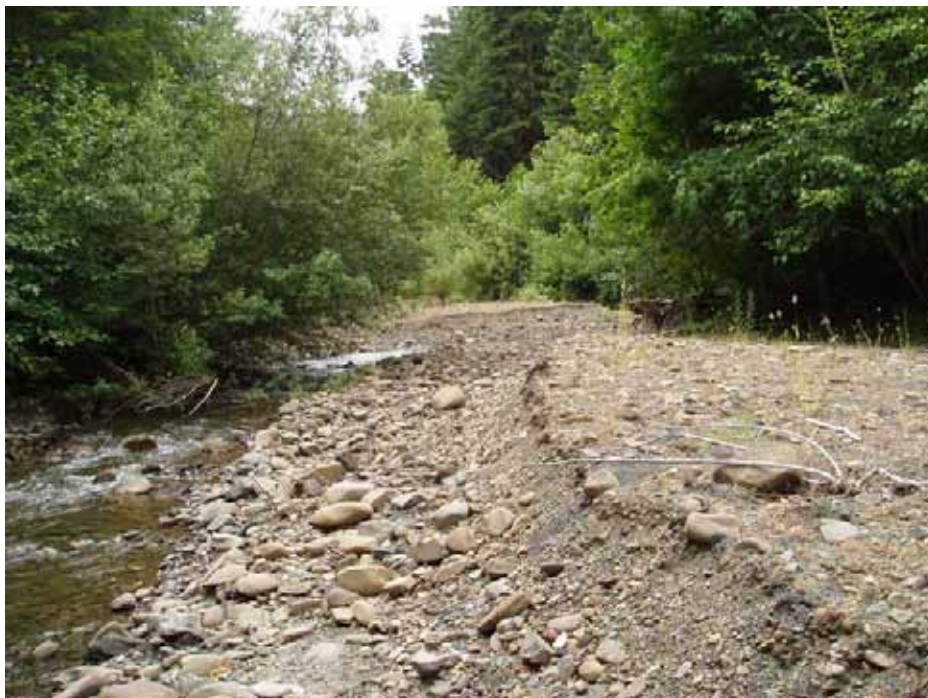
**Photo 5-11. Harmonica Creek Gravel Bar with Evidence of Incision and Recent Transport.**

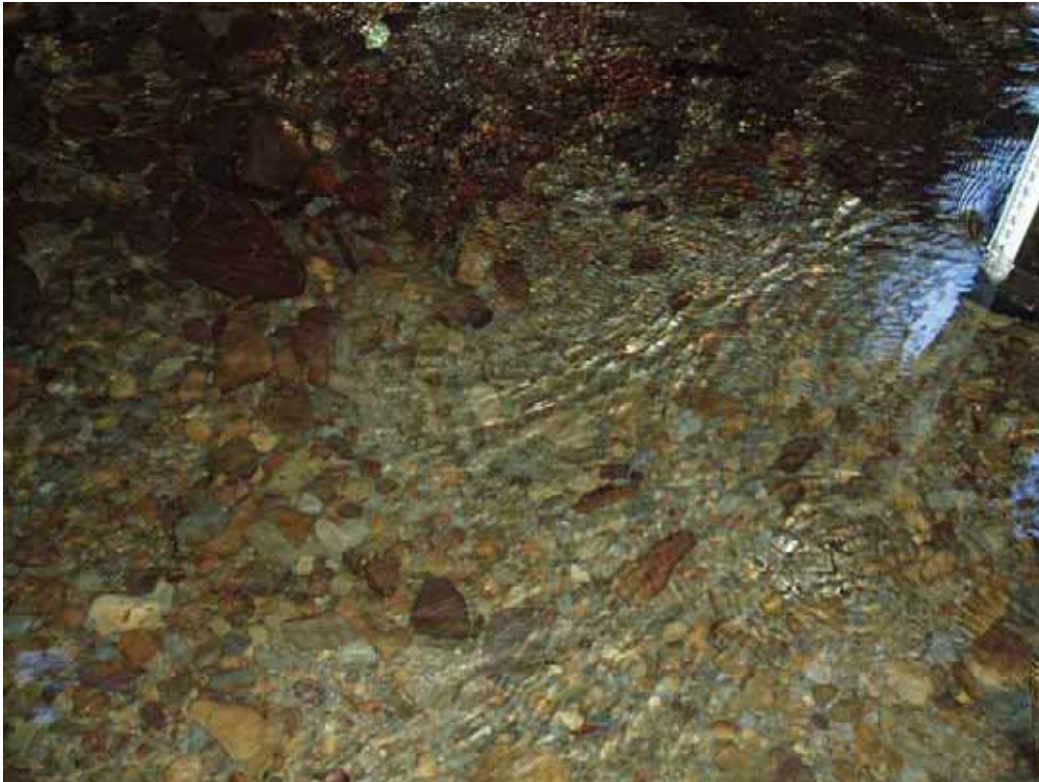
**Photo 5-14. Pool Tail-Out and Suitable Spawning Habitat.**

Further upstream, HCP-covered lands provide abundant spawning size gravels for winter-run steelhead and resident rainbow trout (Photos 5-13 and 5-14). While steelhead spawn in late winter in the mainstem and lower reaches of larger tributaries such as Harmonica Creek, Nelson Creek, and Pullen Creek, resident rainbow trout are essentially spring spawners (mid-April to late June) and utilize smaller gravel sizes and smaller tributaries as well as the headwaters of the mainstem.

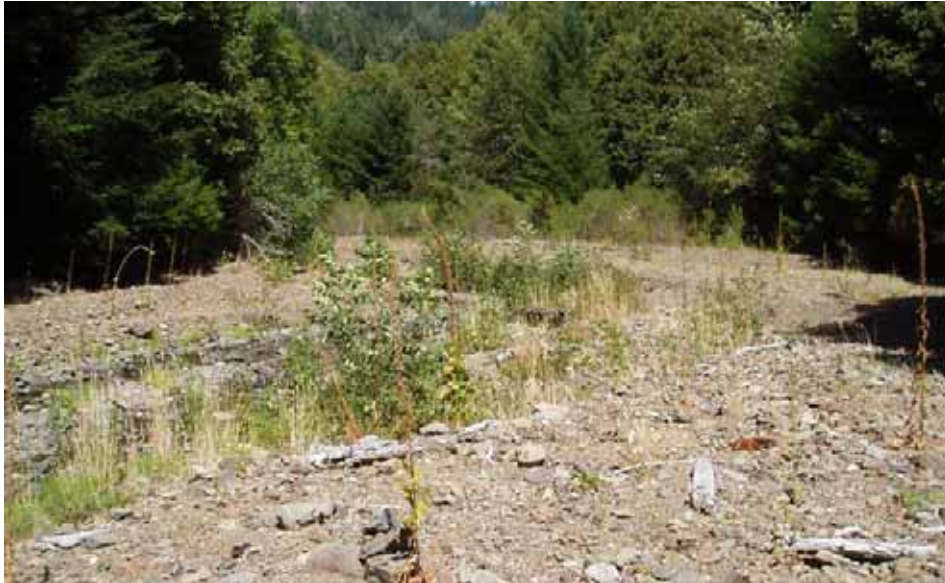
**Photo 5-16. Landslide Deposition in Lower Brushy Creek.**

Tributaries where spawning habitat conditions were less optimal include Nelson Creek, Brushy Creek, and Gorge Creek. While suitable spawning gravel exists in Nelson Creek, substrate size in general was often found to be too large and/or embedded, thus limiting spawning opportunities. Gorge Creek was similar in that most substrate is simply too large (Photo 5-15), as smaller substrate material is quickly transported downstream out of the tributary due to its incised and steep gradient nature. The pockets of smaller gravel that do exist in Gorge Creek are more suited to resident rainbow trout. Brushy Creek has an abundance of appropriately sized spawning gravels but they are highly embedded with fine sediment. The current condition in Brushy Creek is likely linked to a very large landslide which occurred in its headwaters in 1997 (Photo 5-16).

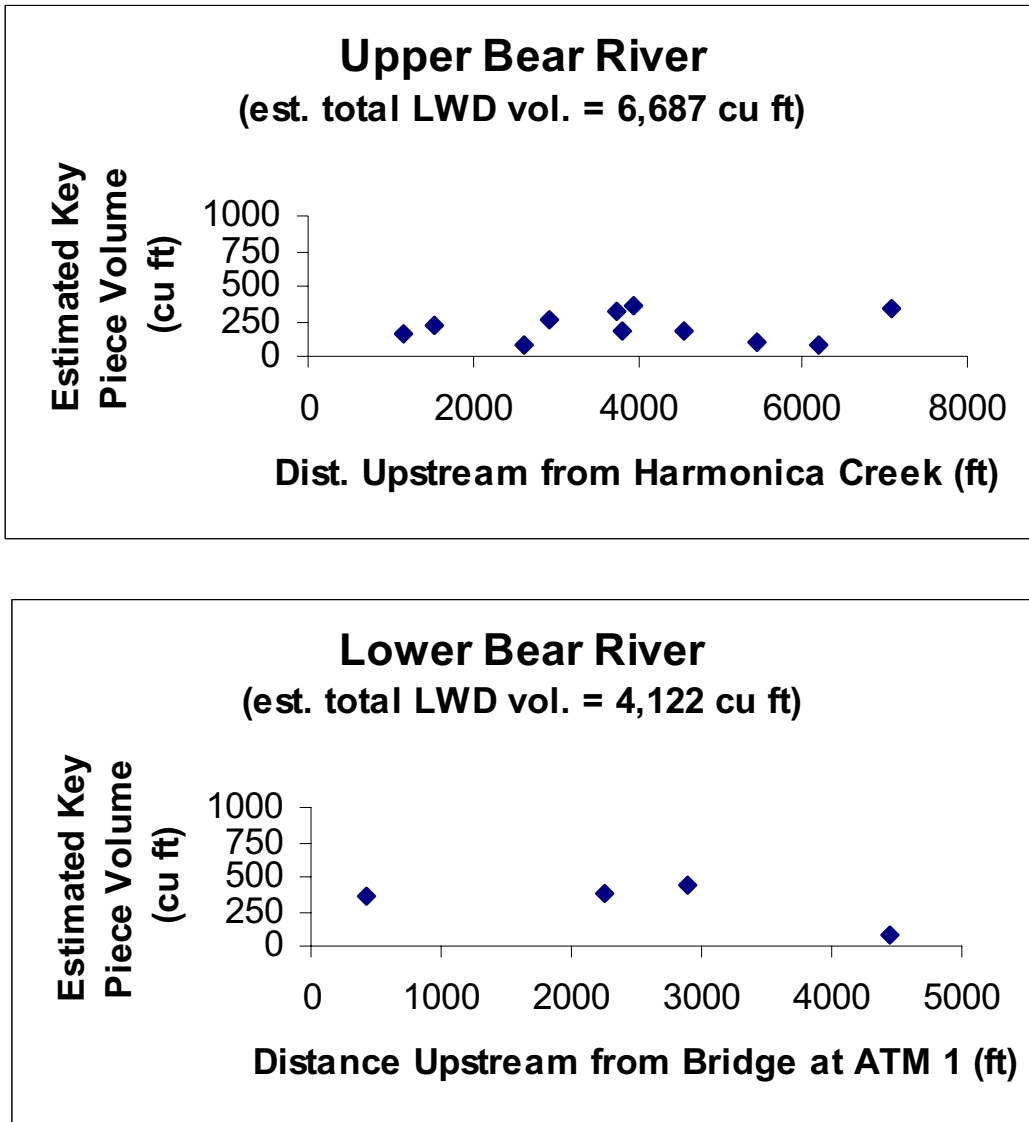
Figure 5-8. Bear River Estimated Key Piece Volume Distribution Along Survey Reaches.

Figure 5-8 illustrates the key LWD piece volume and location in the main channel of two discrete 2005 Bear River survey reaches (Appendix E; map E-15 for survey locations). The upper Bear River reach surveyed appears to contain nearly double the number of key pieces and greater than 50 percent more LWD volumetrically (Photo 5-18) than the lower Bear River reach. Overall, wood volumes are low in the mainstem when compared with most tributaries. ATM data indicate that, while fluctuating from year to year, LWD density decreases moving downstream (Figure 5-9), consistent with the findings of the 2005 stream surveys.

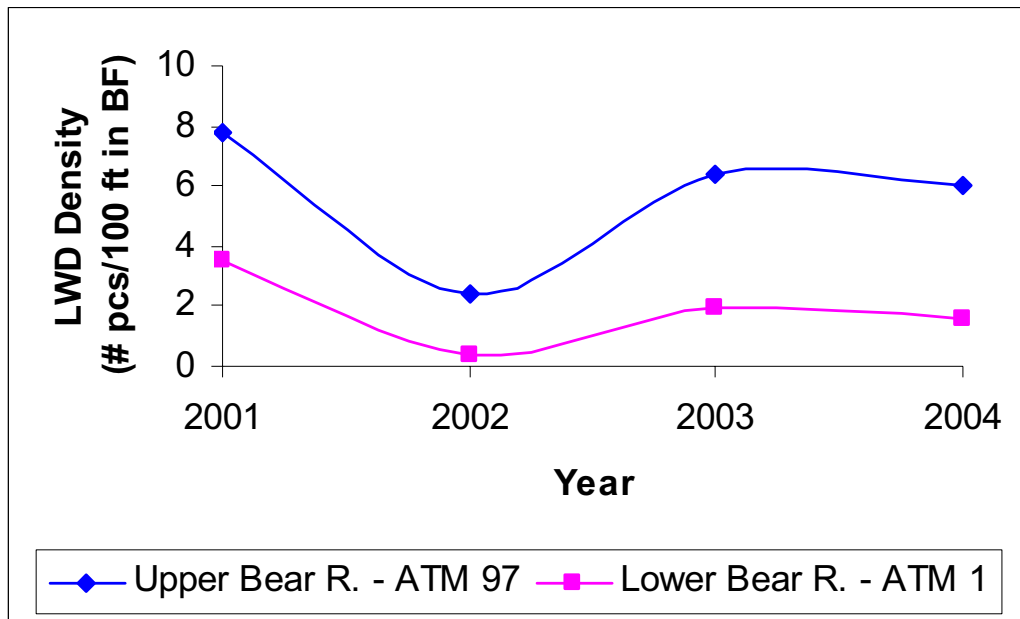
Figure 5-9. LWD Density from Bear River ATM Station Data.

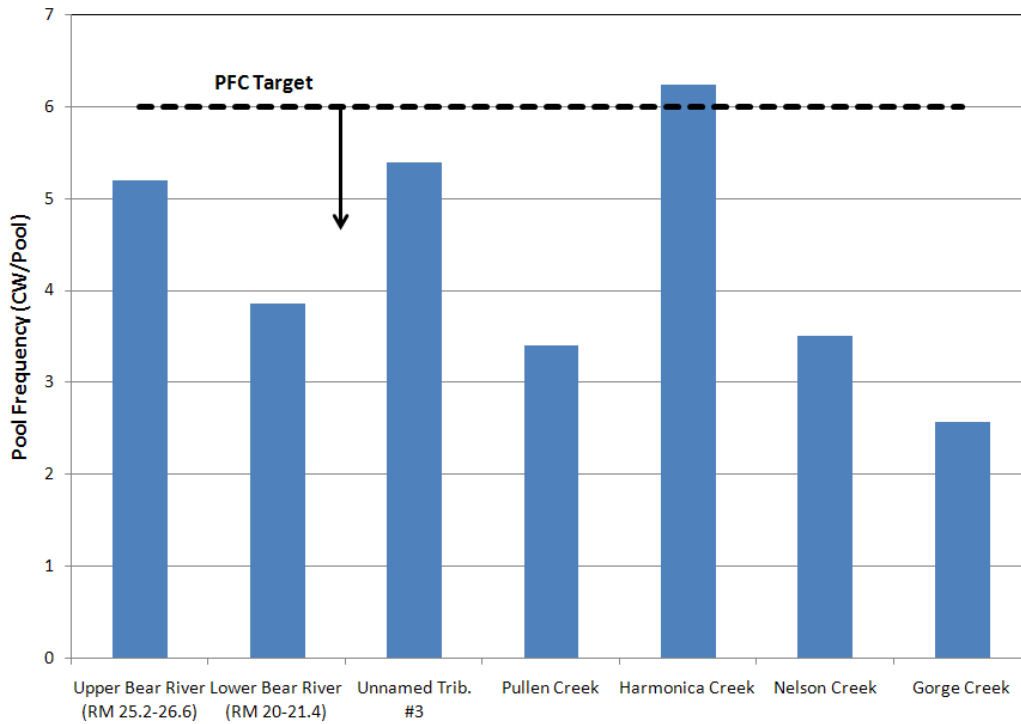
Figure 5-18. Pool Frequency From 2005 Stream Survey Data.

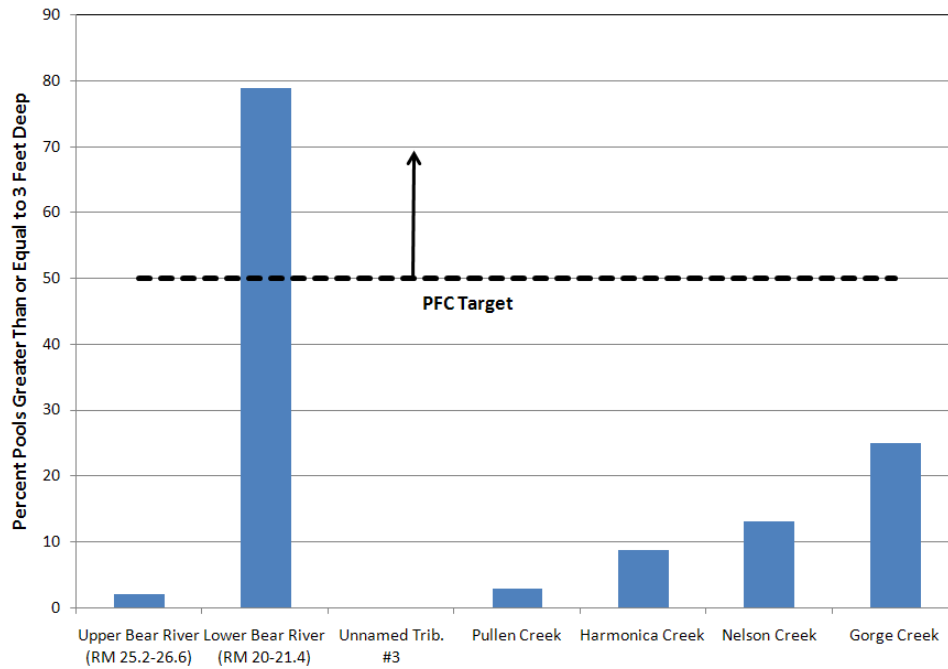
Figure 5-19. Percent Pools  $\geq$  3 Feet Deep From 2005 Stream Survey Data.

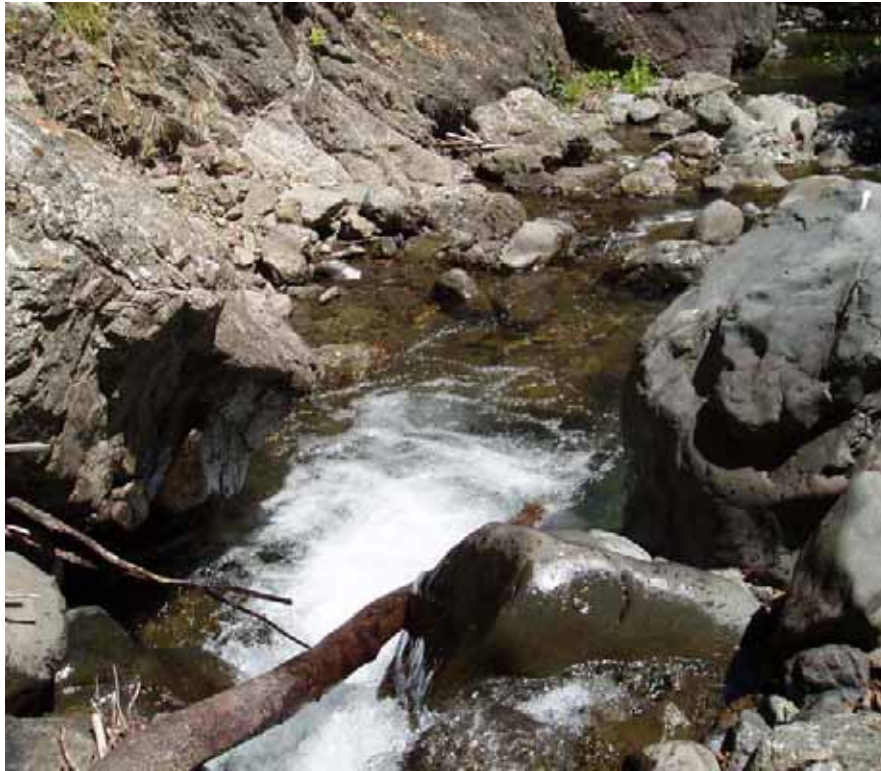
**Photo 5-21. Boulder-Formed Step Pool in Gorge Creek.**

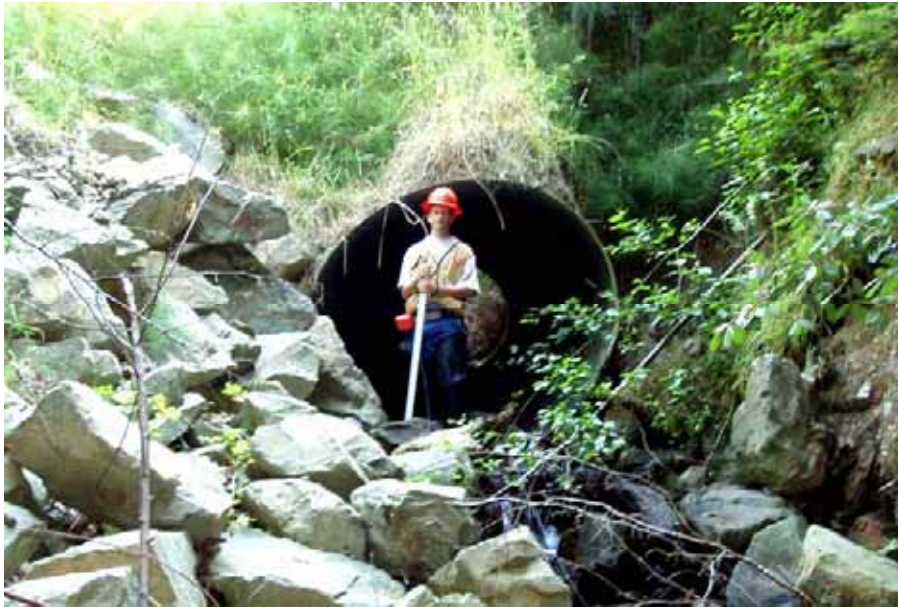
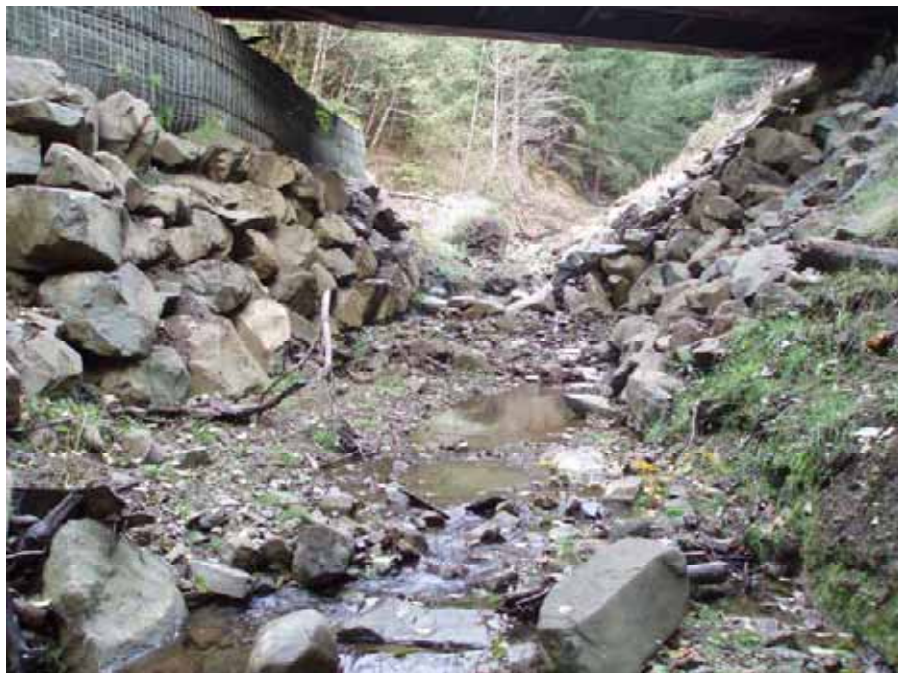
**Photo 5-25. Stream Crossing Fish Barrier Before and After Bridge Installation.**

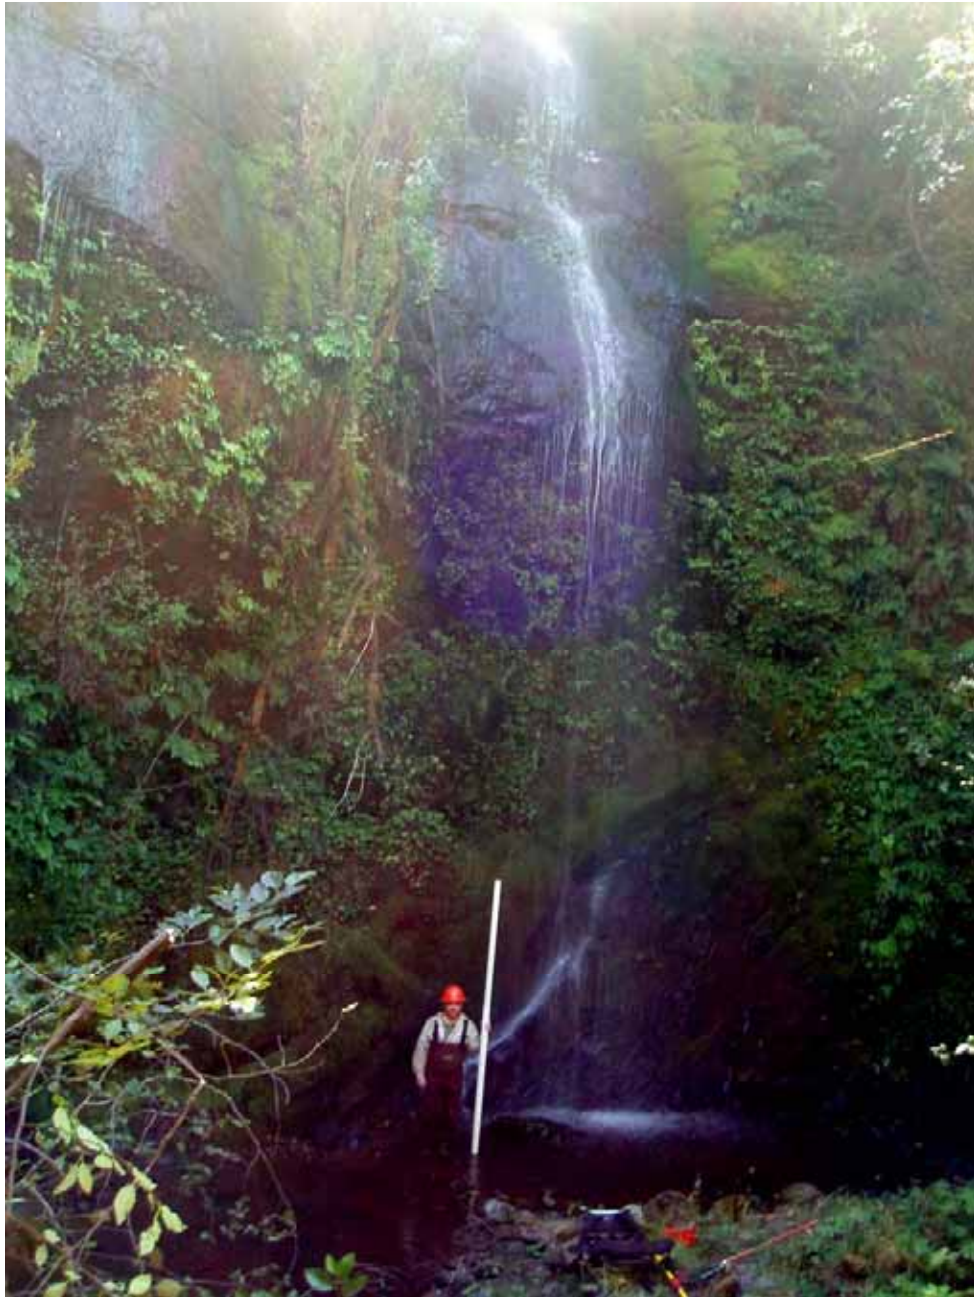
**Photo 5-26. Hidden Falls, Upper Bear River Watershed.**
