SECTION A MASS WASTING

This section summarizes the methods and results of a mass wasting assessment conducted on the Mendocino Redwood Company, LLC (MRC) ownership in the Ackerman Creek and Reeves Canyon areas. The Ackerman Creek area is comprised of the Upper Ackerman Creek and Lower Ackerman Creek planning watersheds. The Reeves Canyon area is comprised of the Jack Smith Creek and Mill Creek planning watersheds. Watercourses of both areas are tributaries of the Russian River at the Northern end of its watershed. Throughout this report, MRC ownership in these areas will collectively be termed the Northern Russian Watershed Analysis Unit (WAU). This assessment utilizes watershed analysis methodology adapted from procedures outlined in the Standard Methodology for Conducting Watershed Analysis manual (Version 4.0, Washington Forest Practices Board).

**Northern Russian River
Watershed Analysis
Unit**

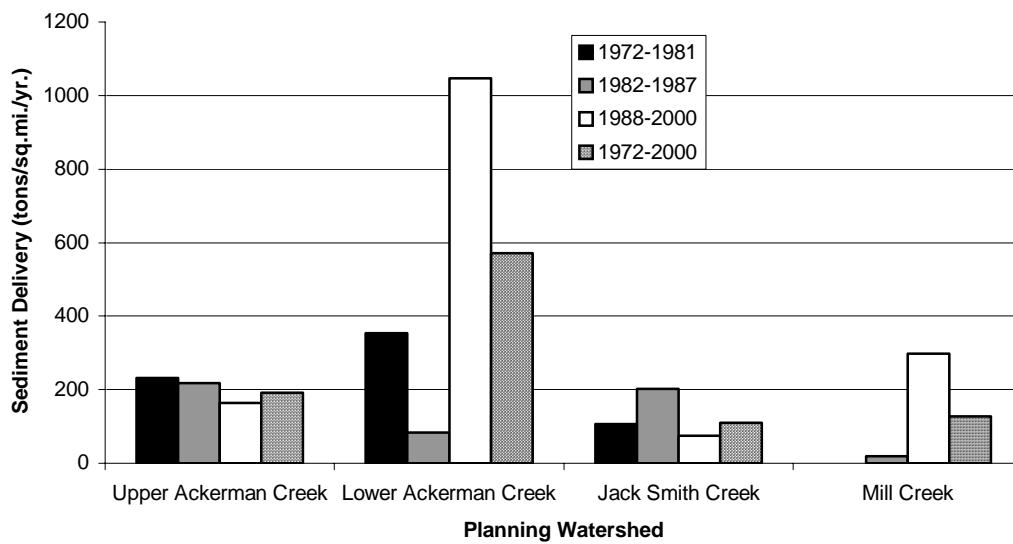
Chart A-1. Total Mass Wasting Sediment Input Rate (tons/yr/sq. mi.) from Landslides for MRC Ownership Shown by Watershed and Time Period.

Planning Watershed	1972-1981	1982-1987	1988-2000
Upper Ackerman Creek	12816	7222	10799
Lower Ackerman Creek	1956	279	6968
Jack Smith Creek	2612	2967	2202
Mill Creek	0	39	1145
Total	17384	10507	21114

The highest sediment input from mass wasting occurs in the Upper Ackerman Creek planning watershed. The higher sediment delivery appears to be due to a relatively large area of ownership in the watershed and a relatively high concentration of road associated, streamside failures. The higher sediment input for the Ackerman Creek planning watersheds is mainly from a few, very large landslides that contributed a high amount of sediment. In contrast, Mill Creek planning watershed has an extremely low mass wasting input. The low input for Mill Creek is attributable to a very small amount of ownership that is in the headwalls of some relatively minor tributaries in the watershed.
