# **Class I Stream Aquatic Habitat Trends Monitoring 2022 Annual Report**

**June 30, 2023**

**Title:** Class I Stream Aquatic Habitat Trends Monitoring

**Purpose:** Habitat Conservation Plan Aquatic Monitoring

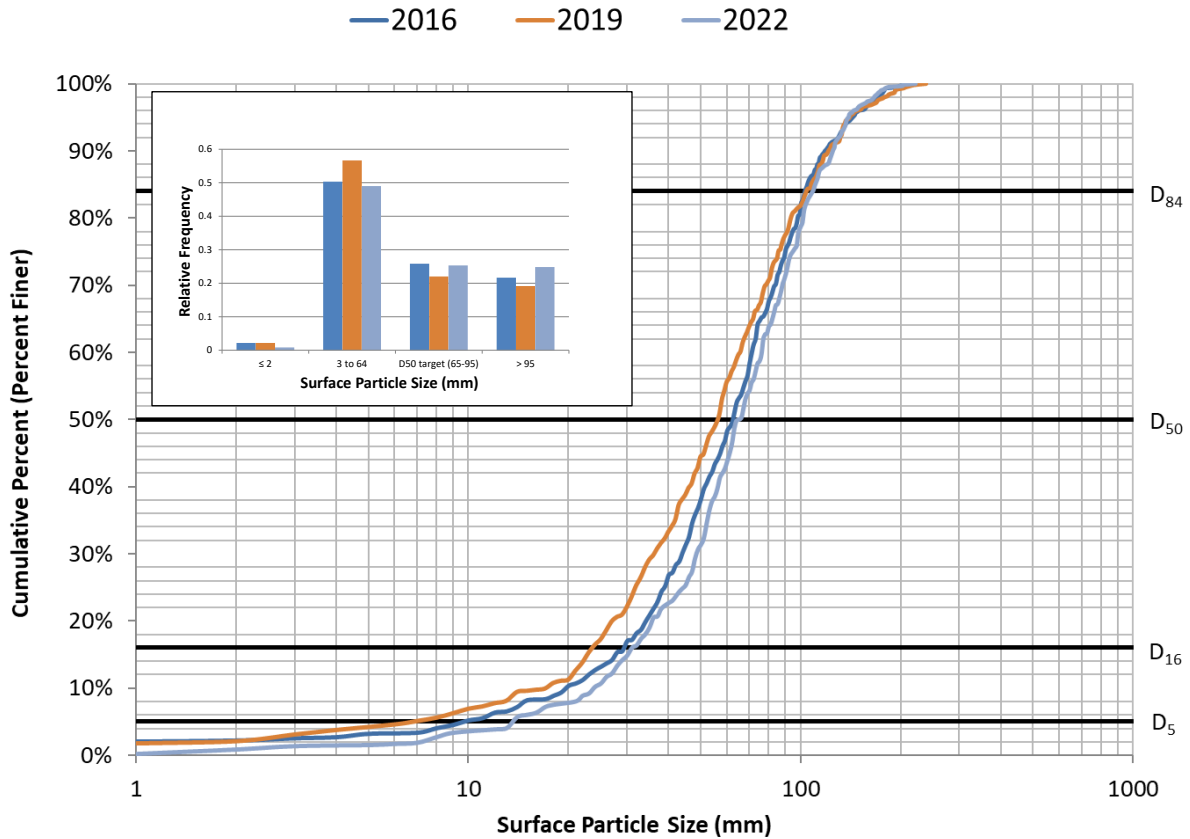
**Figure 2. Example of a cumulative frequency (percent finer) plot of the mean surface particle sizes (mm) of three riffles measured within an ATM survey reach.**

The first three (3) riffles are sampled within each monitoring reach by transecting back and forth over the entire riffle within the active channel. The intermediate axes of 200 pebbles are measured at each riffle. The median particle size is determined for each of the D parameters, although APFC target values have only been established for  $D_{50}$ . Results are reported as mean values within the APFC report card, as well as cumulative particle size frequency plots (Figure 1), which serve to provide a visual aid for improved interpretation. Over time, it is expected that trends will develop that will suggest an overall fining or coarsening of the channel substrate towards APFC target values to the extent provided for by inherent watershed conditions.

Updates to pebble count analysis methodology were made in 2015 which expanded the parameters to include three (3) additional classes ( $D_5$ ,  $D_{16}$ , and  $D_{84}$ ). This was initiated as a substitute for the discontinued streambed subsurface particle size monitoring. Fining of the streambed is a concern property-wide and is a process that can be observed through pebble counts alone. If fining of the bed surface is observed, then one can assume that a similar trend is occurring in the subsurface. Results were reported as mean values within the APFC matrix, although an APFC target value has only been established for  $D_{50}$ . Additionally, cumulative frequency plots were developed to provide a visual aid for improved interpretation of the particle size distributions.

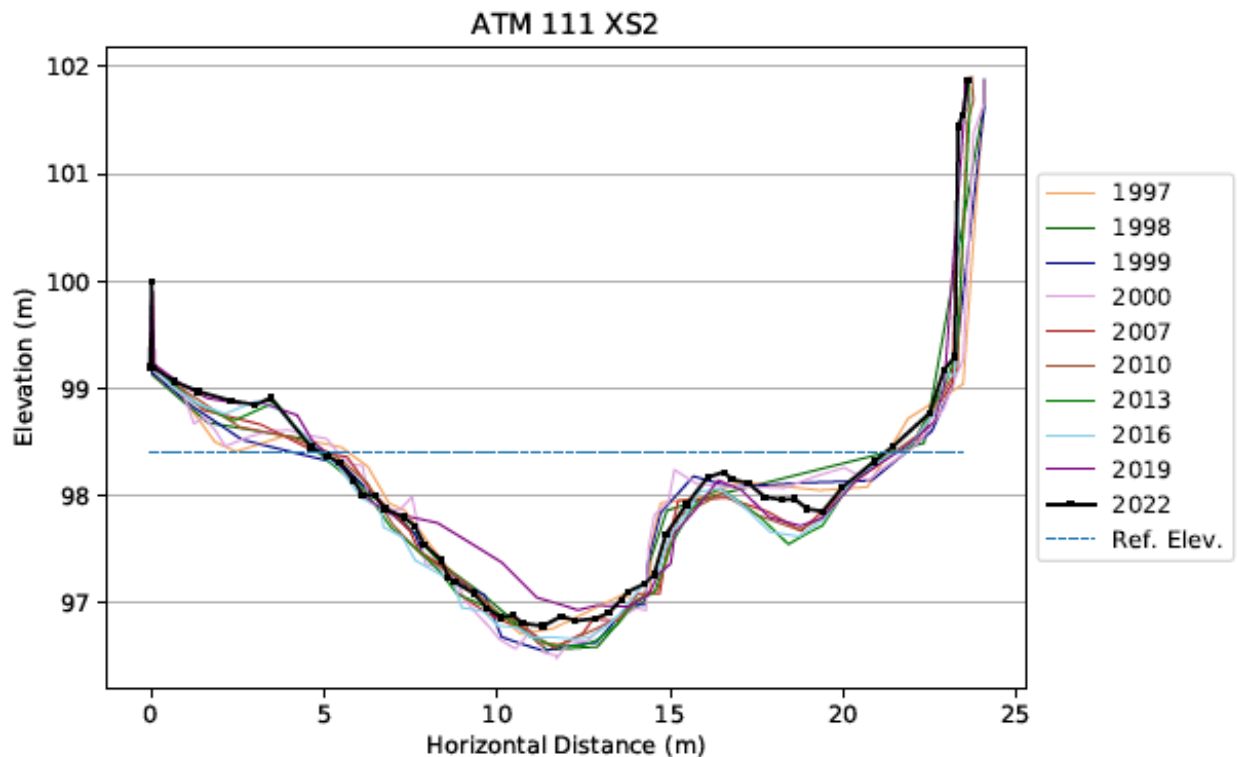
**Figure 3. Example of a typical cross-sectional profile within an ATM survey reach.**

the channel. Cross-sectional area is determined below a reference elevation. This elevation is typically set at a channel feature associated with bank-full depth.

Data processing has been streamlined with electronic data collection, transfer, and processing. HRC has developed an Excel® spreadsheet to process cross-section data from x, y, z coordinates into standard measurements in the x-z plane. An additional spreadsheet computes channel area (m<sup>2</sup>), width (m) and depth (m).

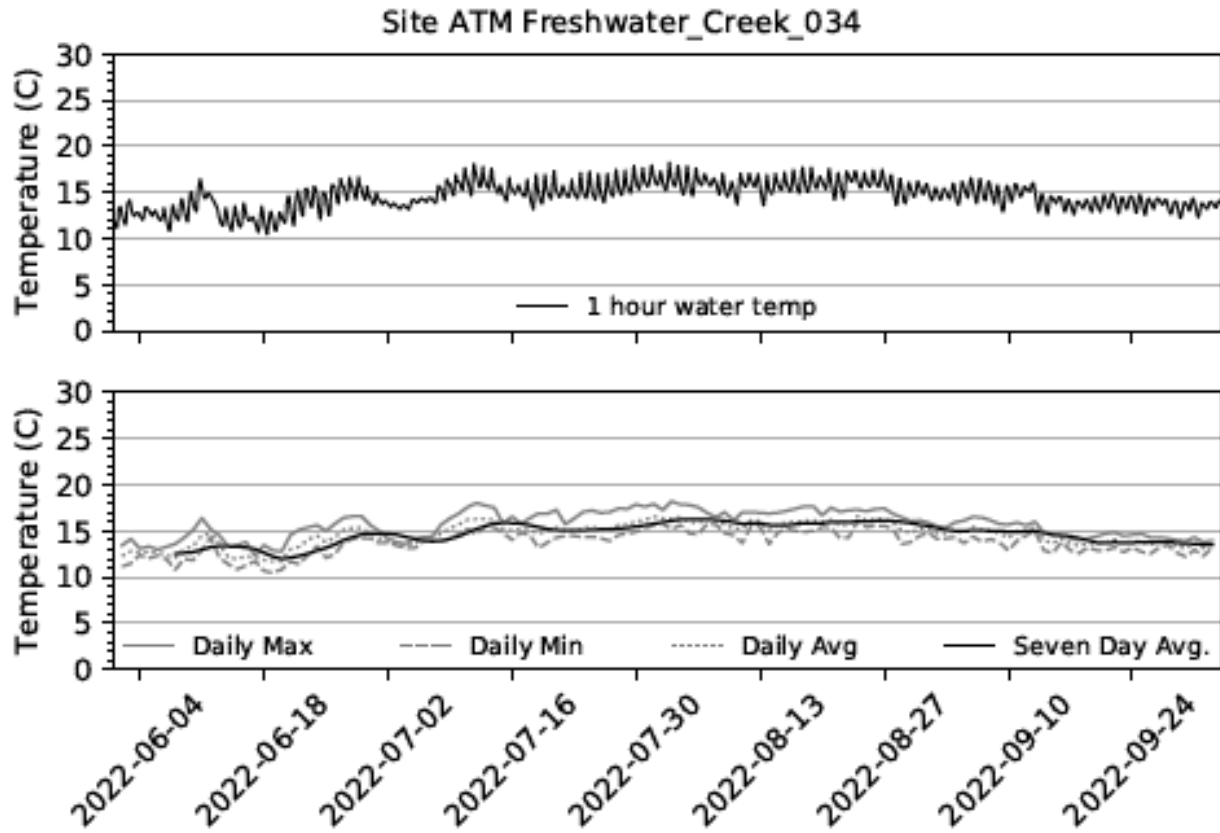
Figure 4. Example of a stream temperature profile generated from a continuously-recording temperature data logger deployed annually at most ATM stations.

Stream temperature (°C) is tracked during the warmest part of the year (typically June through September). Temperature is monitored with continuous recording data loggers (Onset HOBO® Water Temp Pro v2). Temperature data loggers are inserted into perforated PVC cases and placed in the stream at a location that meets requirements for sufficient mixing, adequate cover, and consistent flows during the summer months to ensure data integrity by reducing the likelihood of thermal stratification. Temperature data are used to calculate the maximum weekly average temperature (MWAT), or the average of the daily mean temperature measured during the warmest seven consecutive days each year. The APFC target value for

MWAT at all ATM stations is  $\leq 16.8^{\circ}\text{C}$ . Figure 3 illustrates a typical temperature profile as measured at ATM stations property wide.

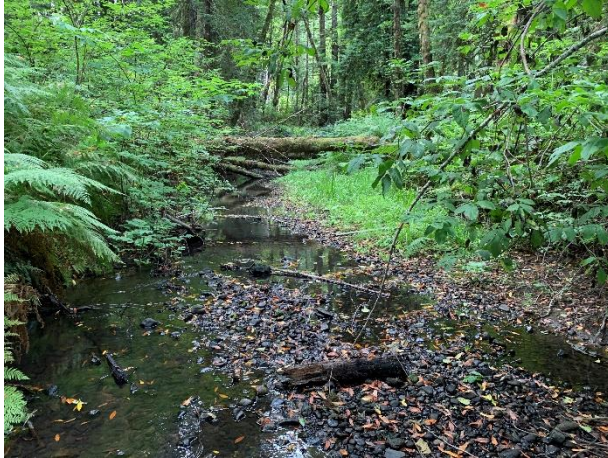
**Root Creek Station 003**

**Figure 8. Typical site conditions of the four ATM stations within the Van Duzen River WAU.**

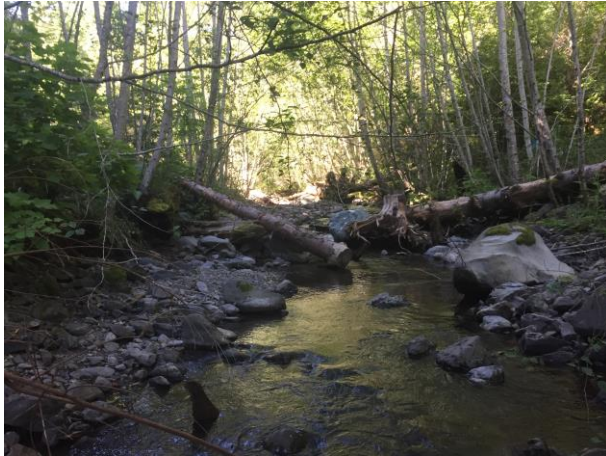
**Jordan Creek Station 205**

**Figure 11. Typical site conditions of the remaining ATM stations within the Lower Eel River WAU.**
