Yager-Lawrence Watershed Analysis

Cumulative Watershed Effects

December 2009

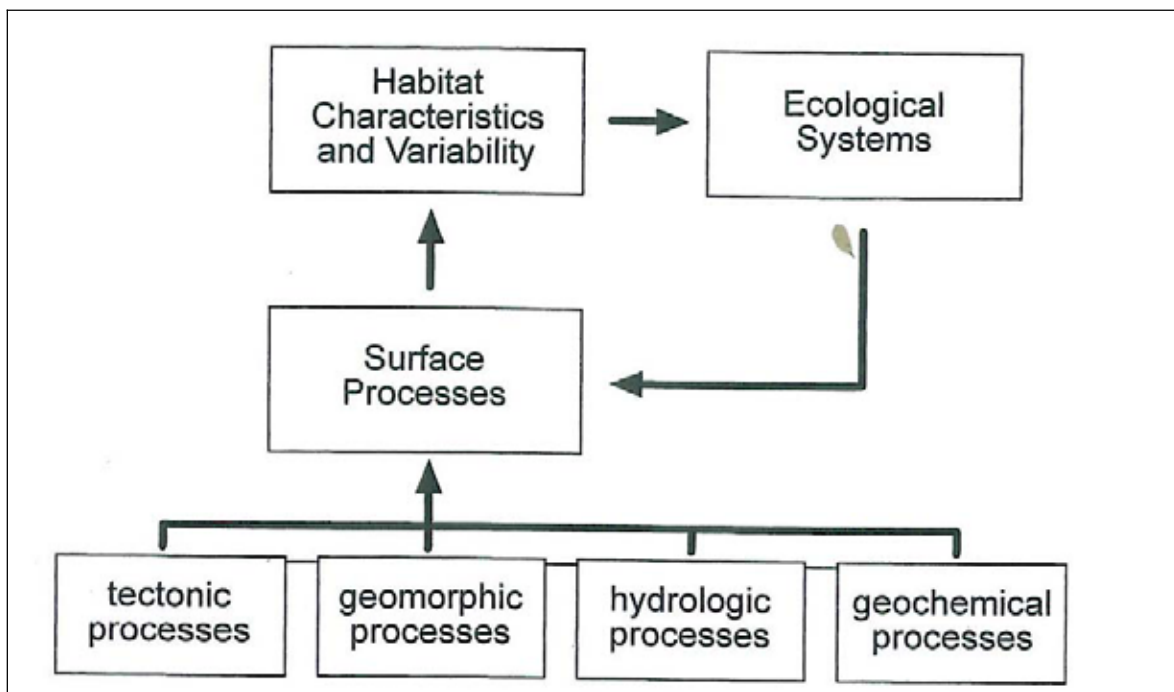
Figure 2-1. Schematic Illustration of the Role of Surface Processes on Shaping Habitat Characteristics and Variability and the Potential for Ecological Systems to Influence Surface Processes. Source: Montgomery (2001).

The mechanisms determining the effect of forest practices on inputs of wood, sediment, water, or thermal energy are relatively well understood. Hypotheses regarding potential effects of forest management on streams include increased hillslope erosion and channel sedimentation, increases in peak stream flow during periods of storm runoff, reduced wood inputs to streams, and increases in the temperature of water caused by harvesting trees that shade the channel (Figure 2-1).

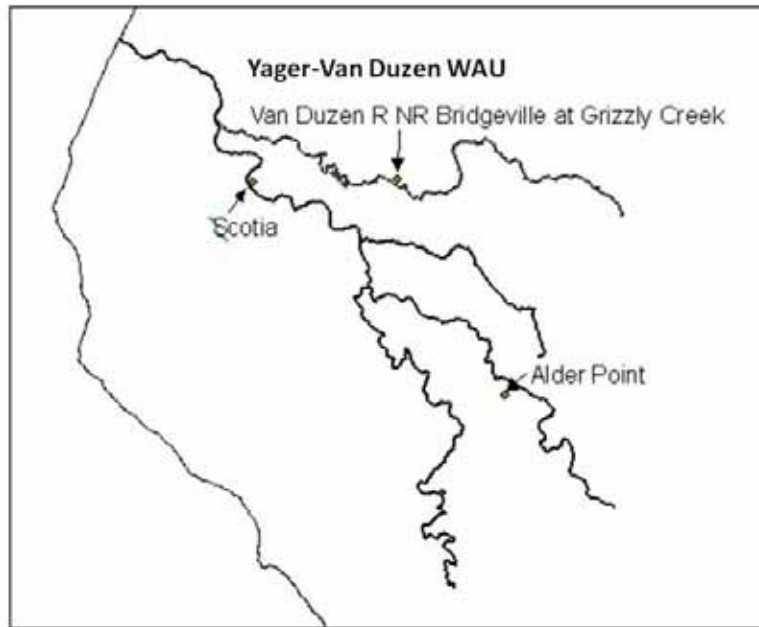
Figure 3-3. Climate Stations in the Vicinity of the Yager-Lawrence WAU.

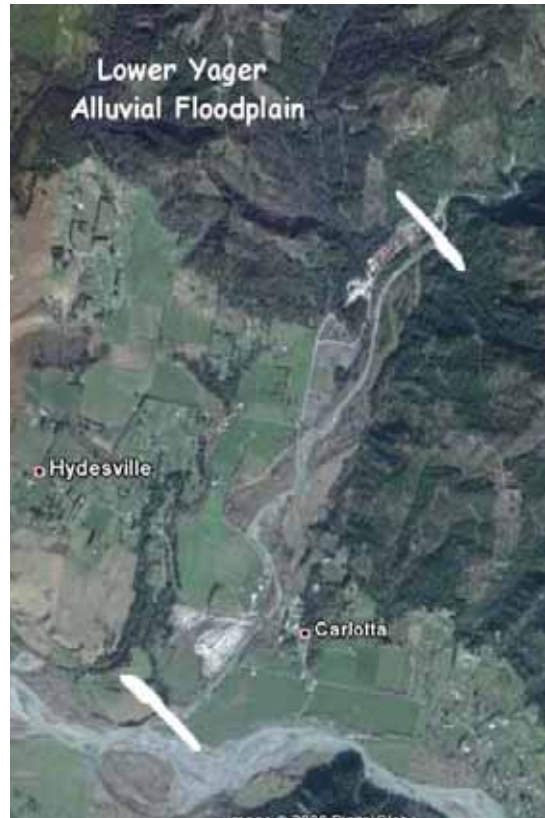
Photo 5-1. Lower Yager Alluvial Floodplain Delineation (photo from Google Earth).

Note: The overall channel gradient of Yager Creek through this reach is 0.5%.

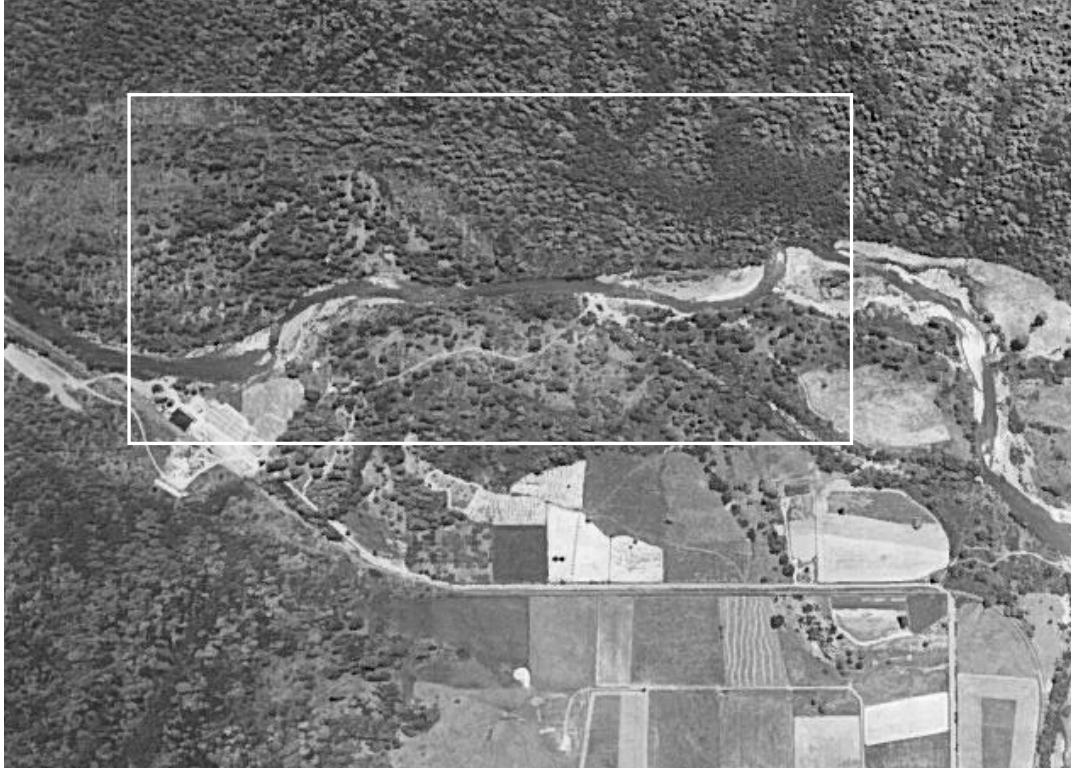
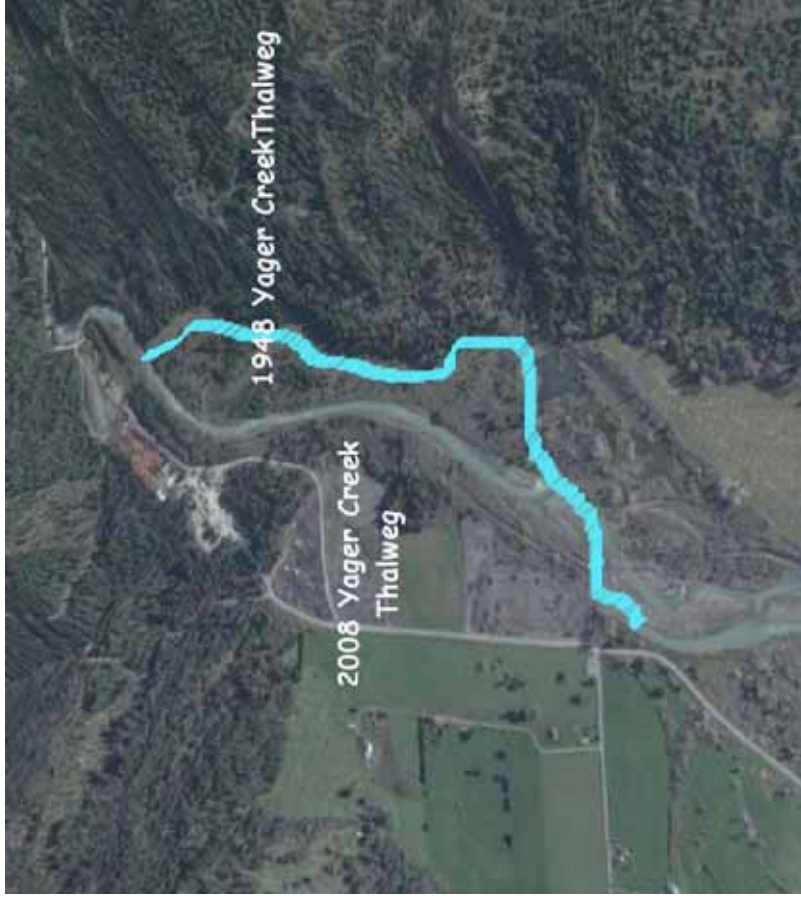
Photo 5-3. Upper Segment of Yager Creek in the Alluvial Valley in 1948 photo (left) and in 2008 (right).

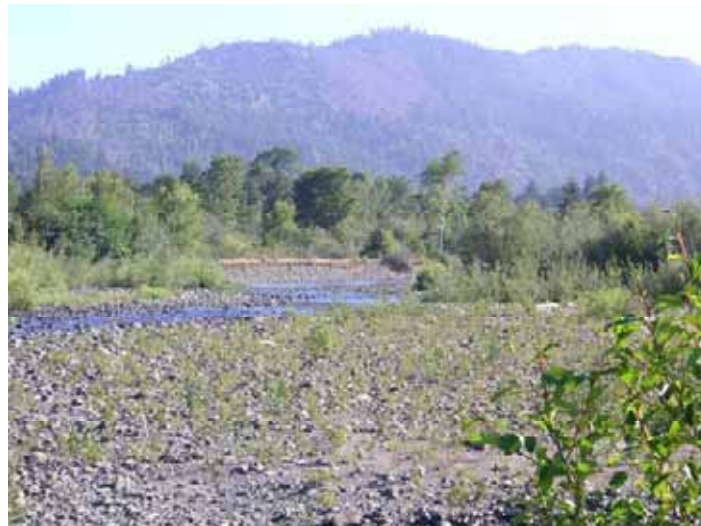
Photo 5-4. Mainstem Yager Creek within the Lower Alluvial Channel Geomorphologic Unit.

riparian area is classified in the HSS Riparian Condition Unit (RCU) which represents hardwoods such as willows, of sapling and pole size (less than 12-inch diameter at breast height [DBH]), and with sparse stand density (less than 40 percent) as presented in the Riparian Function Assessment (Appendix C, Map C-1). Smaller portions of this reach, in the Yager Camp area, have mixed or conifer stands at less than 24-inch DBH, with stand densities ranging from sparse to dense. The riparian forest, such as it is, typically has low LWD recruitment potential (Photo 5-4), with some areas with moderate LWD recruitment potential located in the Yager Camp area (Map C-2).

Despite the large volume of sediment input to this reach from the watershed above, the channel substrate is quite coarse (D_{50} = 110 mm in 2004) and has coarsened from 50 mm since 2000 (Photo 5-4). The portion of sediment less than 0.85 mm is 10 percent while the portion of sediment less than 6.35 mm is 35 percent. The finer fraction meets but the larger fraction does not meet the PFC targets. Neither subsurface fraction has shown a trend since 2002. The bed sediment ratio (D_{50}^*) has increased significantly since 2002, largely due to the coarsening of the surface sediment.

Canopy closure is quite low along Yager Creek (e.g., Photo 5-4). We estimate that canopy closure could improve to about 30 percent overhead cover in old growth conifer stand conditions, and could possibly decrease the annual maximum water temperatures (MWAT) about 2°C from current annual maxima of about 22°C.

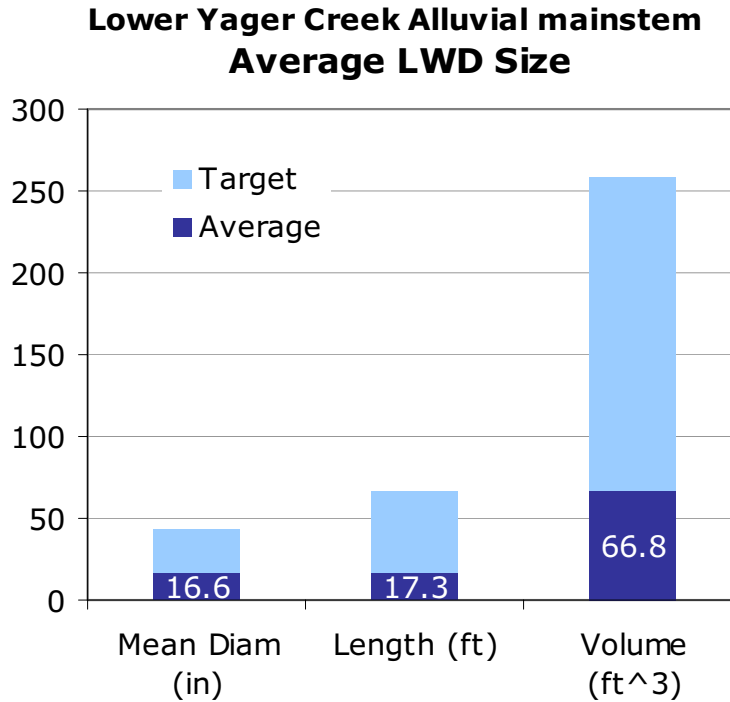
Figure 5-3. Average Size of Wood Pieces at ATM 164 in the Lower Mainstem Alluvial CGU.

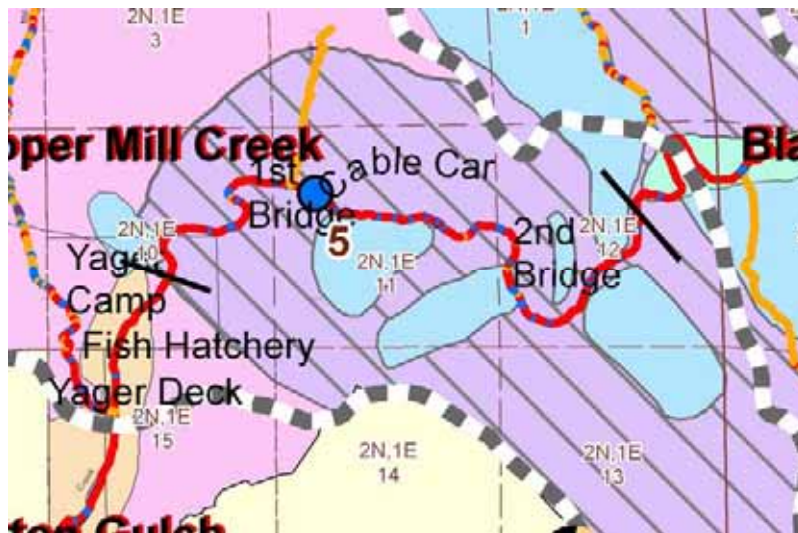
Note: CGU boundaries are delineated with black line. Stream gradient is 0-2% where red, 2-4% where blue and >4% where yellow.

Although the canyon constrains the channel, the average channel gradient is 1 percent, just marginally steeper than the completely unconstrained reach downstream. Figure 5-4 shows the gradient class determined from Lidar DEM through the reach. Most of the reach is 1 percent gradient. There are local short reaches with gradient between 2-4 percent. There are no barriers to salmon migration.

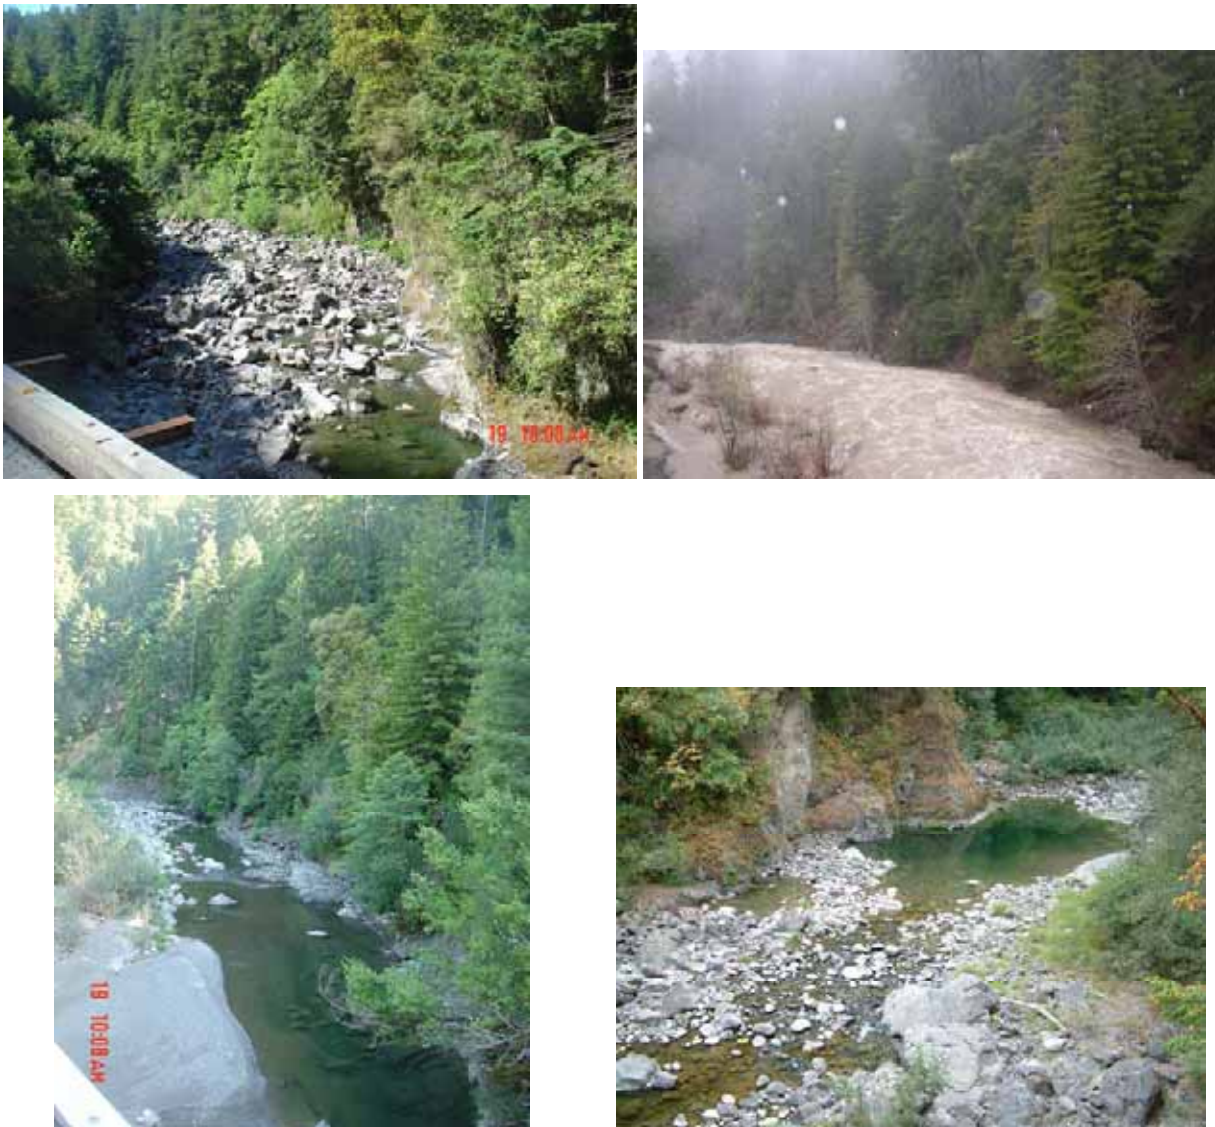
Photo 5-5. Stream Channel Characteristic of the Yager Mainstem Canyon.

Note: The photographs on the top row are taken from the 1st bridge looking downstream and bottom left is looking upstream. There is localized deposition of sediment around obstructions such as the bridge and rock outcrops, creating gravel deposits similar in size to the bed load.

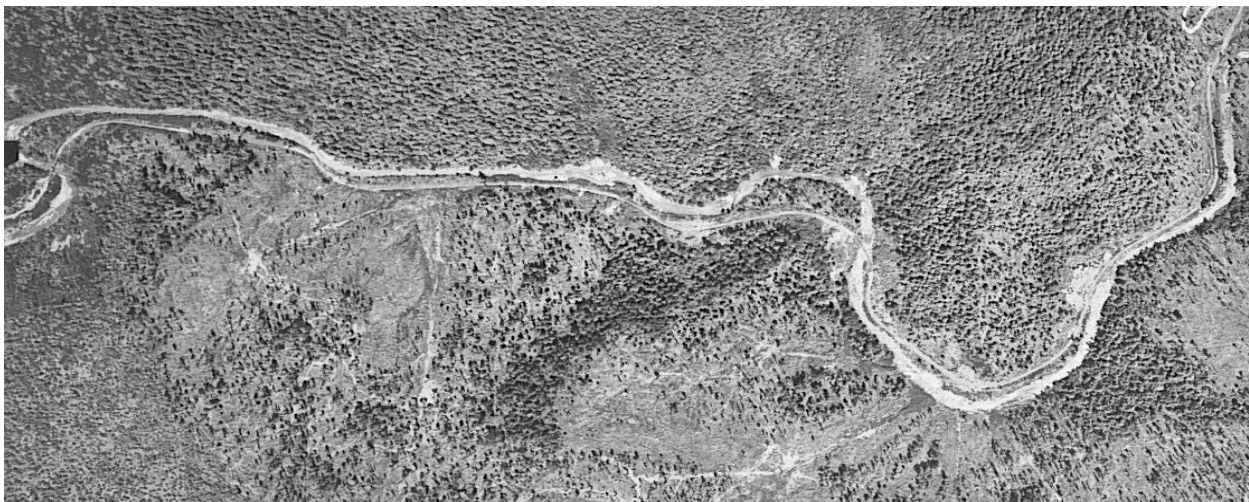
Photo 5-6. Yager Mainstem Canyon CGU Reach (1948 aerial photograph).

Evidence of Channel Disturbance and Adjustment. There has been no alteration of channel location during the 60 years of photographic record. The channel is subject to streamside landslides as the river works on the canyon walls (Photo 5-7). Large and small landslides occur along the channel and lower slopes throughout the CGU. Most of these are likely natural slides resulting from streamflow destabilizing the lower slopes, especially at river bends. The large landslides evident today were also evident in the 1948 photos (Photo 5-6).

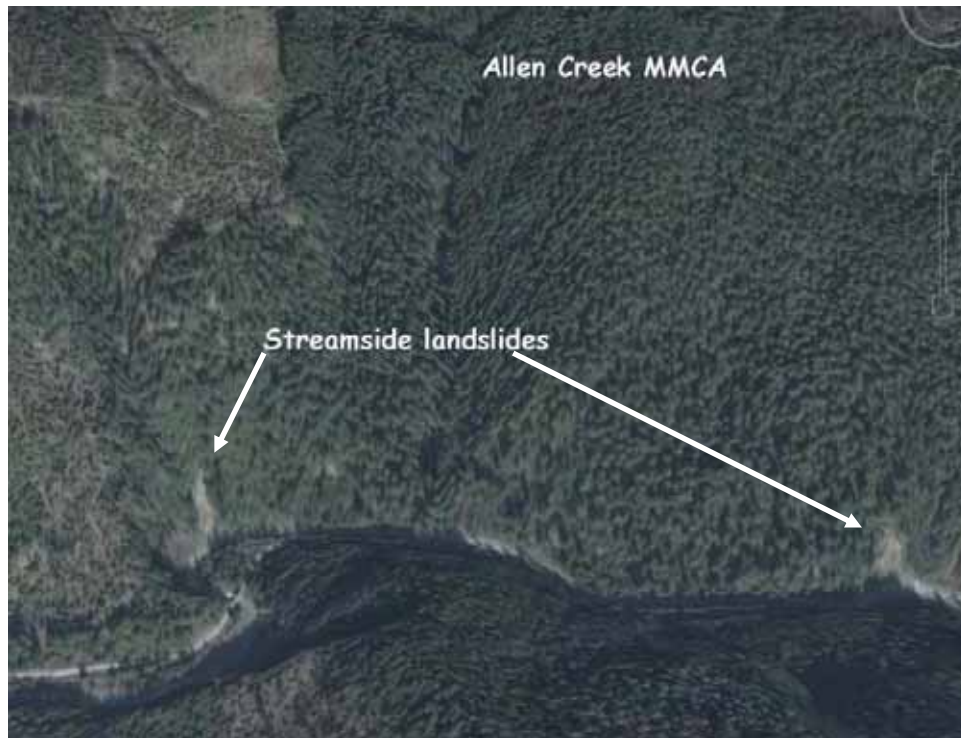
Photo 5-7. Streamside Landslides along Yager Mainstem Canyon Reach.

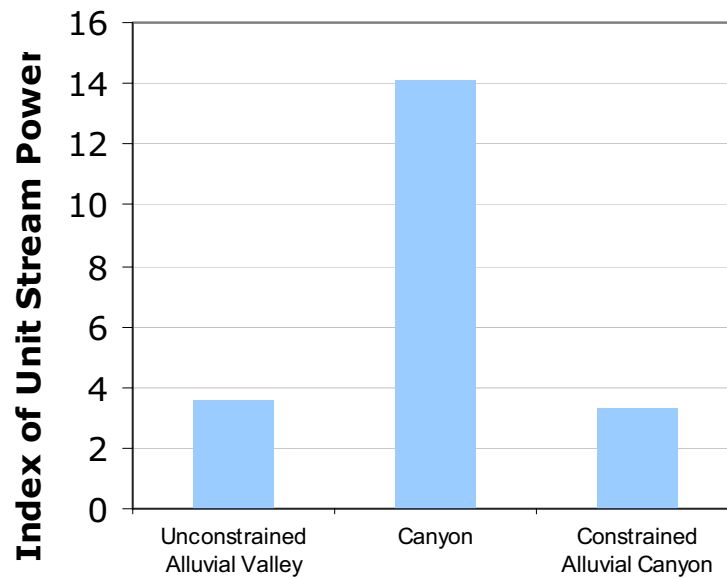
Figure 5-5. Index of Unit Stream Power (Basin Area x Slope/Bankful Width) for the Yager Mainstem Channel Geomorphic Units.

Recent Trends in Stream Channel Conditions. The tight constraint of the valley walls has a significant effect on the channel dimensions within the CGU. The mainstem Yager Creek within the reach is significantly narrower and deeper than the basin trend in these characteristics. This CGU is represented by ATM Station 5. The residual pool depth is over 2 times deeper than pools in the downstream alluvial zone. Cross-sectional area is also significantly smaller. This contributes to the high scour power as velocity is forced through the relatively small channel area. The index of unit stream power introduced in the discussion of bed sediment characteristics (Sections 5.2.4 and 5.2.5 of Appendix D) is shown for the Yager mainstem CGUs, including the alluvial, canyon, and the constrained alluvial valley reaches (Figure 5-5). The index of unit stream power increases significantly within the canyon, compared to the alluvial

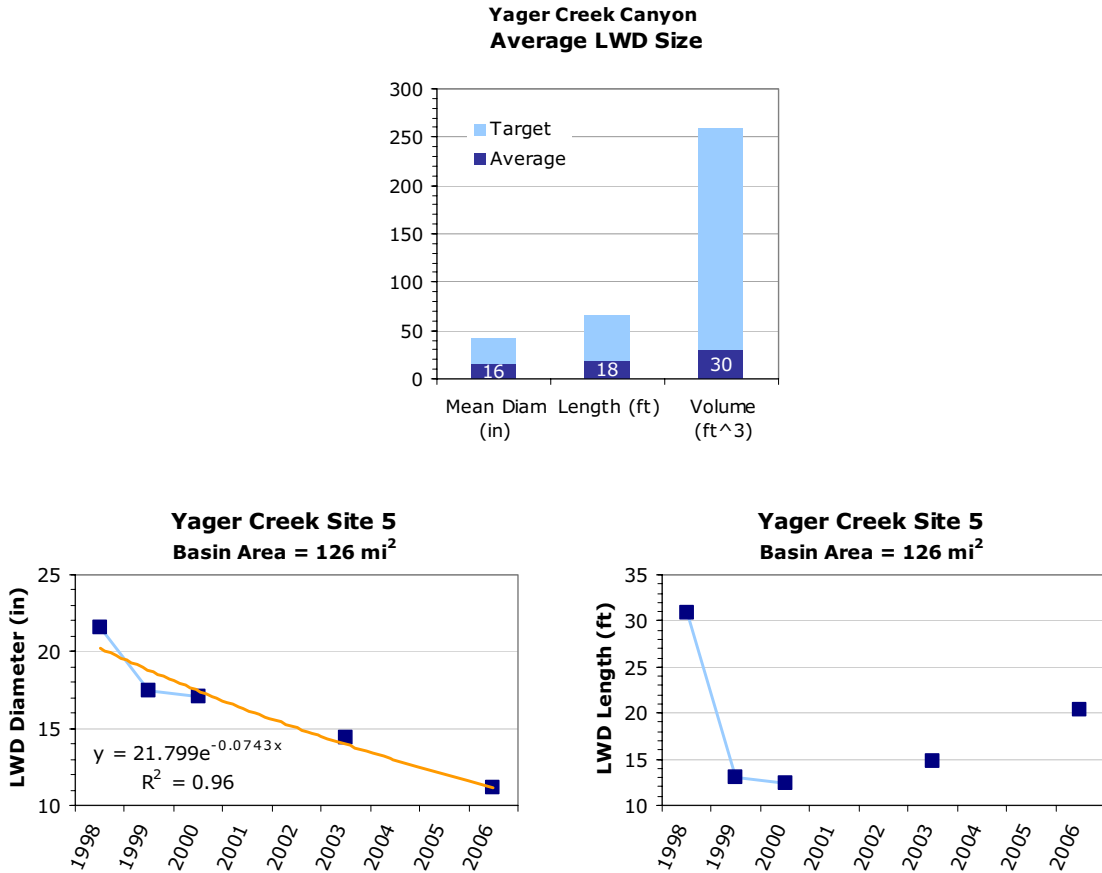
Figure 5-6. Average LWD Dimensions and Recent Trends within the Yager Canyon CGU.

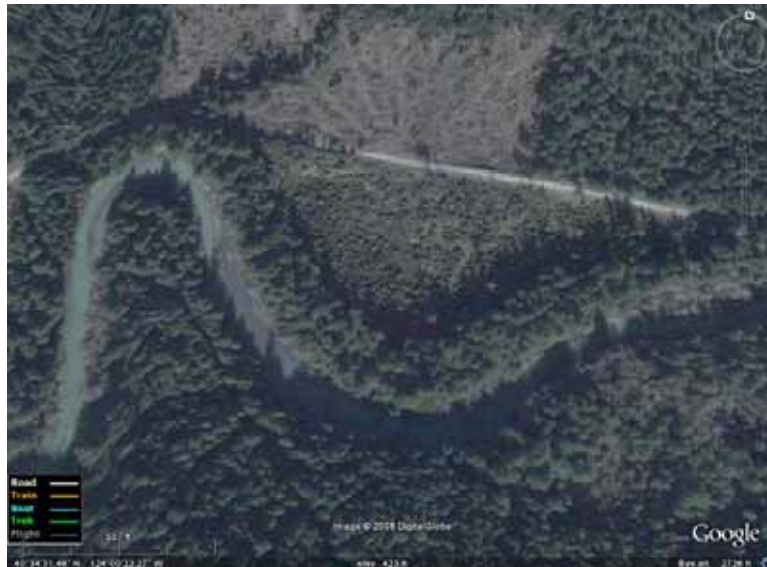
Photo 5-8. Segment of Yager Creek within the Yager Canyon CGU (topographic and riparian shading).

It is likely that the road in a few locations as well as logging have reduced canopy closure from potential levels along Yager Creek within the canyon. Canopy closure above the stream is rather low (30 percent at ATM 5) given the relatively narrow stream, and does not meet the PFC target of greater than 85 percent. The MWAT currently exceeds 21°C, exceeding the PFC target of 16.8°C. Topographic shading by the canyon walls is significant when the stream flows east to west, but this direction also exposes the water to sunlight longer during the day, somewhat ameliorating the benefit of the topography (Photo 5-8). Note the riparian buffer in the recently logged area on the north side of Yager Creek in Photo 5-8. The stream cover along most of the stream reach has not changed substantially from that evident in the 1948 aerial photo (Photo 5-6). An increase in canopy closure to potential (perhaps as high as 50 percent) could probably improve water temperature by 3°C.

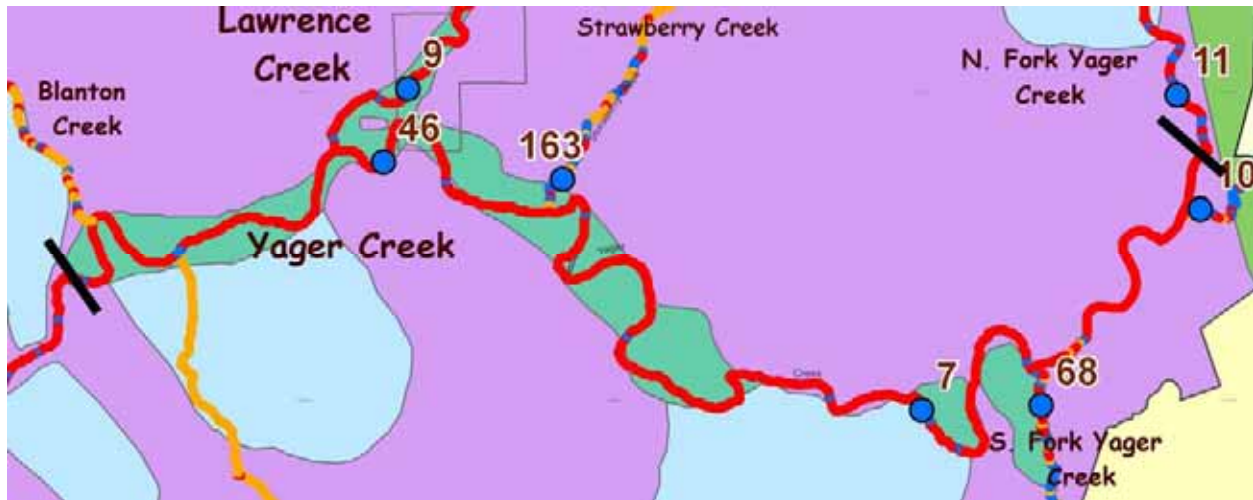
Figure 5-7. Location of the Yager Mainstem Constrained Valley Alluvium CGU on the Standard Geologic Map of the Watershed (from Map D-1).

Purple is the Yager Formation (yf), blue is Qls, and blue green is Qtw. Franciscan is bright green (cb); right side at stations 10 and 11. Channel gradient classes: red 0-2%, blue 2-4%, orange >4%.

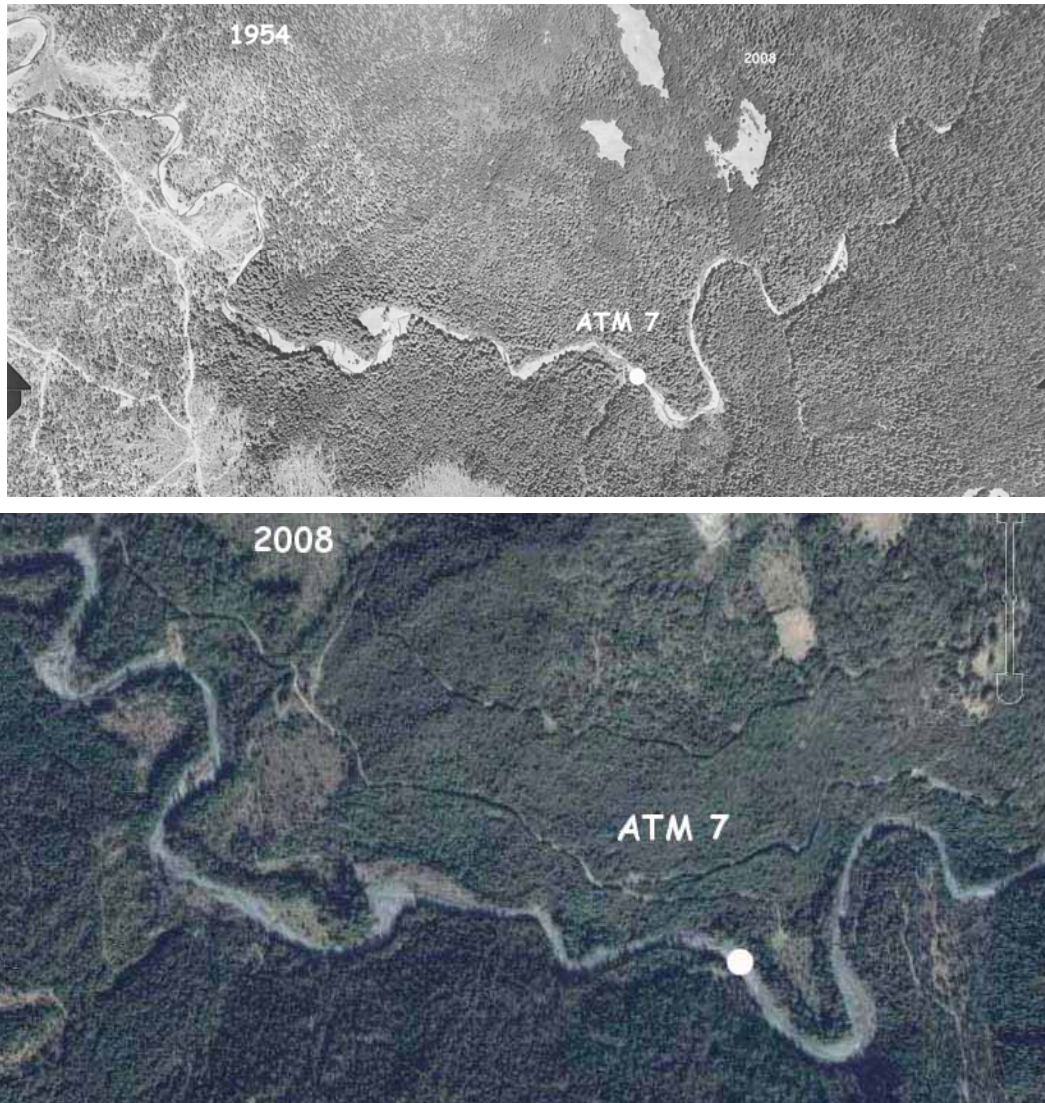
Photo 5-9. Aerial Photo View of the Yager Constrained Valley Alluvium CGU in 1954 and 2008.

Anthropogenic Disturbances. Photo 5-9 shows roughly the same reach of Yager Creek within the Constrained Alluvial Valley CGU in 1954 and recently. The mainstem of Yager Creek was progressively logged upstream several miles as early as 1948. However, as late as 1954, most of the CGU on the easterly side had not been logged. Riparian forests were clearcut in many locations from the period 1949 to 1997, but residual stands were left in some locations. By 1997, the majority of the CGU had been clearcut logged at least once, or harvested in a series of selection cuts. There was no direct disturbance to Yager Creek locally from log hauling. The haul roads do not impinge on Yager Creek within this CGU although there are several bridge crossings.

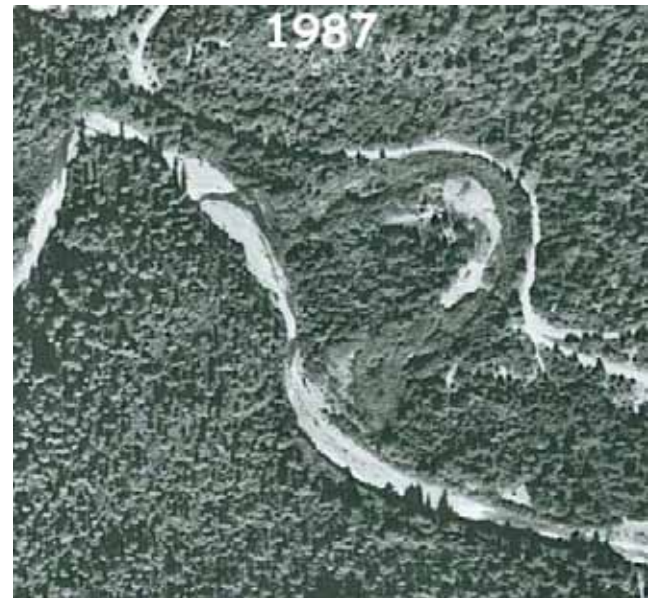
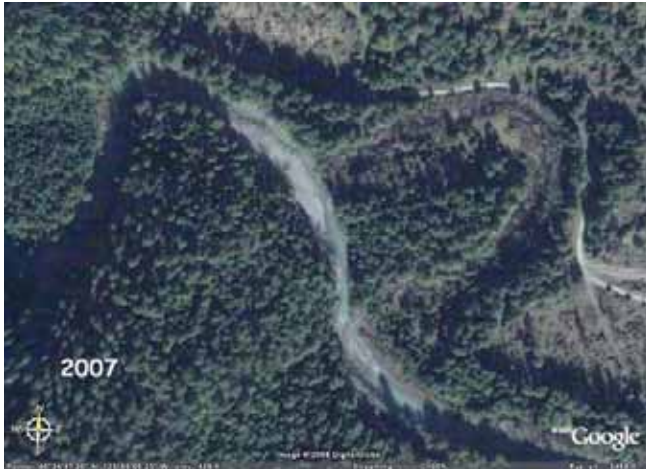
Photo 5-10. Meander Bend Cutoff of Yager Creek Upstream from Confluence with Lawrence Creek (photos are from 1948, 1987, and 2007).

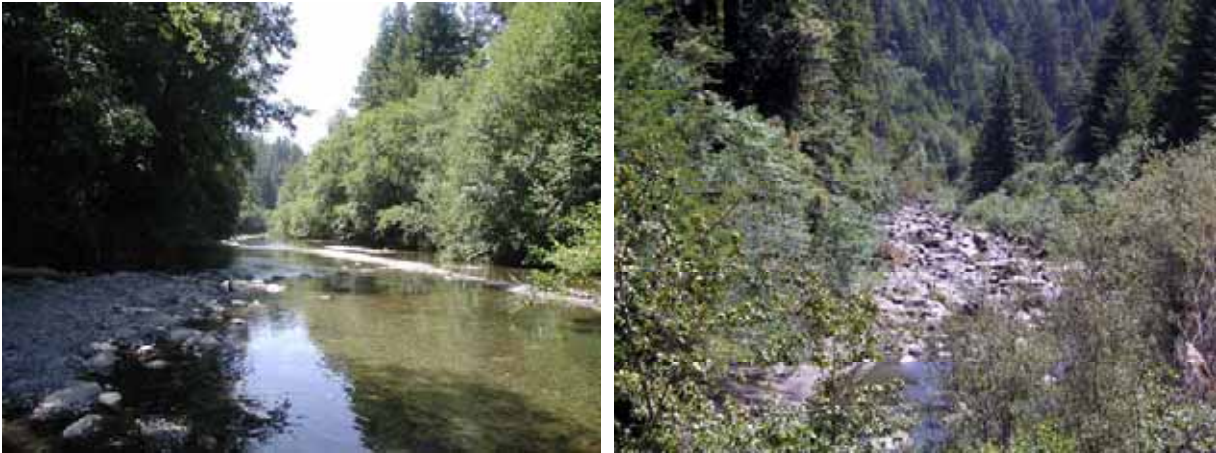
Photo 5-11. Yager Creek in the Lower Gradient Reach in the Downstream End of the CGU and the More Constrained Reach in the Upstream Portion of the CGU.

Canopy closure is low over Yager Creek in much of the upper portion of the CGU, but is somewhat higher in the lower reach. The canopy closure measured in 2000 ranged from 25-55 percent at the lower station (left in Photo 5-11) and from 0-20 percent in the upstream reach (right in Photo 5-11). We hypothesize that this portion of the stream could have significantly greater canopy closure (+30 to 40 percent) over much of the stream. If this canopy closure could be achieved, we estimate that water temperature could improve at least 3°C from the current summer maxima (MWAT) of about 21°C.

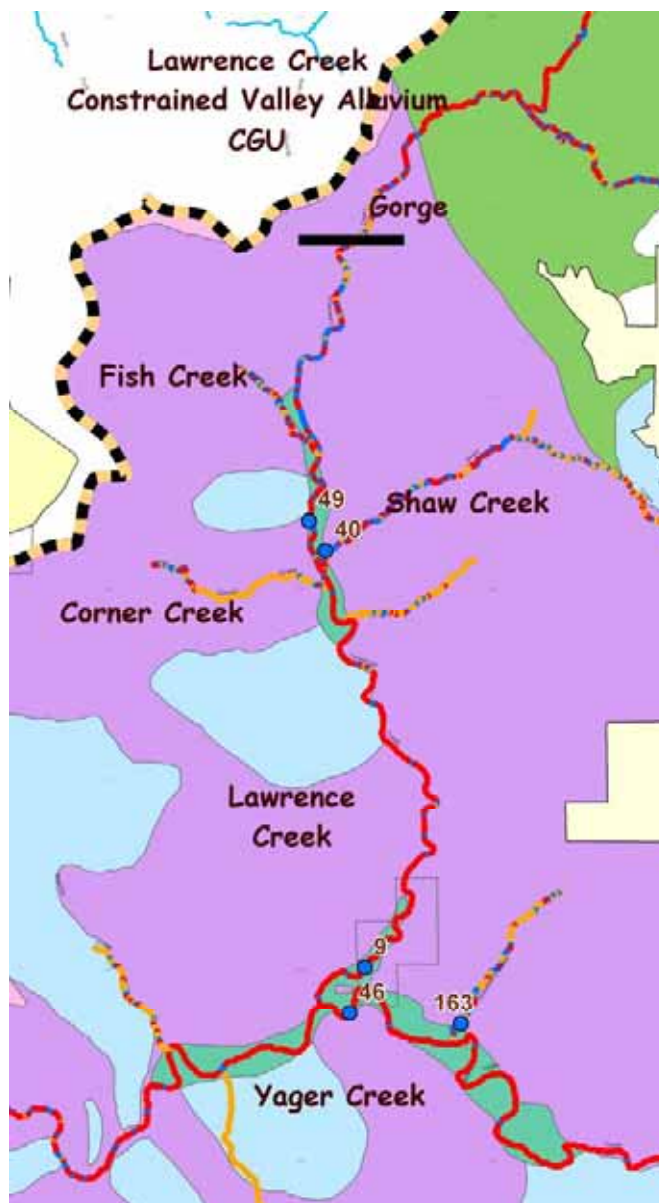
Figure 5-11. Location of the Lawrence Creek Mainstem Constrained Valley Alluvium CGU on the Standard Geologic Map of the Watershed (from Map D-1).

Note: Purple is the Yager Formation (yf), blue is Q1s, and blue green is Q1w; Franciscan is light green (cb). Channel gradient classes are red 0-2%, blue 2-4%, orange >4%.

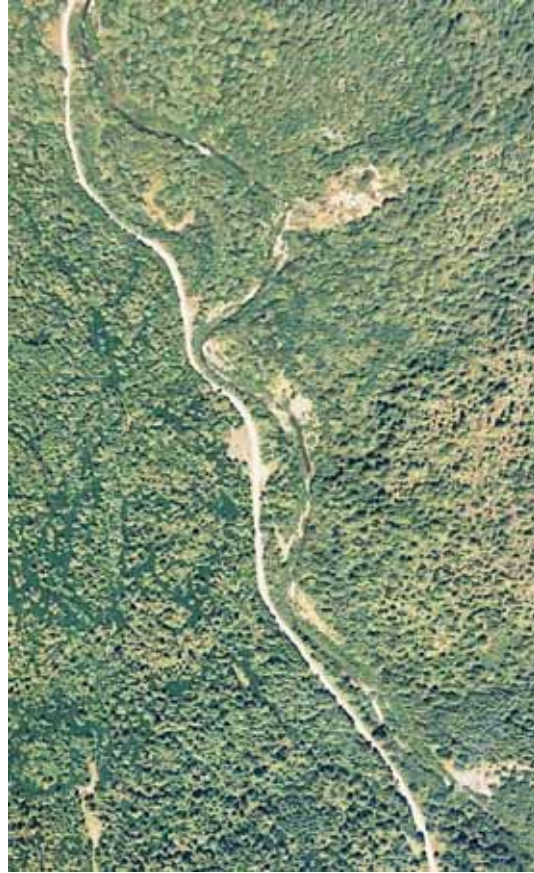
Photo 5-15. Section of Lawrence Creek Downstream from Shaw Creek.

Evidence of Channel Disturbance and Adjustment. The aerial photos provide evidence of direct channel disturbance during early logging practices. However, there has been no obvious channel adjustment of channel position within the valley during the 60 years of the aerial photo record. Today, the riparian forest is largely composed of hardwood, classified as the “Hardwood stand, small trees, moderate/dense canopy” (HMD) Riparian Condition Unit (RCU) (Appendix C, Map C-1) with 12-24 inches DBH and moderate to dense stands; the channel is open to the sky for much of its length (Photo 5-15). Several large slides that introduce sediment to the streams are also evident in the photo. The channel width appears somewhat wider than it did in the photos prior to logging (Photo 5-13). We expect that this channel is depauperate of wood and that stream temperature has increased post logging.

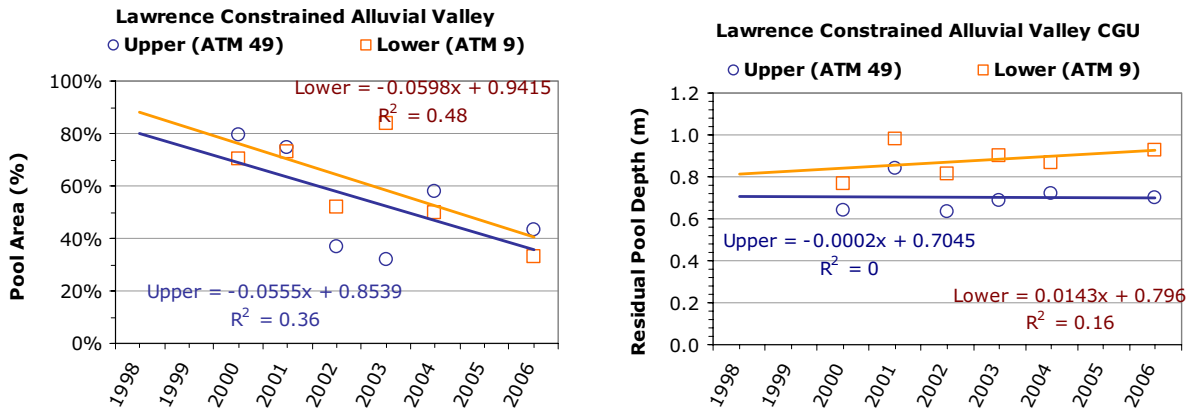
Figure 5-13. Trends in pool characteristics within the Lawrence Mainstem Constrained Valley Alluvium CGU.

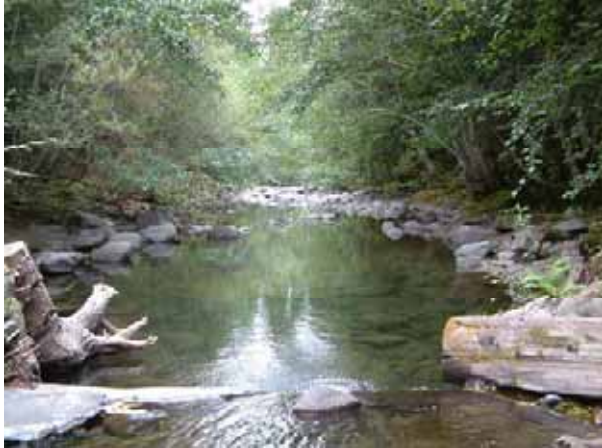
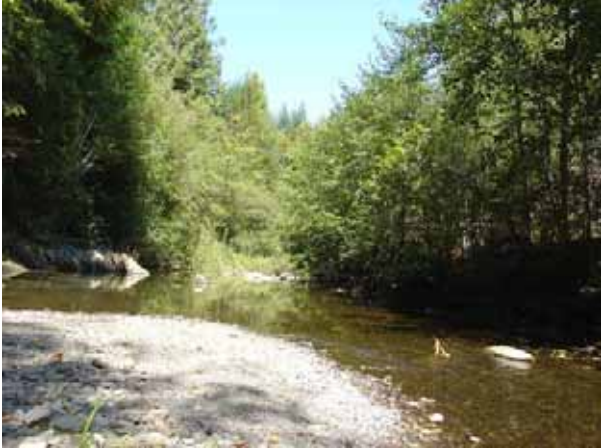
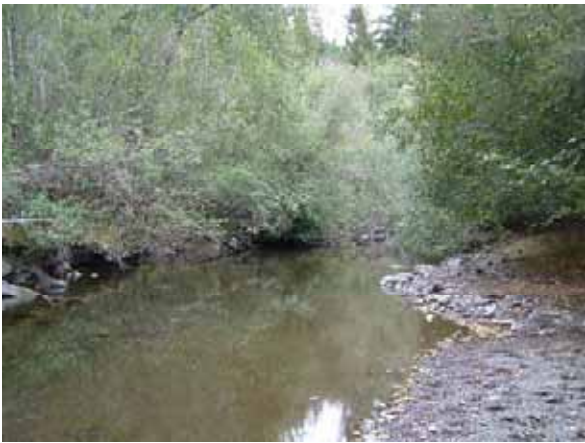
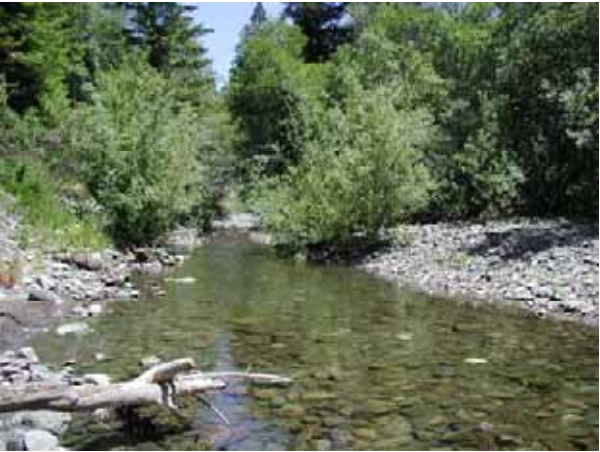
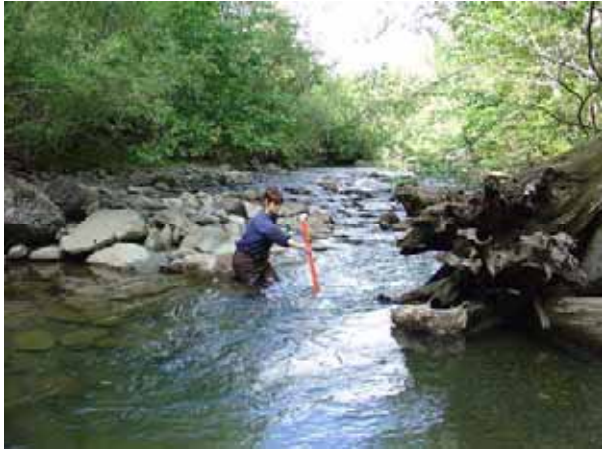
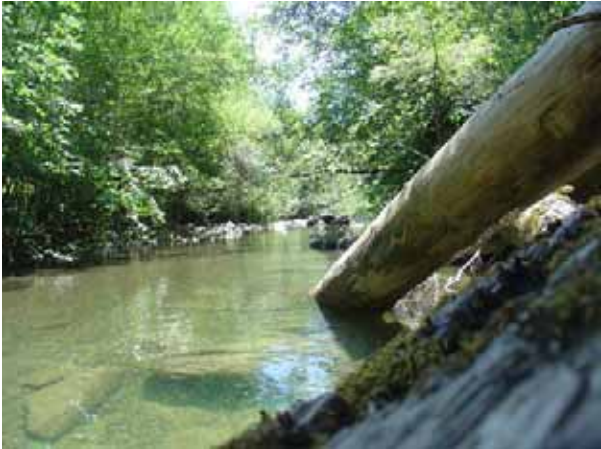
Channel morphology and sediment deposits vary through the CGU. Photo 5-16 shows Lawrence Creek at various points along its length.

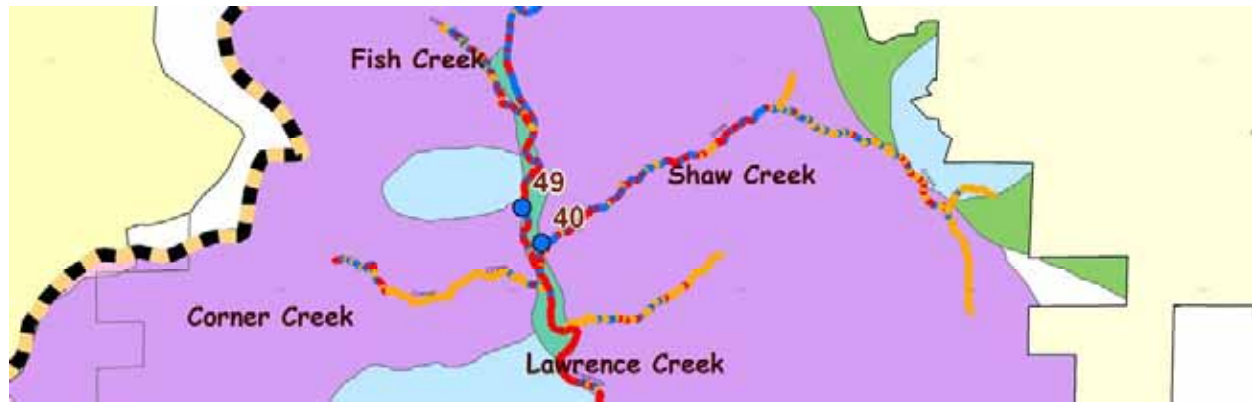
Note: Purple background is the Yager Formation (yf), blue is Qls, and blue green is Qtw. Franciscan is light green (cb). Channel gradient classes are red 0-2%, blue 2-4%, orange >4%.

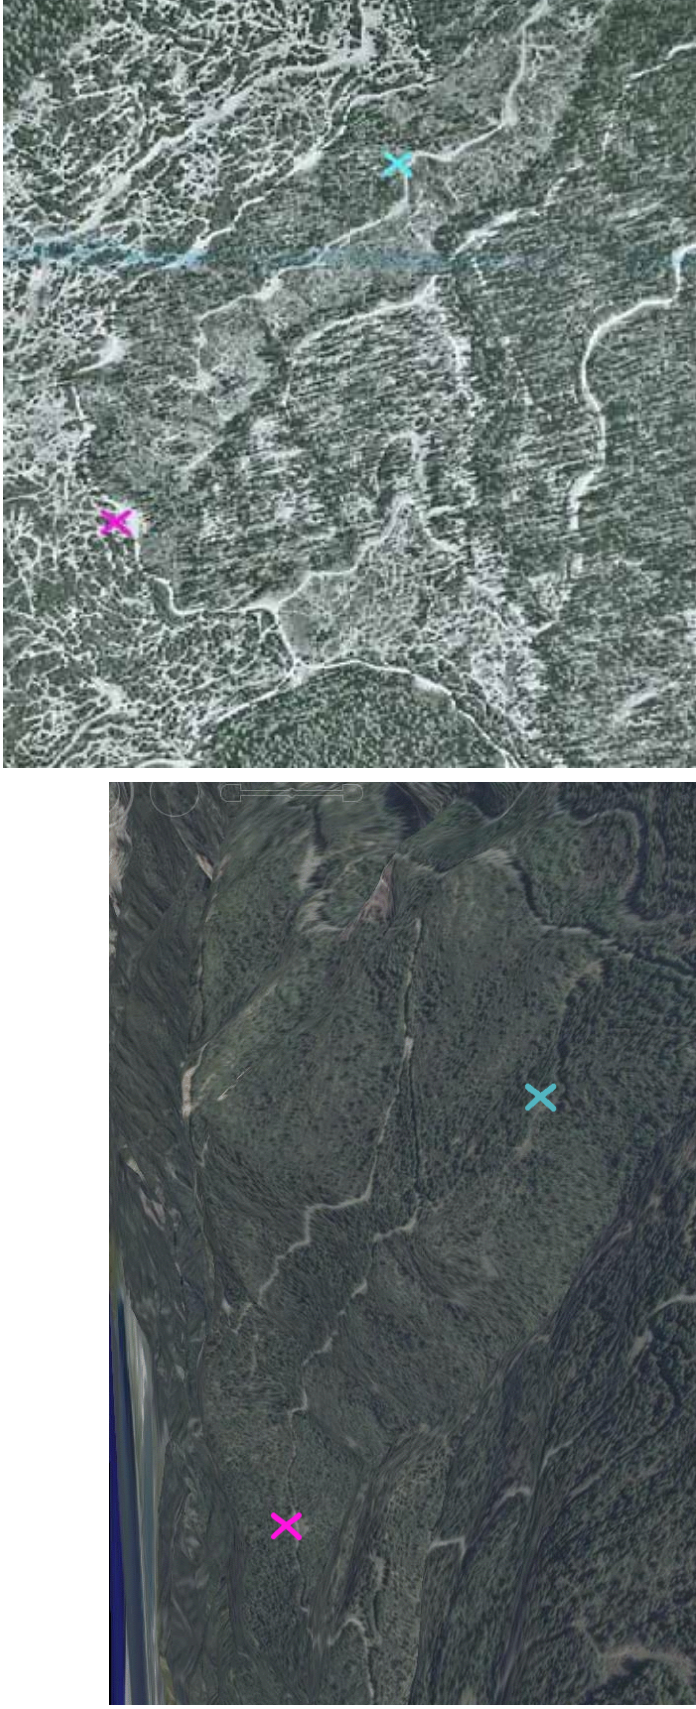
Note: At left is a 3-D view of Fish Creek in 2007. At right is the aerial photo image of the area in 1987. The two colored x's are reference point. Riparian areas are in place and have been avoided by tractors. However, hillslopes are covered with a dense network of skid trails.
