## **Section A MASS WASTING**

This module summarizes the methods and results of a mass wasting assessment conducted on the Mendocino Redwood Company, LLC (MRC) ownership in the Elk Creek watershed, the Elk Creek Watershed Analysis Unit (Elk Creek WAU). California Planning Watersheds included in the Elk Creek WAU include portions of the Lower Elk Creek (CL) and Upper Elk Creek (CE). This assessment is part of a watershed analysis initiated by MRC and utilizes modified methodology adapted from procedures outlined in the Standard Methodology for Conducting Watershed Analysis (Version 4.0, Washington Forest Practices Board).

The products of this report are: a landslide inventory map (Map A-1), a Terrain Stability Unit (TSU) map (Map A-2), and a mass wasting inventory database (Appendix A). The assembled information will enable forestland managers to make better forest management decisions to reduce management-induced risk of mass wasting. The mass wasting inventory will provide the information necessary to understand the spatial distribution, causal mechanisms, relative size, and timing of mass wasting processes active in the basin with reasonable confidence.

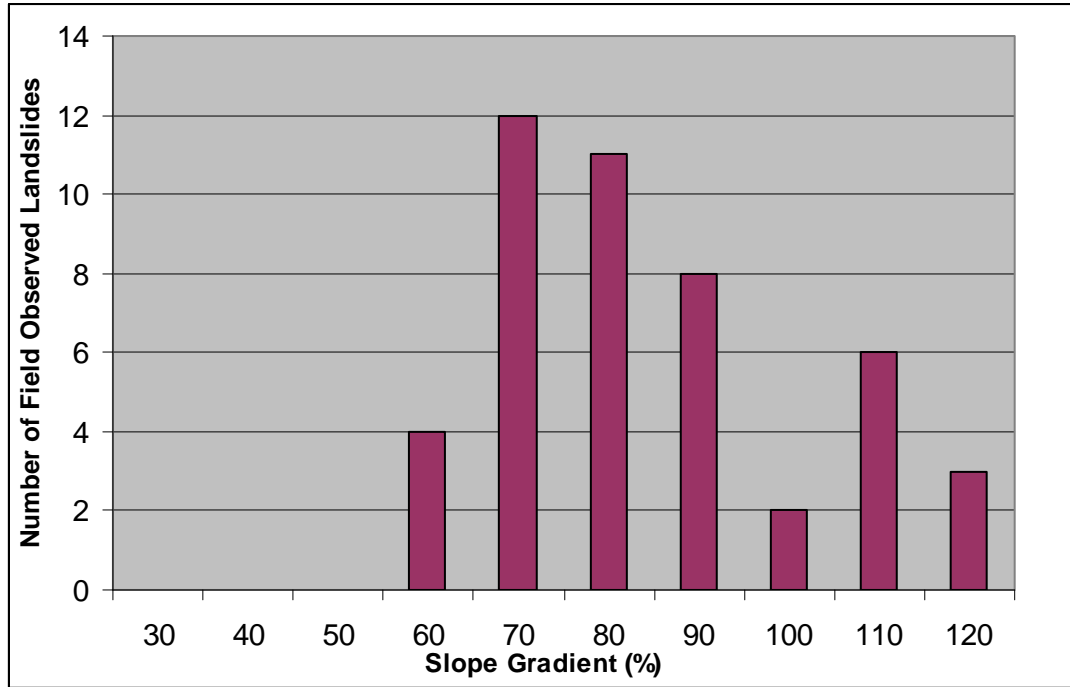
Chart A-1. Slope Gradient Histogram for Shallow-Seated Landslides Occurring on MRC Ownership in Lower Elk Creek.

Of the 46 field observed shallow-seated landslides across the MRC Ownership in Lower Elk Creek, 91% (42/46) were initiated on slopes of 70% gradient or higher (Chart A-1). Of the 60 field observed shallow-seated landslides across the MRC Ownership in Upper Elk Creek, 85% (51/60) were initiated on slopes of 70% gradient or higher (Chart A-2). Of the 106 field observed shallow-seated landslides across the Elk Creek WAU, 88% (93/106) were initiated on slopes of 70% gradient or higher (Chart A-3).

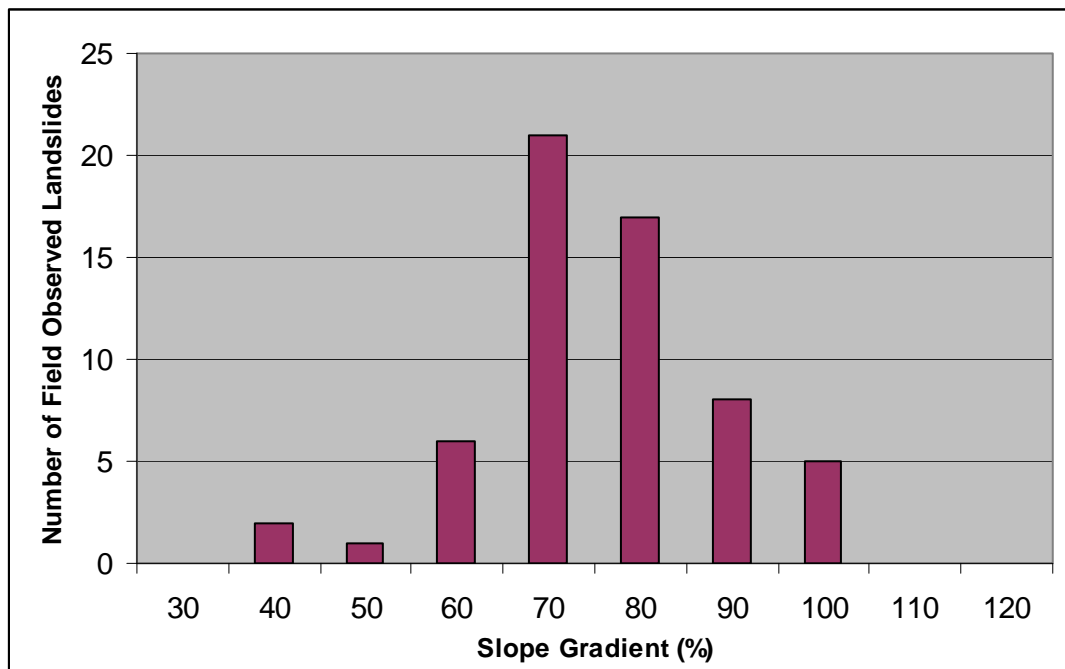
Chart A-2. Slope Gradient Histogram for Shallow-Seated Landslides Occurring on MRC Ownership in Lower Elk Creek.

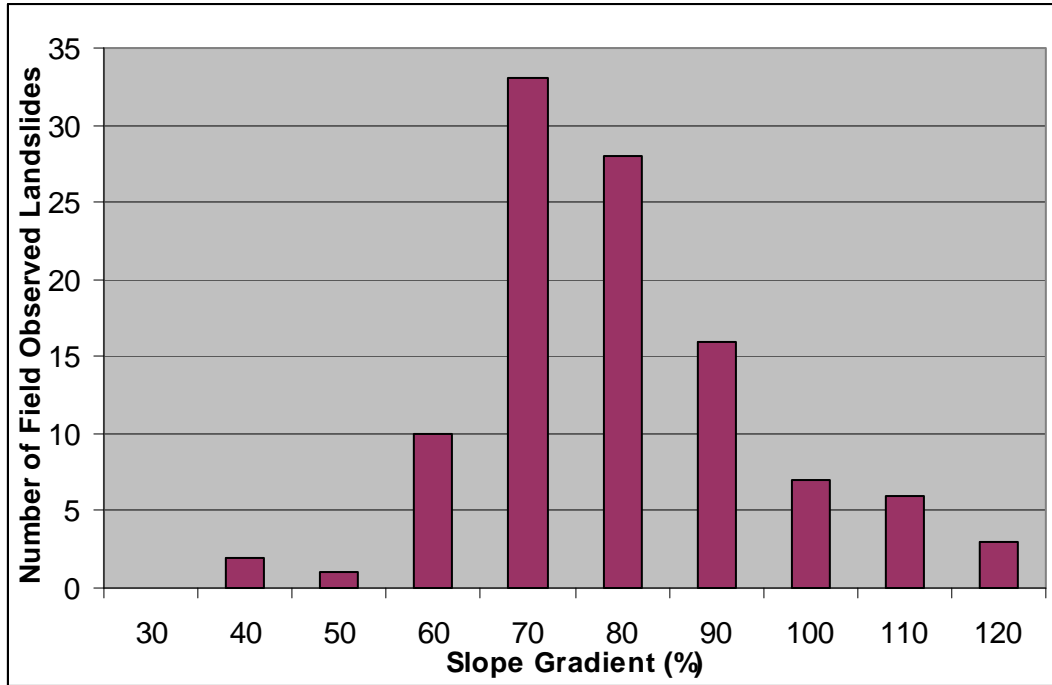
**Chart A-3.** Slope Gradient Histogram for Shallow-Seated Landslides Occurring on MRC Ownership in the Elk Creek WAU.

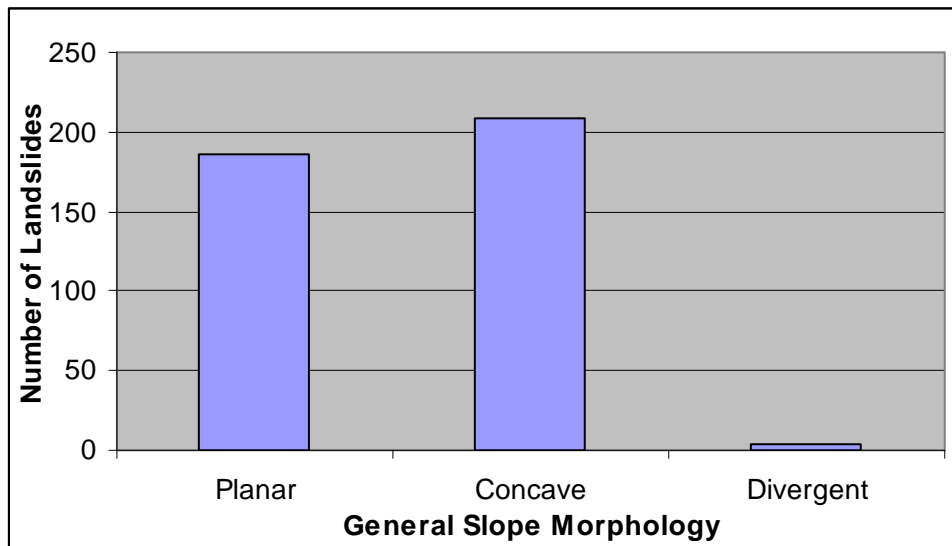
**Chart A-4.** Slope Morphology Summary for Shallow-Seated Landslides Occurring on MRC Ownership in the Elk Creek WAU.

The majority of inventoried landslides originated in convergent topography (209/399, or 52%) where subsurface water tends to concentrate, or on steep, planar topography (186/399, or 47%), where sub-surface water can be concentrated at the base of slopes, in localized topographic depressions, or by local geologic structure. Few landslides originated in divergent topography (4/399, or 1%), where subsurface water is typically routed to the sides of ridges (Chart A-4).

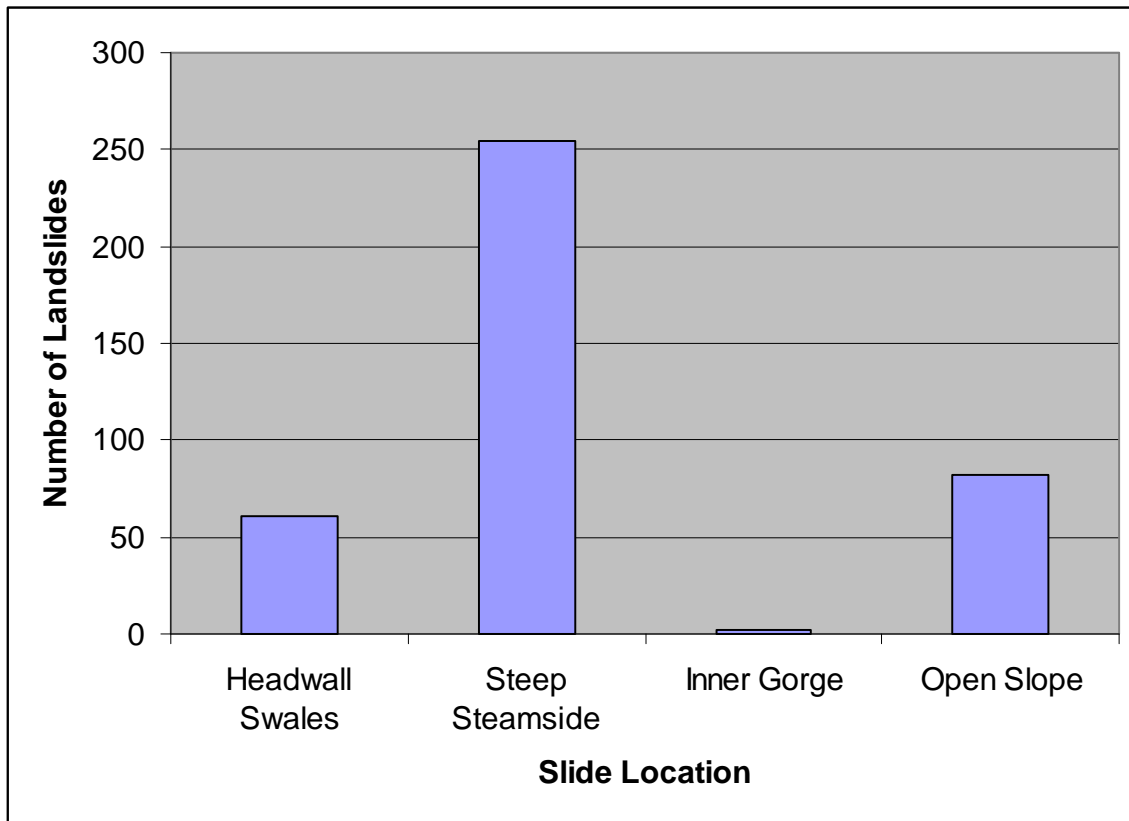
**Chart A-5.** Slide Location Summary for Shallow-Seated Landslides Occurring on MRC Ownership in the Elk Creek WAU.

A majority of the inventoried landslides were discovered along steep streamside slopes (254/399, or 64%), with fewer found in headwall swales (61/399, or 15%) and inner gorge slopes (2/399, or 1%) observed along the outside edge of meander bends. A significant portion (82/399, or 21%) of the inventoried landslides were observed on open slopes away from any inner gorge, steep streamside slopes, or headwall swales, however, a majority of these slides originated in fill material along the outside edge of roads and skid trails (Chart A-5). Such observations were, in part, the basis for the delineation of the WAU into Terrain Stability Units.

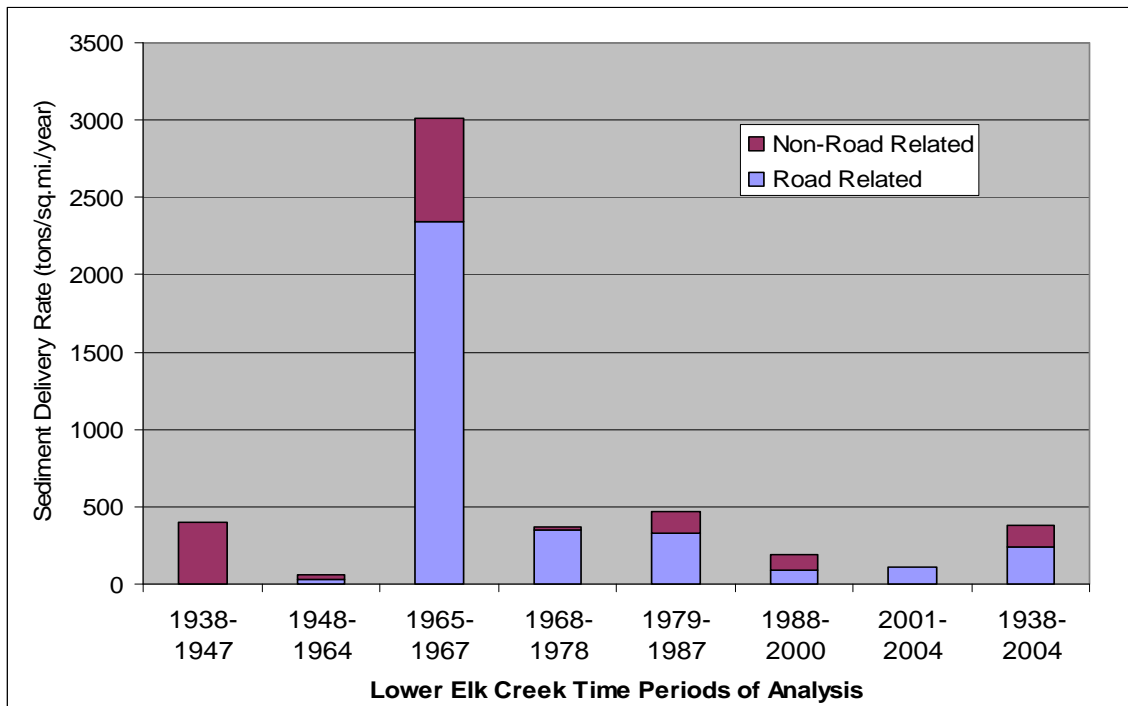
Chart A-4. Mass Wasting Sediment Delivery Rate (tons/sq.mi./year) from Landslides for MRC Ownership in Lower Elk Creek Shown by Time Period.

The sediment delivery estimates were normalized by time (years) and area (square miles) for the purposes of relative comparison between time intervals and planning watershed. The resulting sediment delivery rates in the Elk Creek WAU change dramatically over the time period investigated (Chart A-4).

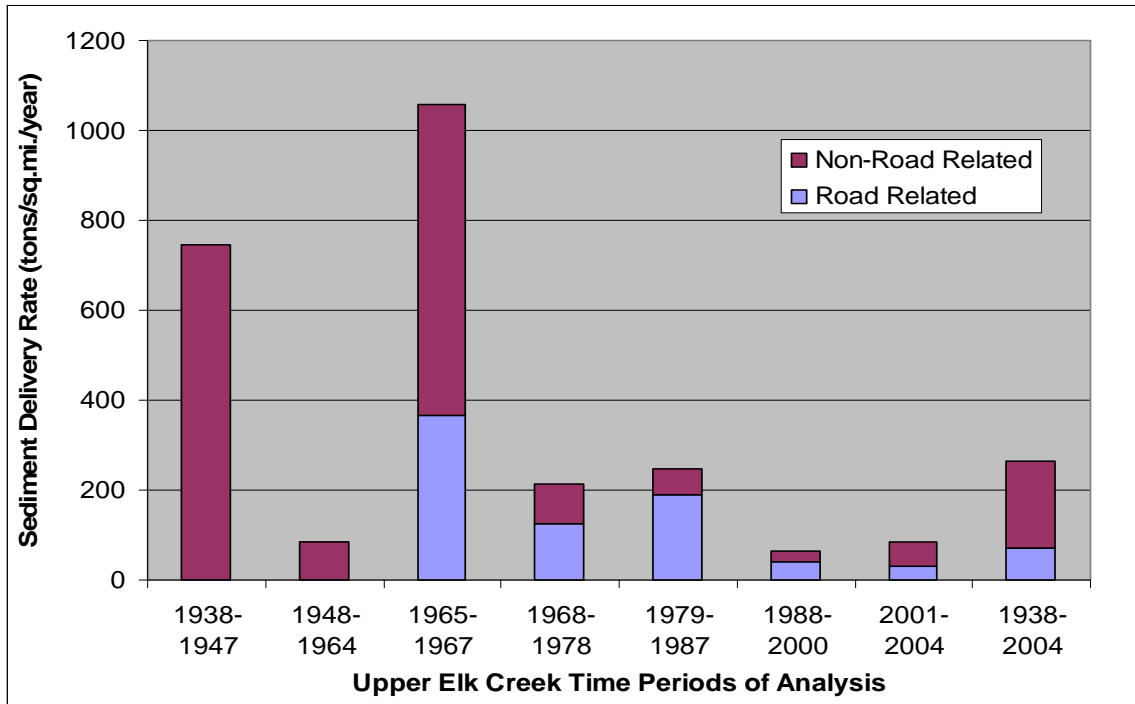
Chart A-5. Mass Wasting Sediment Delivery Rate (tons/sq.mi./year) from Landslides for MRC Ownership in Upper Elk Creek Shown by Time Period.

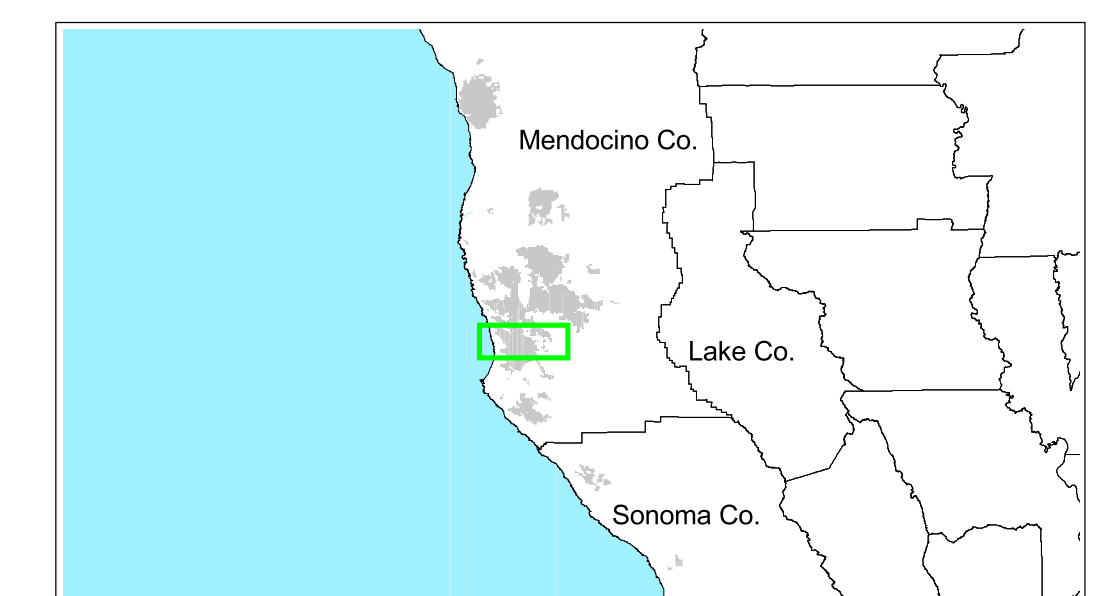
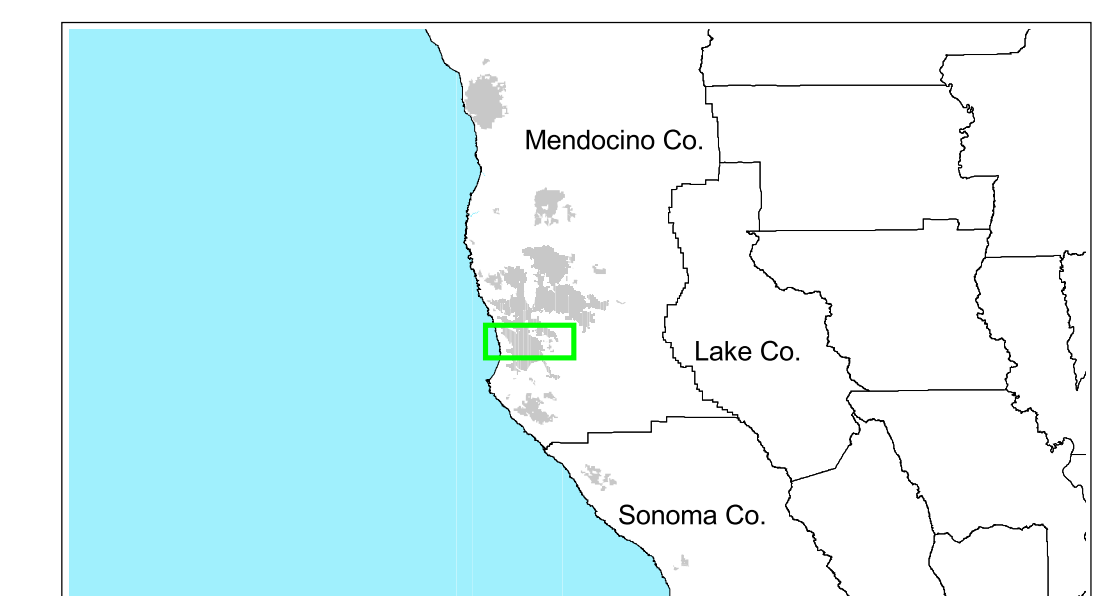
# Elk Creek Watershed Analysis Unit

- Unit 1: Inner gorge or steep slopes adjacent to low gradient watercourses
- Unit 2: Inner gorge or steep slopes adjacent to high gradient intermittent or ephemeral watercourses
- Unit 3: Dissected and convergent topography
- Unit 4: Non-dissected topography
- Unit 5: Low relief topography
- Unit 6: Identified earthflow complexes
- Unit 8: Unique geological terrain with low gradient slopes (typically <30%) that have a very high potential for surface erosion.

The landscape was partitioned into seven Terrain Stability Units representing general areas of similar geomorphology, landslide processes, and sediment delivery potential for shallow-seated landslides (Map A-2). The units are to be used by forest managers to assist in making decisions that will minimize future mass wasting sediment input to watercourses. The delineation for the TSUs was based on qualitative observations and interpretations from aerial photographs, field evaluation, and SHALSTAB output. Deep-seated landslides are also shown on the TSU map (Map A-2). The deep-seated landslides have been included to provide land managers with supplemental information to guide evaluation of harvest planning and subsequent needs for geologic review.
