Cleanup and Abatement Order Status Report- PALCO

Project CAO SF Elk 2006

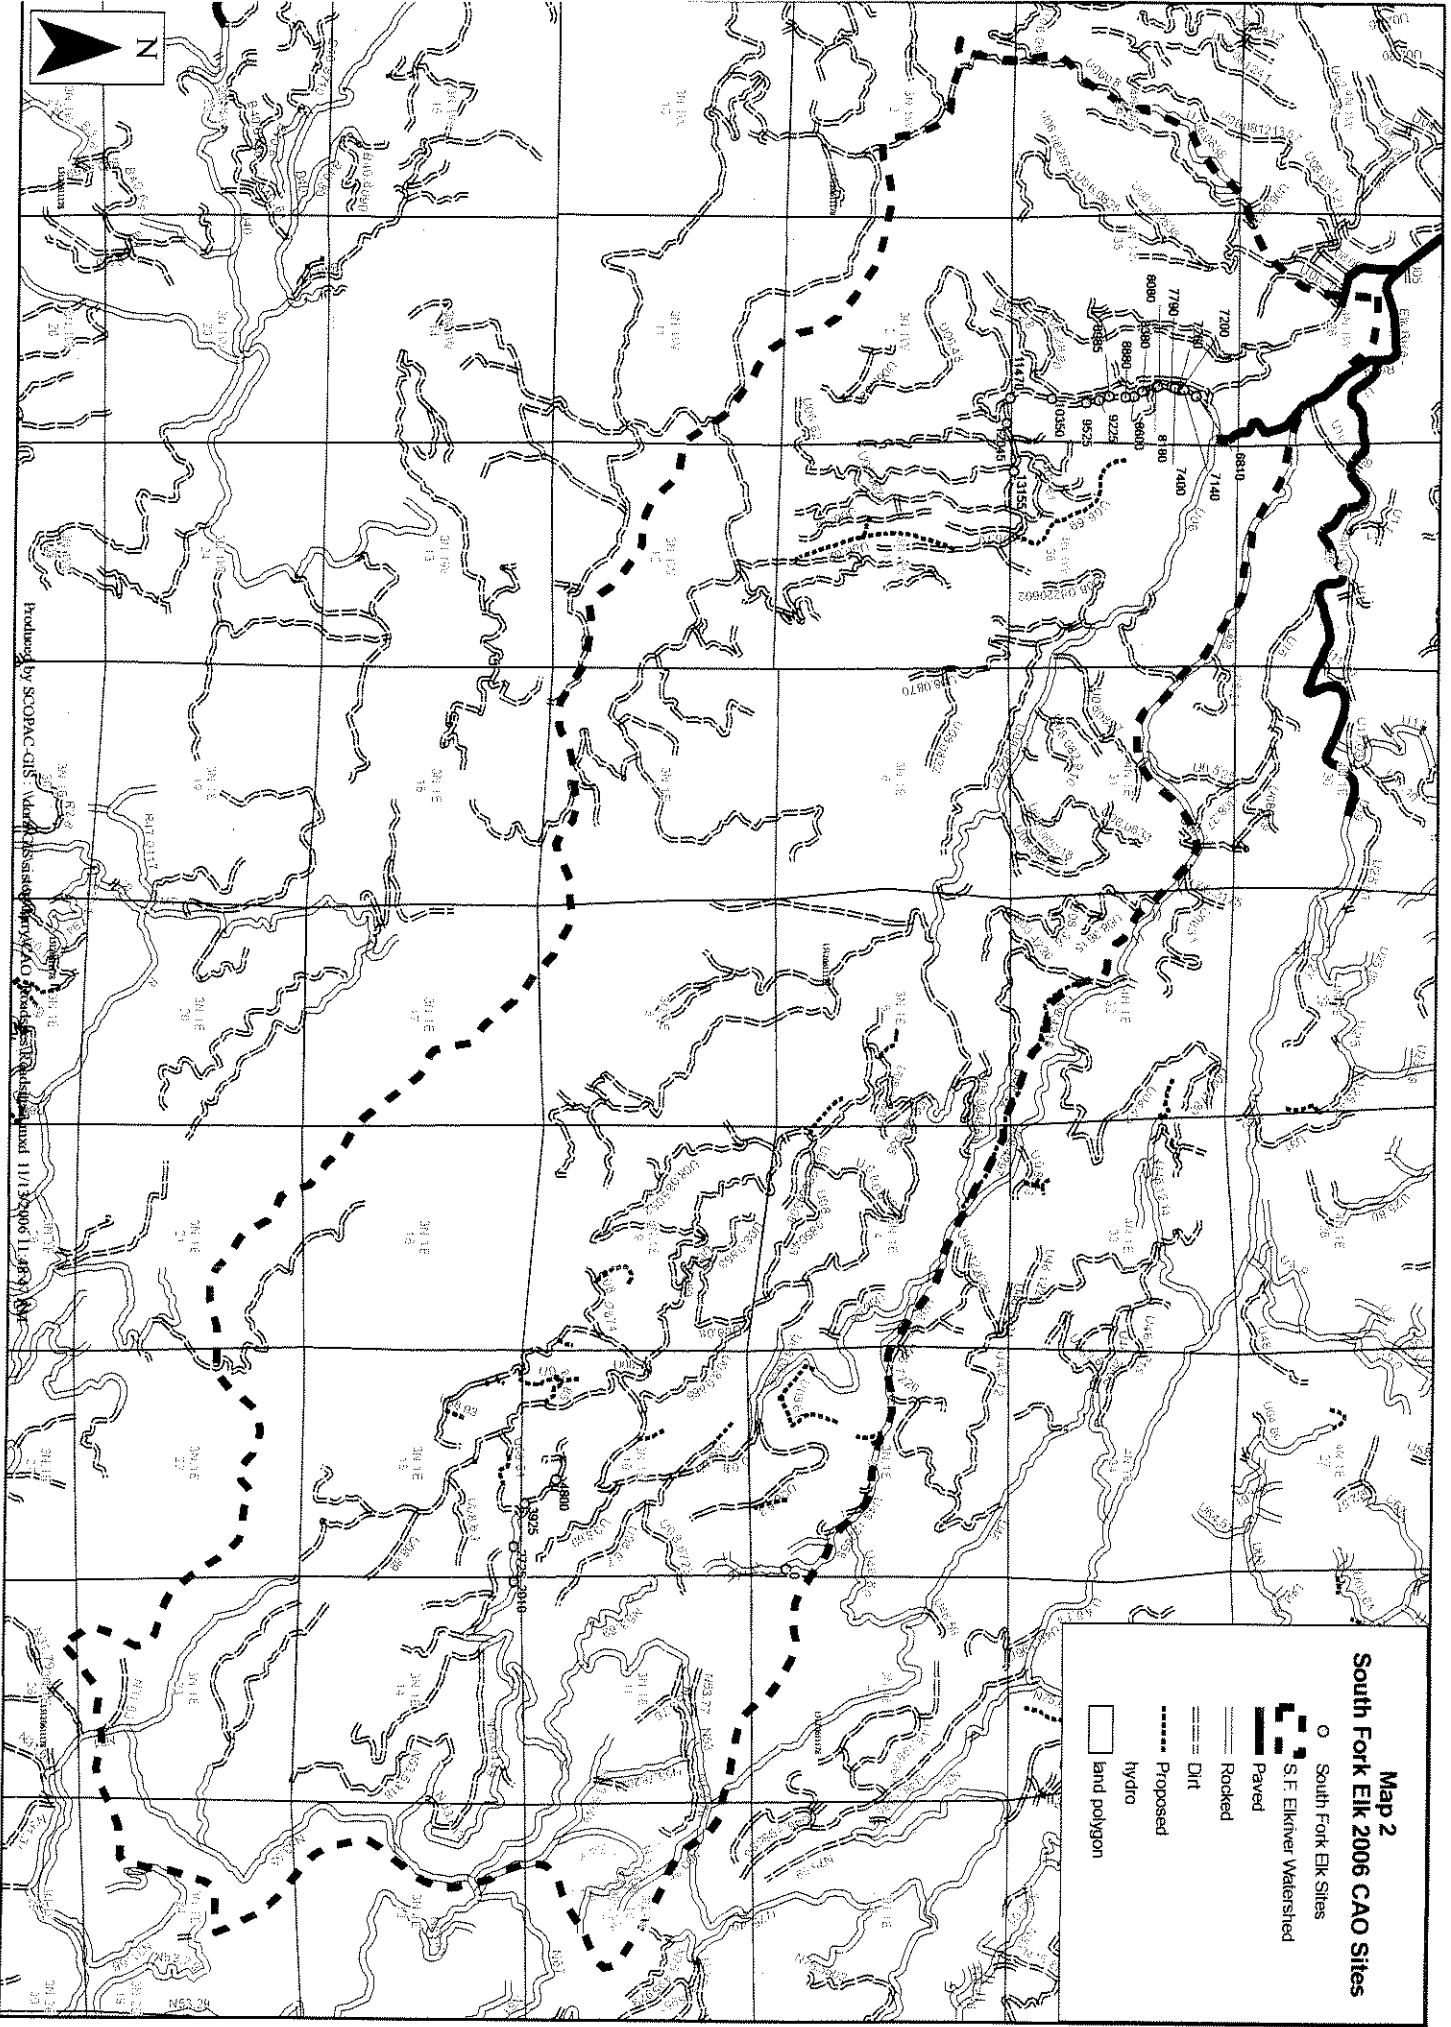
Map 2
South Fork Elk 2006 CAO Sites

- South Fork Elk Sites
- ▣ S. F. Elkriver Watershed
- ▬ Paved
- ▬ Rooked
- ▬ DIRT
- ▬ Proposed
- ▬ hydro
- ▭ land polygon

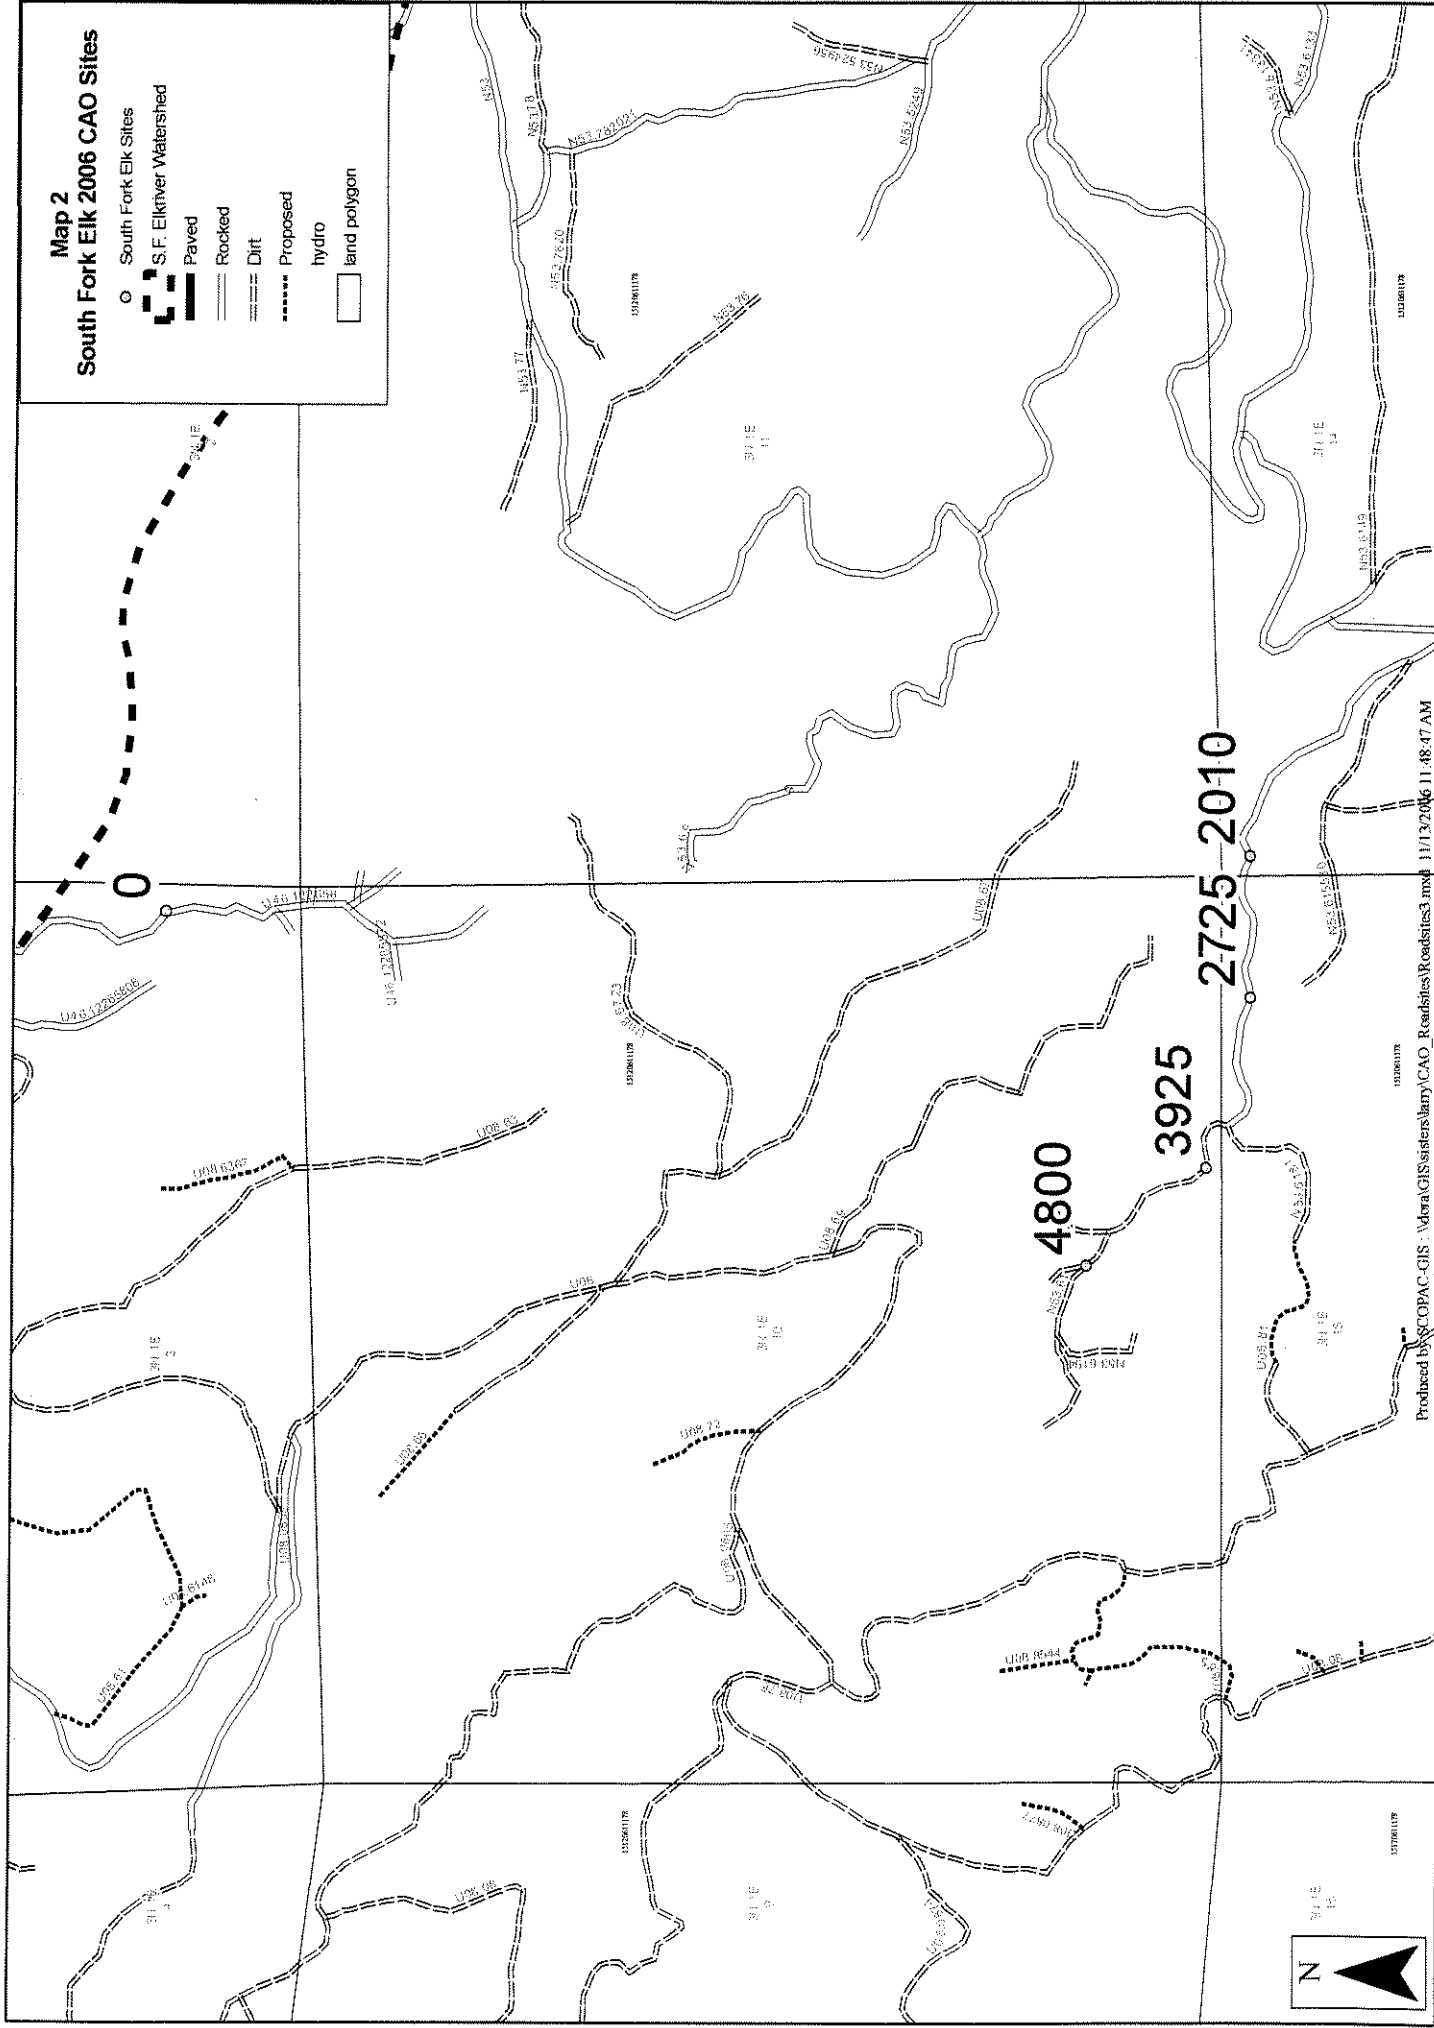
Map 2
South Fork Elk 2006 CAO Sites

- South Fork Elk Sites
- ◻ S.F. Elkriver Watershed
- ▬ Paved
- ▬ Rocked
- ▬ Dirt
- ▬ Proposed
- hydro
- ▭ land polygon
